Inspection Report

John and Jessie Doe - SAMPLE REPORT ONLY

Property Address:
9954 S Main Ave
Surprise AZ 85379

Shining Light Home Inspection Services, LLC

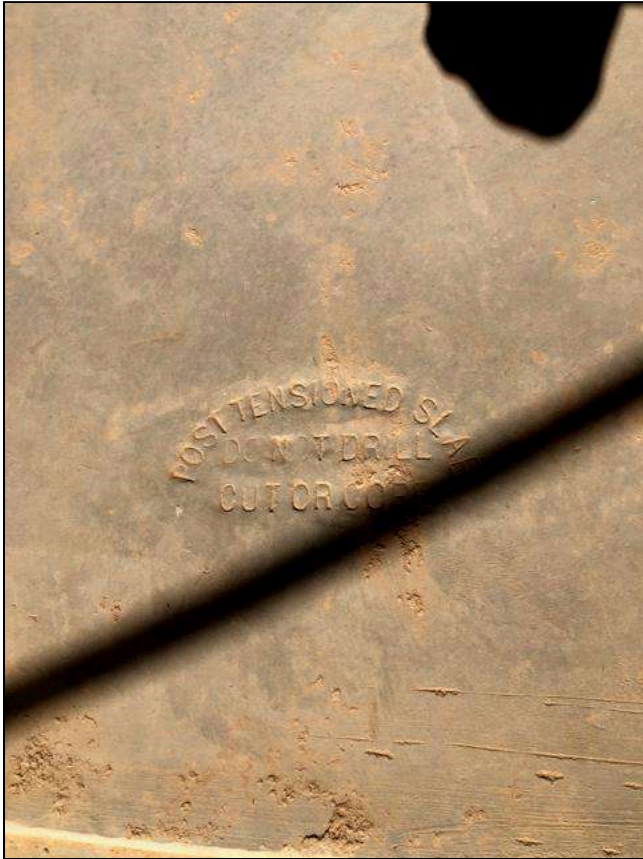
1.0 Item 1(Picture)

1.0 This post-tension concrete slab was visually observed to be at grade, visible within the garage, throughout the framed house and at various locations around the external structure. Except as noted elsewhere in this report, it

appeared to be in satisfactory condition where it was visible and functioning as intended.

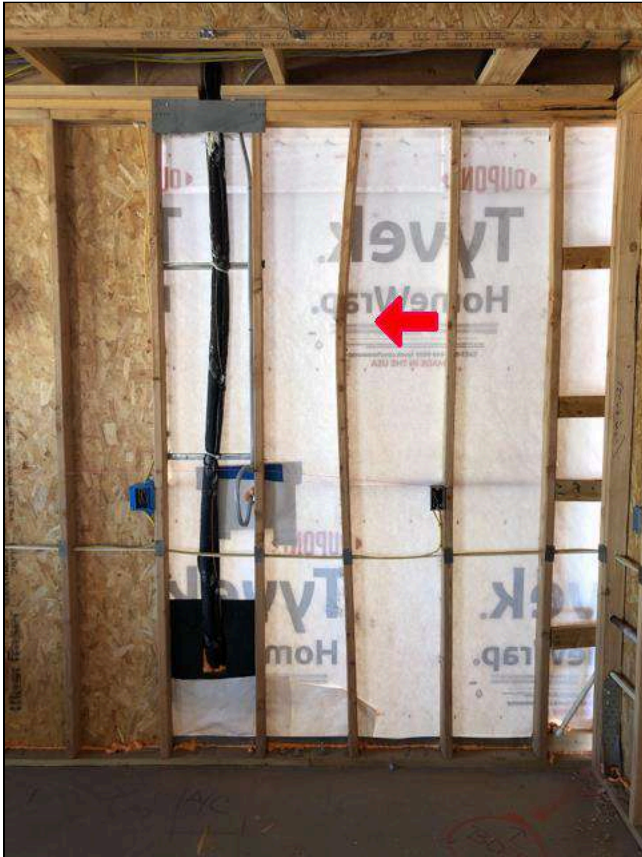
1.1 Item 1(Picture)

1.1 (2) On a date of inspection I am observing more than one wall stud, including those for load-bearing walls, that are warped, bowed, torqued, or have significant cracks in them. Some of these are significant enough such that nails that were supposed to attach to them from the outside or unable to. I recommend discussion with the builder to determine appropriate remediation which may include adjustments, Repairs, or replacement. **Attention**

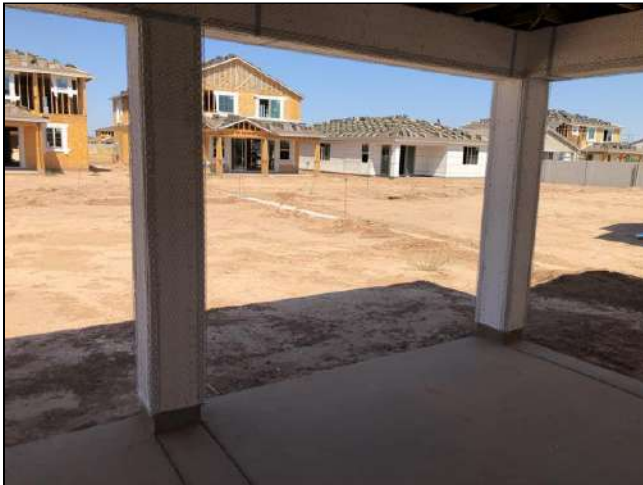
1.5 Item 1(Picture)

1.5 Columns were observed on the both the front porch and the back covered patio. The visible portions of these support columns for the covered front porch and the rear screened in patio cover appeared to be in satisfactory condition during on the date of this home inspection, however the structural portions are prepared for stucco over-coating and not visible during the inspection. Normal cosmetic, wear and tear are considered to be permissible.

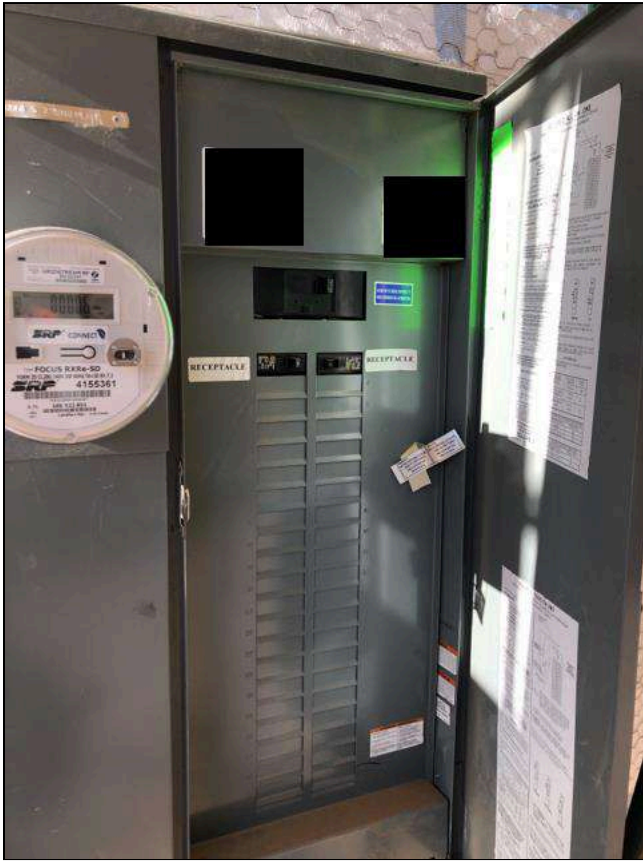
2.0 Item 1(Picture)

2.0 Due to the design of the main electrical panel, the service conductors could not be observed.

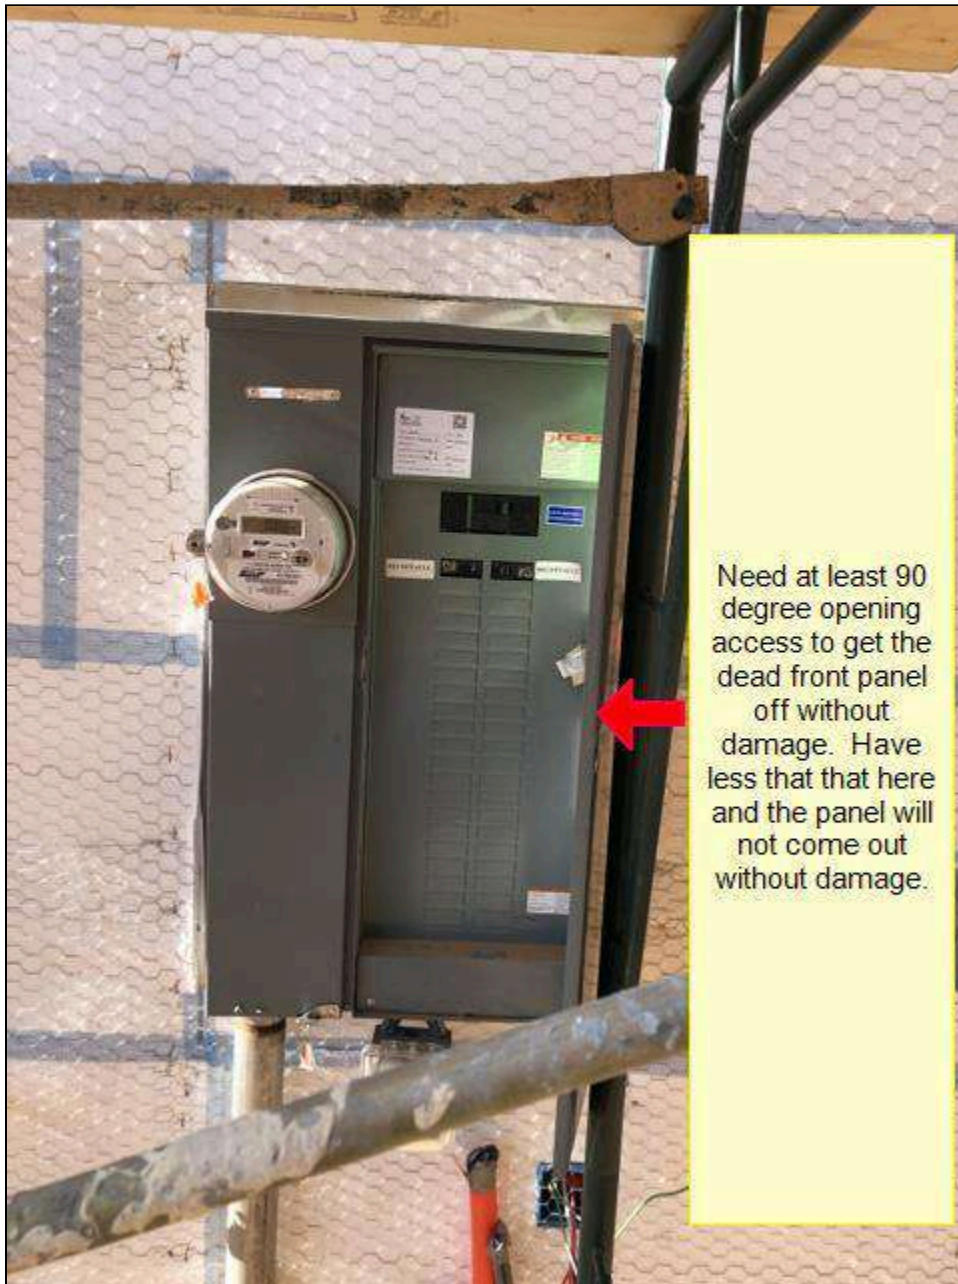
2.1 Item 1(Picture)

2.1 (1) On the date of inspection, due to the location of the scaffolding for the stucco preparation, I was unable to open the dead front panel to investigate the wiring behind. Observing throughout the house however, I can see that there is at least one aluminum wire going to at least the air conditioning unit. On the final inspection we will make sure that they have an antioxidant coating on them in the electrical panel. This will be completed on the date of final inspection. This is for your information

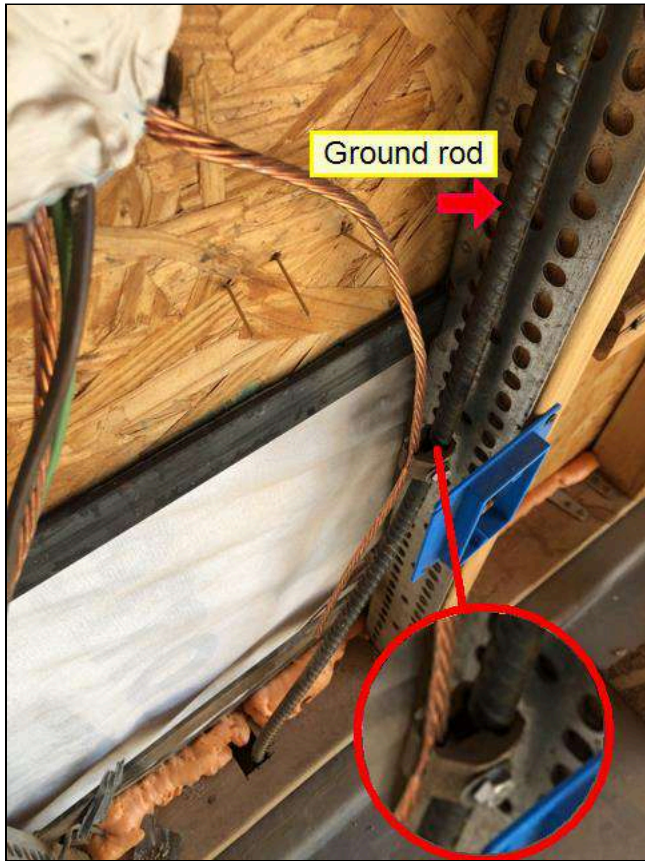
2.1 Item 2(Picture)

2.1 (2) There are two main grounds from the panel into the property which should go to the grounding rod. However only one is connected to the grounding rod. The other one appears to be set for a gas pipe which is not here. I recommend that this be a discussion with the builder to find out how these are going to be taken care of prior to drywall and stucco. **Attention**

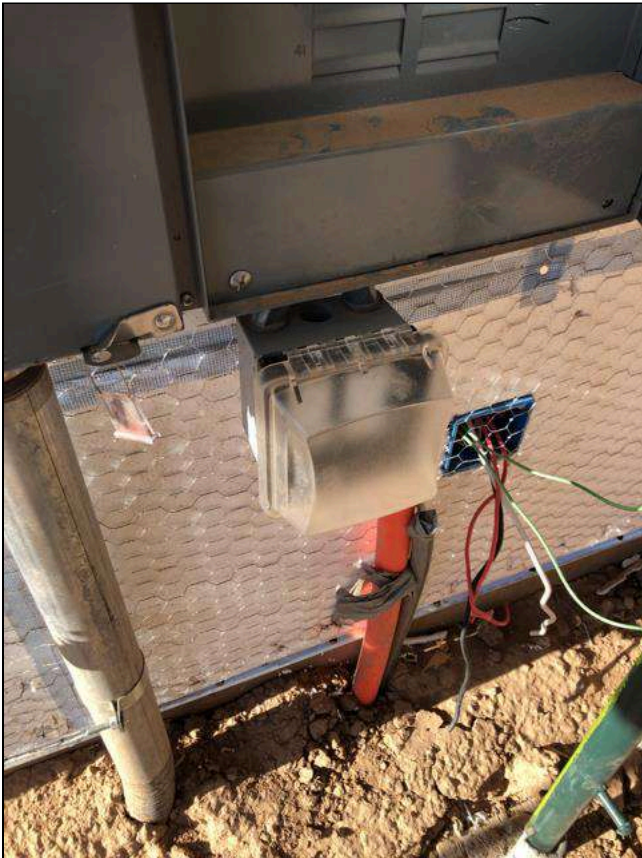
2.4 Item 1(Picture)

2.4 (2) On the date of inspection, the receptacle box on the bottom of the main panel was loose. I recommend discussion with the builder to assure that this is tightened down prior to closing. **Attention**

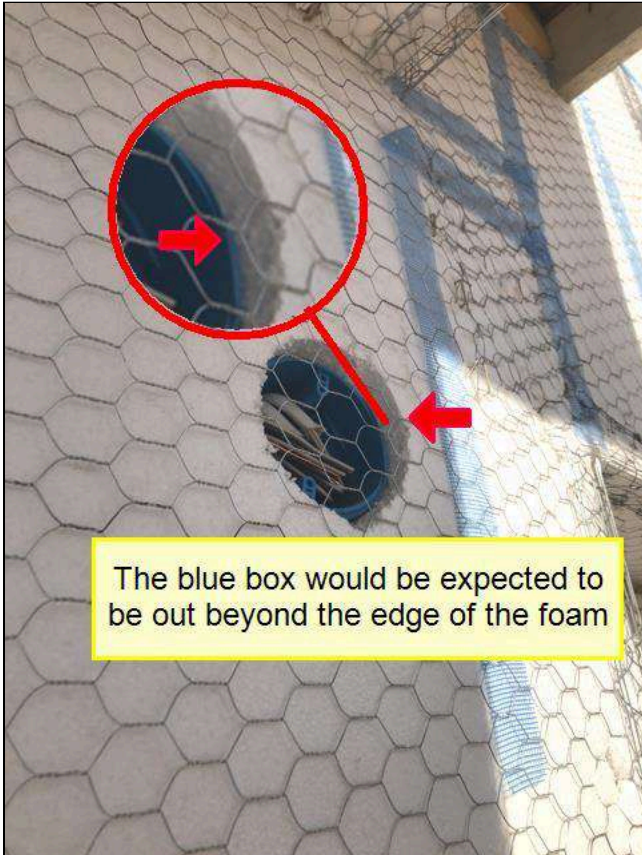
2.6 Item 1(Picture)

2.6 (2) Exterior lighting fixture on the front porch column is not showing the quarter inch from final finish as is expected. This may cause an issue with the fixture adhering properly to the wall so that no moisture or insects can get behind it. I recommend that this be discussed with the builder to bring this out such that it is at the proper length or that an additional fixture can be applied to bring this to standard. **Attention**

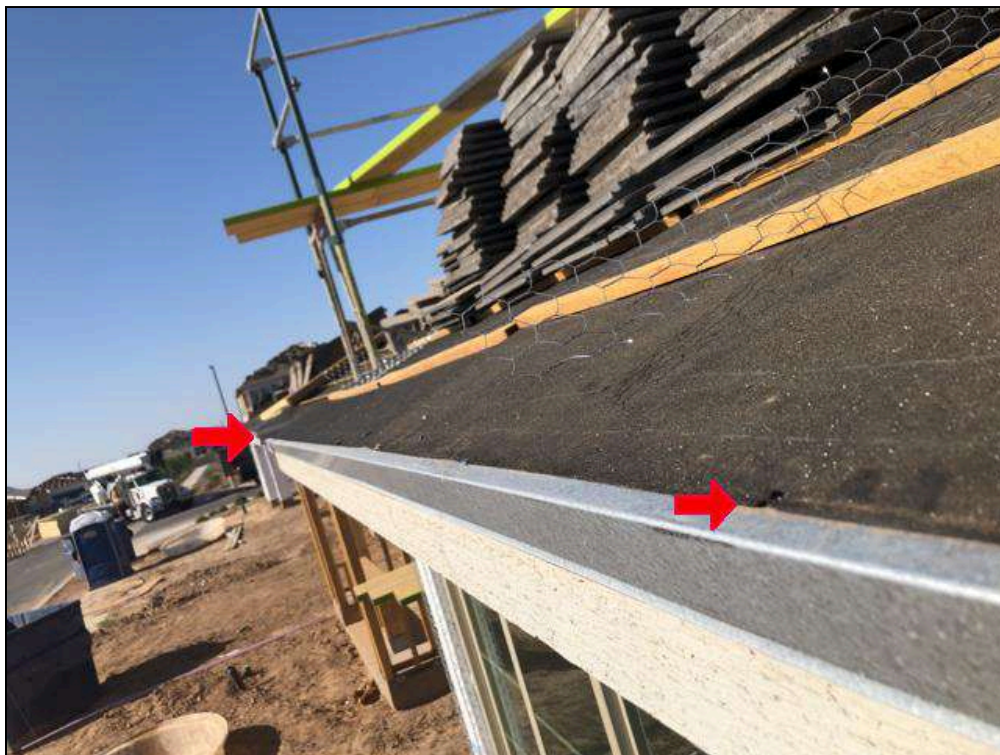
3.1 Item 1(Picture)

3.1 Underlayment that is visible on the roof is not yet sealed at all edges as would be expected and are not properly nailed down. It is also standing up from the metal drip edge in some places. It should be installed over the metal drip edge and then sealed once it is in place. I recommend asking the builder when the final sealing for the underlayment will occur for this property. **Attention**

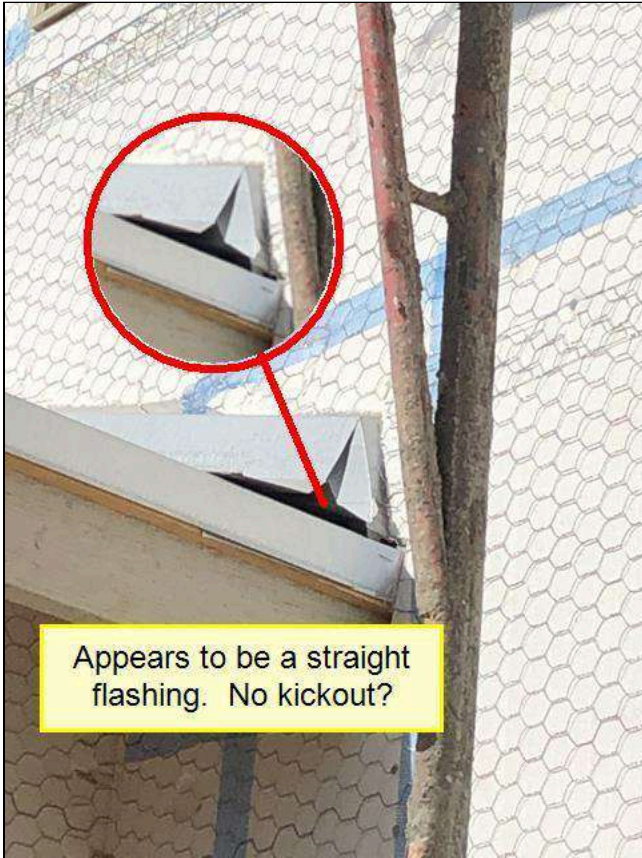
3.3 Item 1(Picture)

are meant to keep water away from a wall interface to a roof such that the wall does not become soaked with water. I recommend discussion with the builder determine when they kick out flashings will be installed prior to stucco.

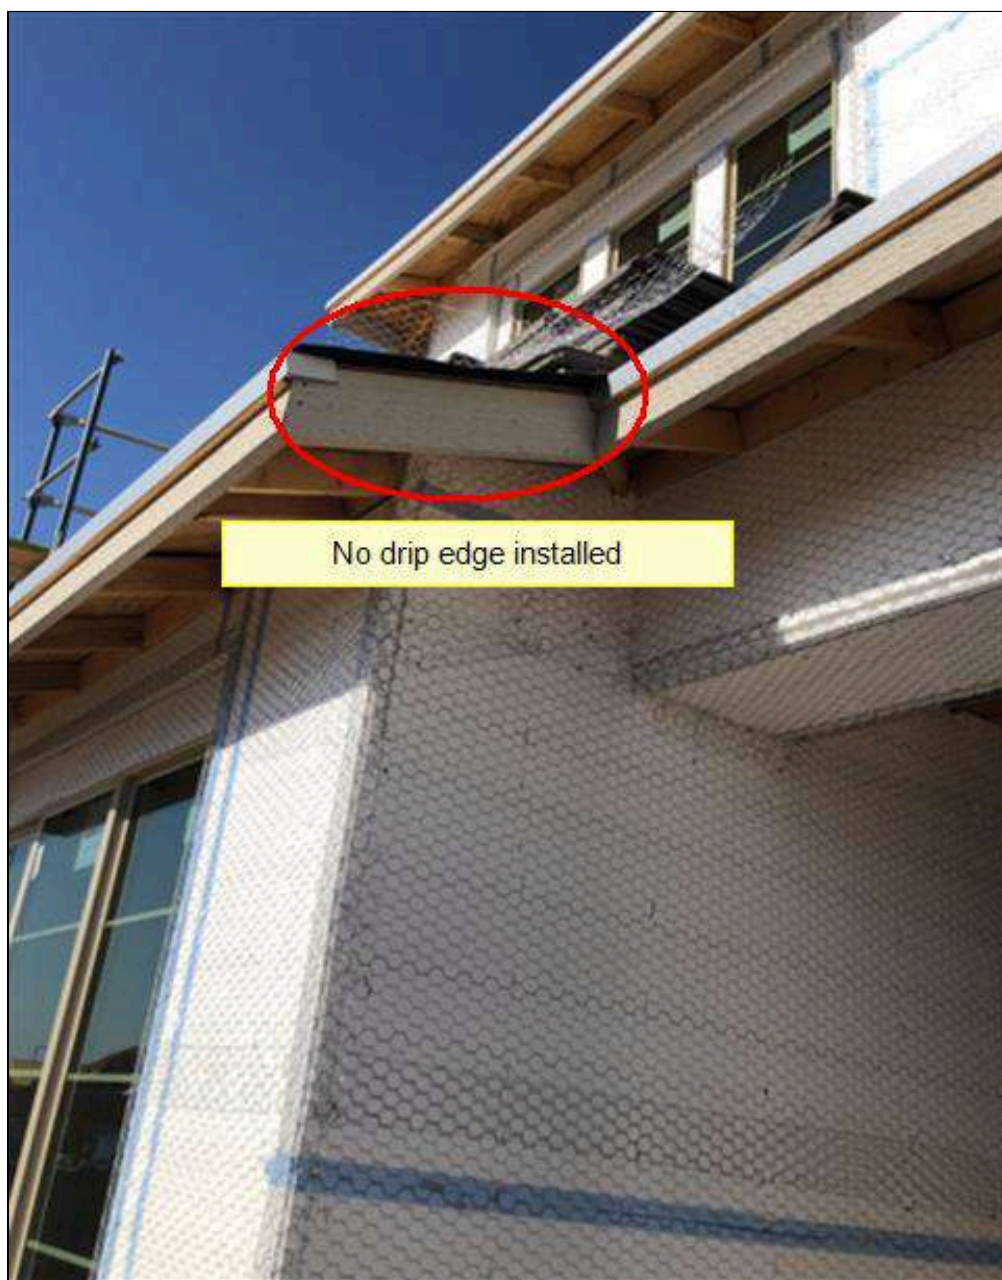
3.6 Item 1(Picture)

3.6 Metal drip edge is missing or open in some locations. In other locations it is well wrapped and overlapped. I recommend reviewing this with the builder to a sure that it is properly and fully install. **Attention**

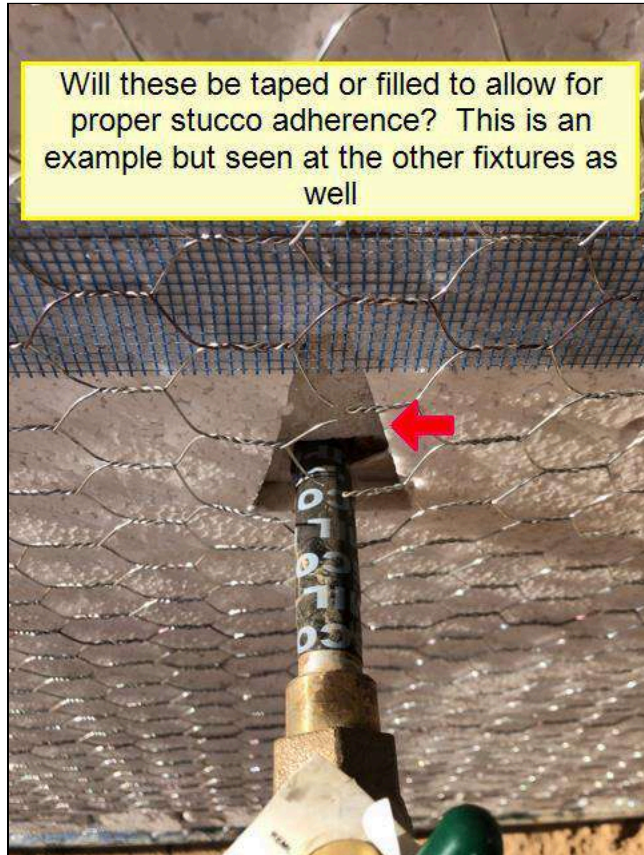
4.1 Item 1(Picture)

4.1 (2) Taping of all stucco joints or holes in the styrofoam sheeting under the lathing is not completed. Observing some holes around fixtures that are also larger than expected. I recommend discussion with builder regarding these joints that are not currently taped. **Attention**

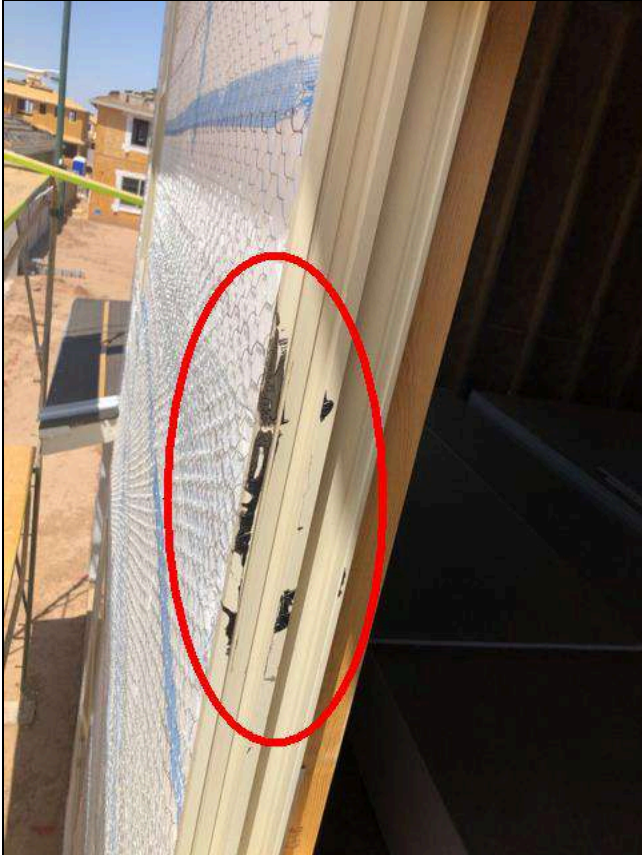
4.3 Item 1(Picture)

4.3 (2) Second-floor window in the south west side of the second floor is marred with some kind of tar. It appears to be roof tar of some sort. I recommend discussion with the builder to determine when this will be cleaned or replaced.

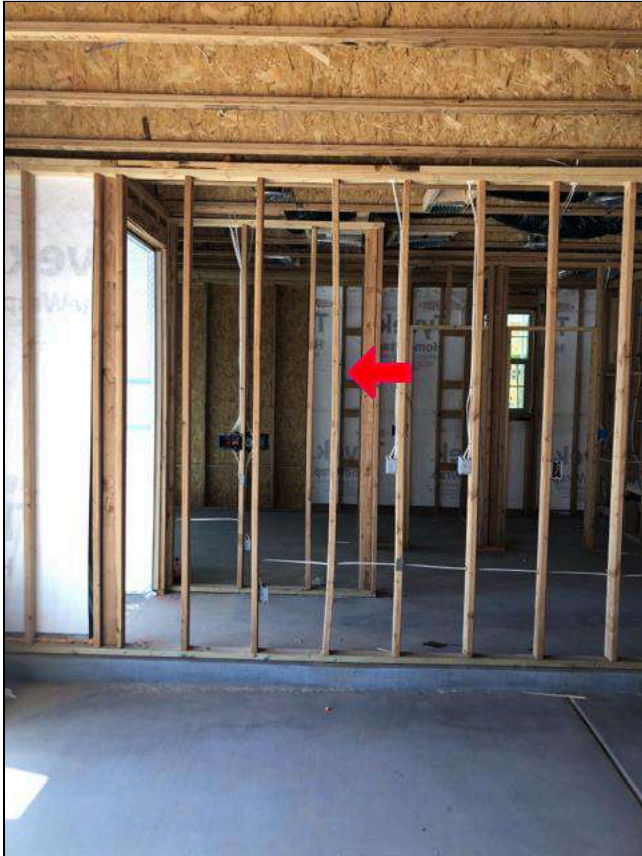
5.1 Item 1(Picture) Garage

5.1 (2) There are a number of studs in the home that are warped, significantly cracked or torqued. I recommend that these be reviewed with the builder for repair or replacement as needed. **Attention**

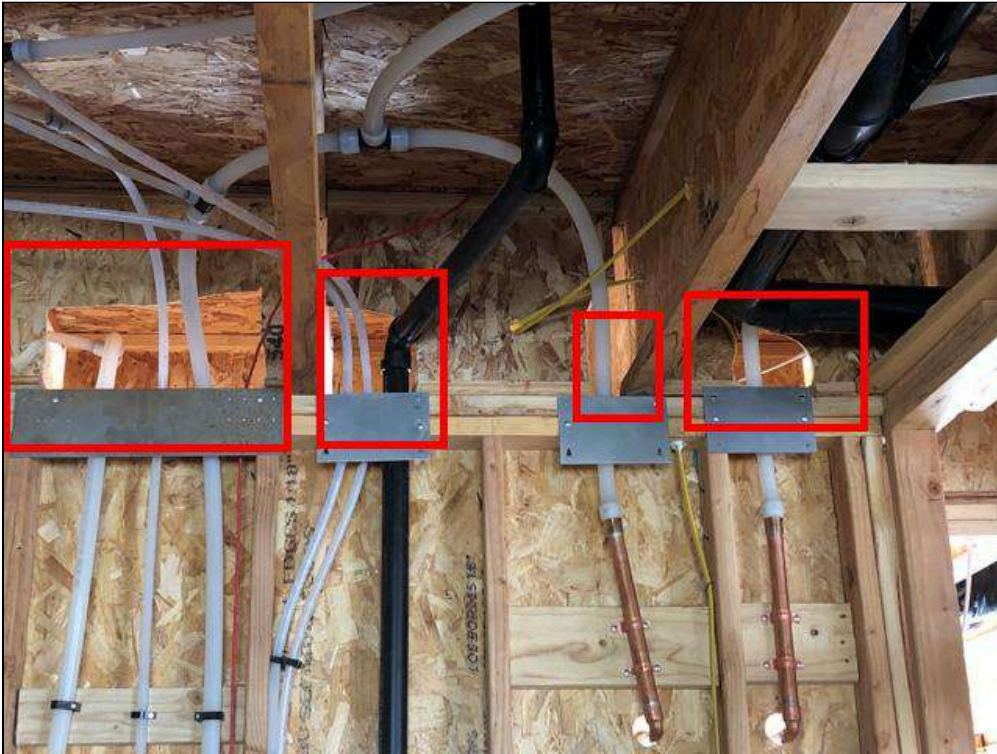
5.3 Item 1(Picture) Kitchen area

5.3 (2) On the date of inspection, I am observing a few of the I-beam flanges that have been cut away and are no longer in place. These are not just minor or allowed notching: the entire flange has been cut away. This will deteriorate the load carrying capability of these I-beam flanges. I recommend discussion with the builder on why these flange cuts are allowed in this circumstance, what they will do to restore the load carrying capability of these joists (if this is needed) and if these cuts were approved by a structural engineer. **Attention**

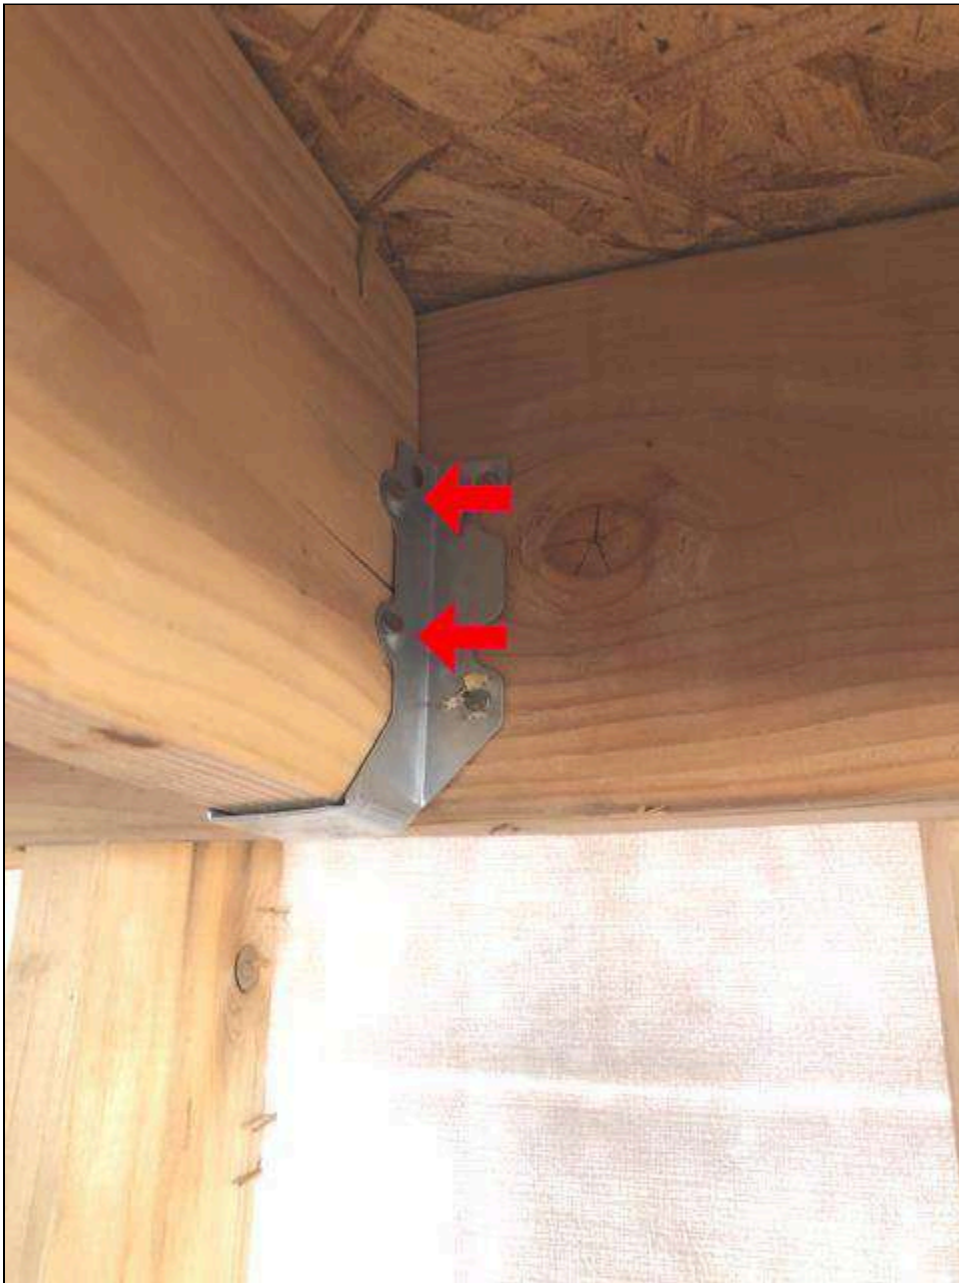
5.4 Item 3(Picture)

5.4 (2) On the date of inspection, looking at the joist hangers being used for the steps and the landing, I am observing a similar situation to the patio cover joist hangers where not every hanger hole that should have a nail in it has been nailed. Also a few that appear to be deformed. I recommend this be discussed with the builder for remediation. **Attention**

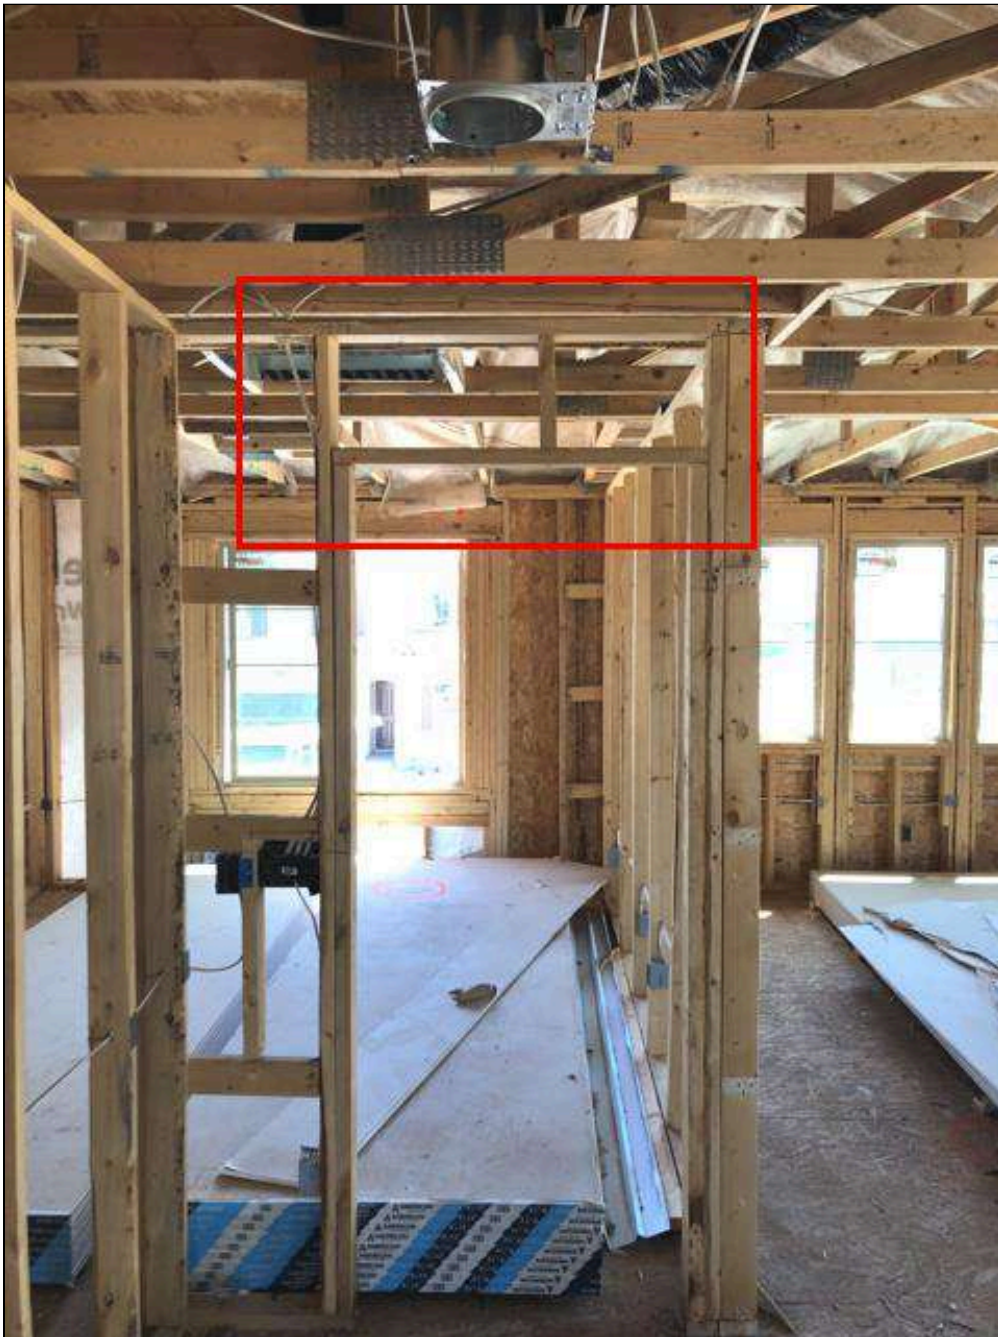
5.11 Item 1(Picture)

5.11 Interior door headers on the home are only one, flat 2 x 4 versus the expected two 2 x 4 laid flat. Exterior doors appear to be framed properly with at least a 2 x 8 header. These interior door jams are framed the same as would be typical into an archway or walkway. This type of door framing is in use today for some interior doors where there is little load. I recommend discussion with the builder to assure that the size and construction of these interior door headers are appropriate to the expected load. **Review**

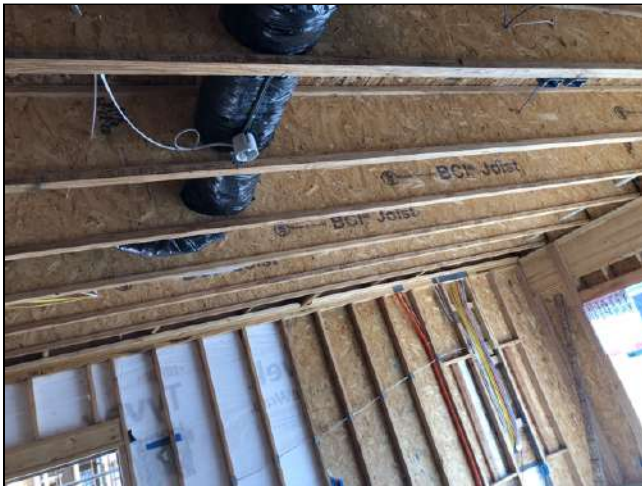
6.0 Item 1(Picture)

6.0 Garage ceiling was visually observed and appeared to be functioning as intended on the date of inspection. Note that when this garage ceiling is drywall, it must use 5/8 inch type X drywall minimum. This is required and builder must assure that this occurs. Observed that on the date of inspection, there is drywall on the second floor however it is all half-inch drywall. I see no 5/8 type X drywall at the job site on the date of inspection.

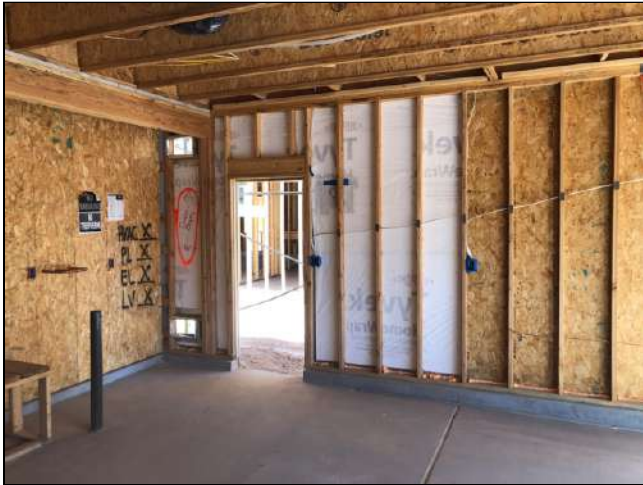
6.1 Item 1(Picture)

6.1 Garage walls were visually observed and appeared to be functioning as intended on the date of inspection for the period of construction. Firewall separation between house and attached garage is framed in and will be reviewed once drywall is in and finished.

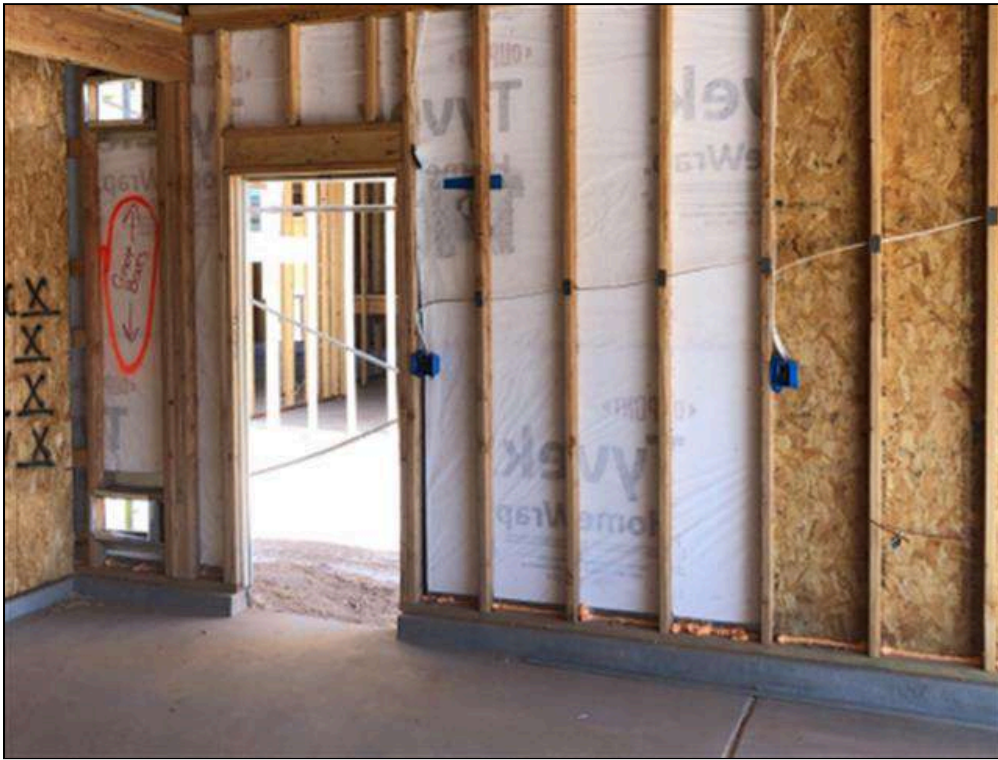
6.6 Item 1(Picture)

6.6 The additional service door is properly framed with an appropriate header for an exterior door.

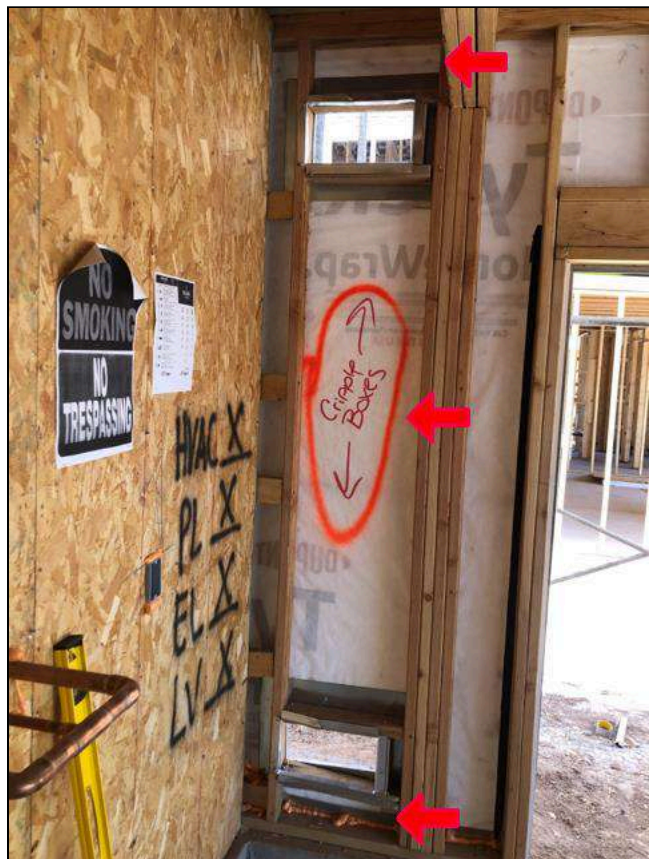
6.7 Item 1(Picture)

6.7 (2) On the date of inspection, I noticed that the vent insulations were not crippled and there is a note on the wall to cripple these boxes prior to drywall. Also on the lower vent they support lower support needs to be replaced prior to crippling. Recommend discussing with the builder to ensure this happens prior to drywall. **Attention**

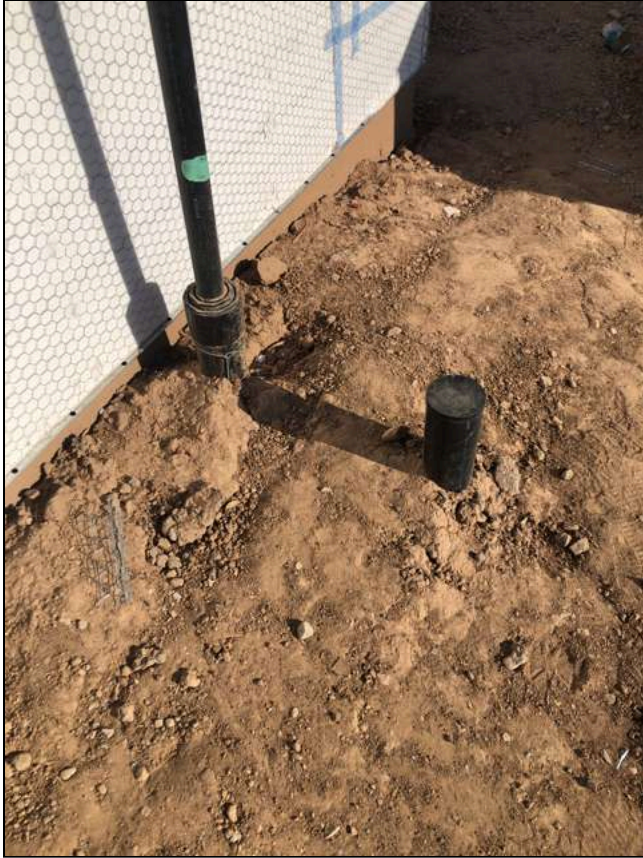
8.0 Except as may be otherwise noted in specific comments the drain, waste and vent systems within this property were roughed in and properly supported. Materials observed to be appropriate to the application and functioning as intended.

8.0 Item 1(Picture) Exterior clean outs

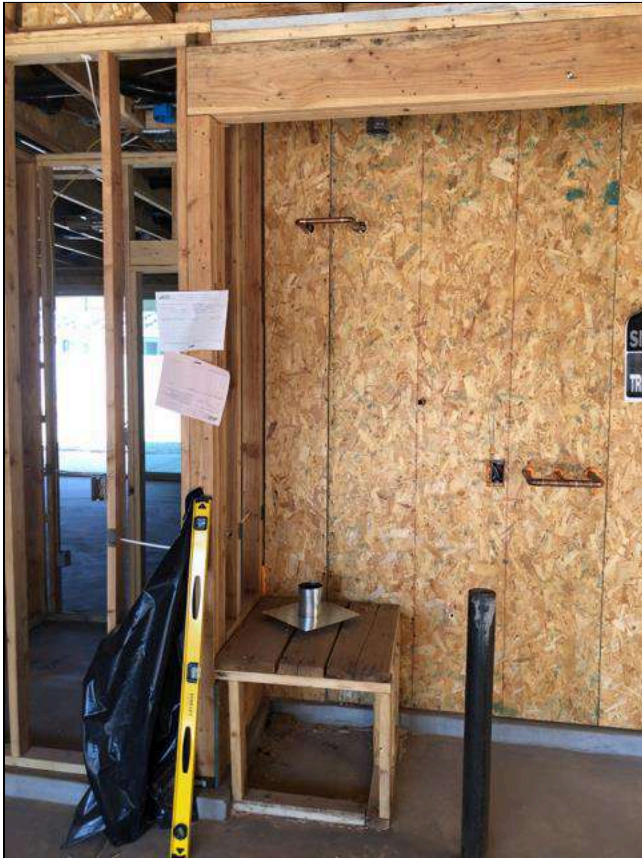
8.3 Item 1(Picture)

8.3 Hot water system appears to be intended as a traditional gas water heater inside of the garage. It was not yet installed, is roughed in without gas stubbing and could not be inspected fully. The flue for this installation is double walled exhaust and it at least 1" from flammable materials. Plumbing appears to be in place for both TPR and secondary containment pan. TPR is copper with CPVC in the walls. This is ok

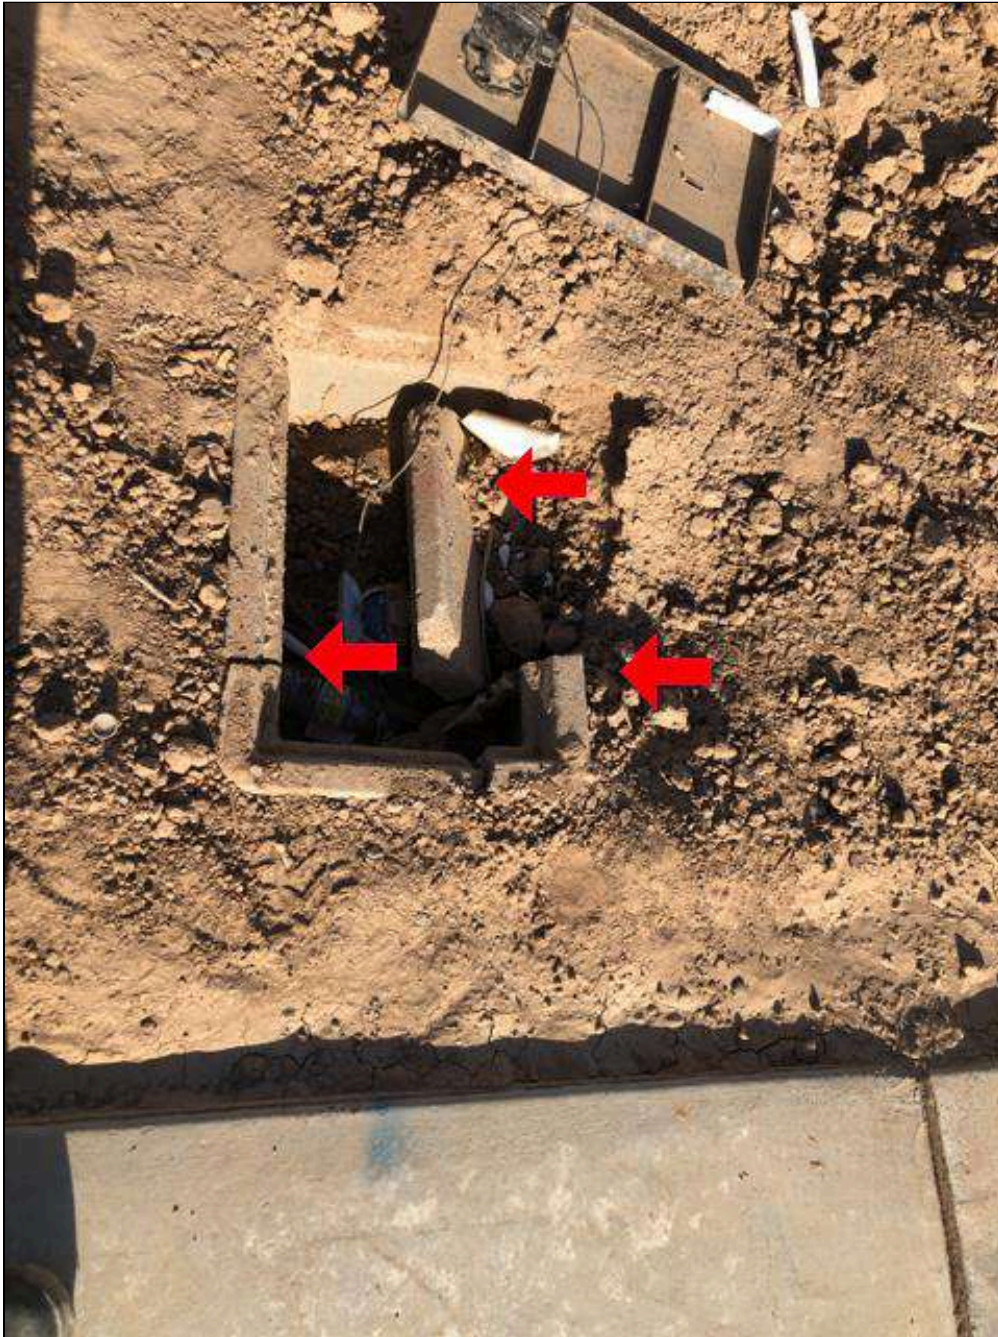
8.4 Item 6(Picture)

8.4 (3) On the date of inspection the concrete retaining walls around the meter and main shut off valve is broken in numerous places. This will not work as the final to set the meter or to set up for the long term. I recommend discussion with the builder on when this containment will be replaced by the builder. **Attention**

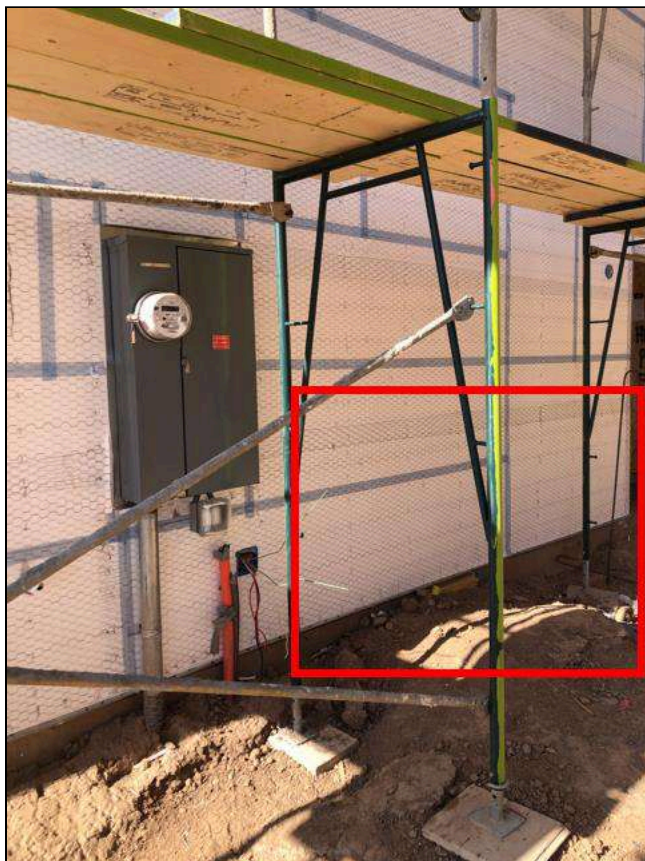
8.5 Item 1(Picture)

8.5 On the date of inspection, I am not observing the presence of a gas line to the property nor a gas installation within the home even though I am seeing others in the neighborhood. I do, however, observe some yellow PVC or plastic piping that would appear to be used for gas pipe. I am also seeing the beginnings of installation for a gas water heater as well as a gas furnace in the attic. This appears to be a rather large missing. I recommend discussion with the builder to determine how this is to be resolved. **Attention**

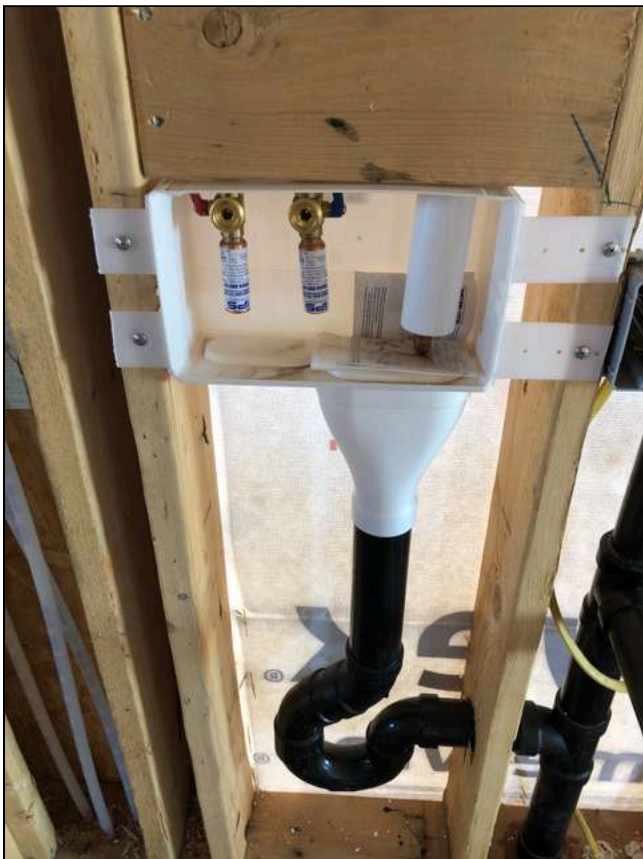
11.0 Item 1(Picture)

Note, as this is a second story laundry room it would be advisable to assure that the washing machine is installing into a secondary (spill) water containment pan plumbed to the exterior. I would recommend discussing this with the builder at this point as I am not seeing the plumbing connection readily. **Review**

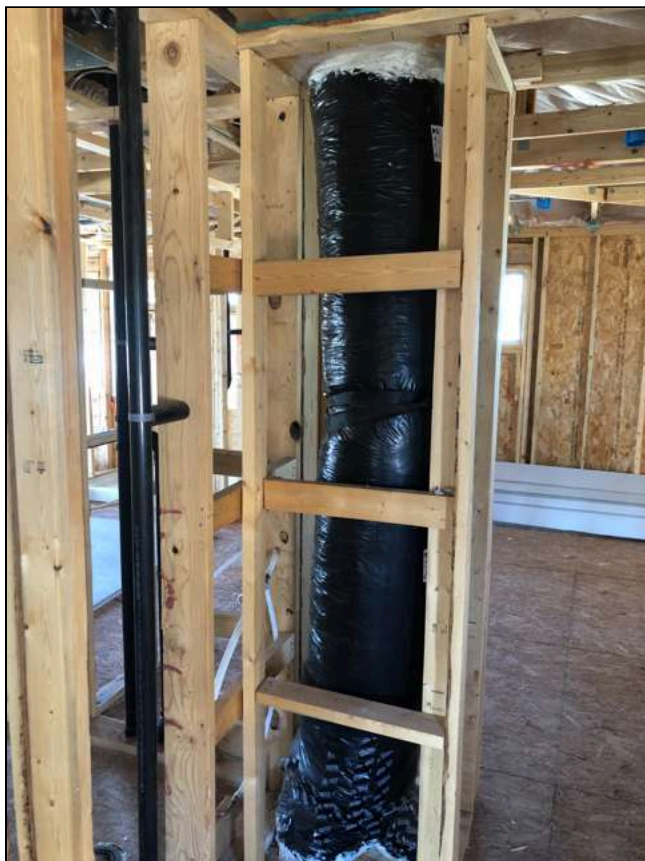
12.4 Item 1(Picture)

12.4 Visually observed the integrated heating / cooling distribution system within the property. All appears to be installed for functioning as intended on the date of the inspection and the stage of construction. All heating / cooling registers appeared to be in place in all habitable rooms. Flexible, insulated ducts are installed in the attic to all registers. I recommend that the distribution system, especially the filters and ducts, are regularly changed (filters) and cleaned (ducts) to continue to function as intended.

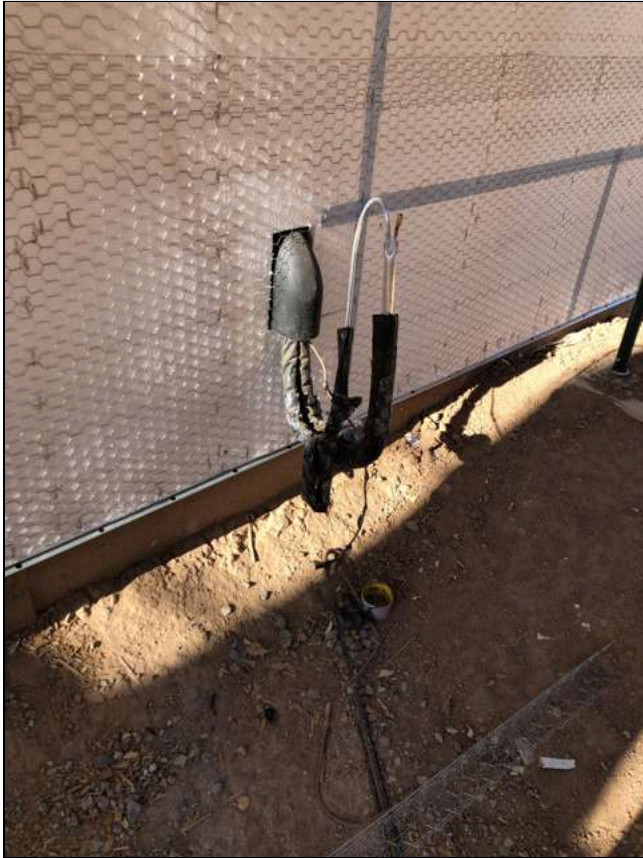
12.8 Item 1(Picture)

12.8 The exterior AC condenser unit has not yet been placed externally. This is for your information

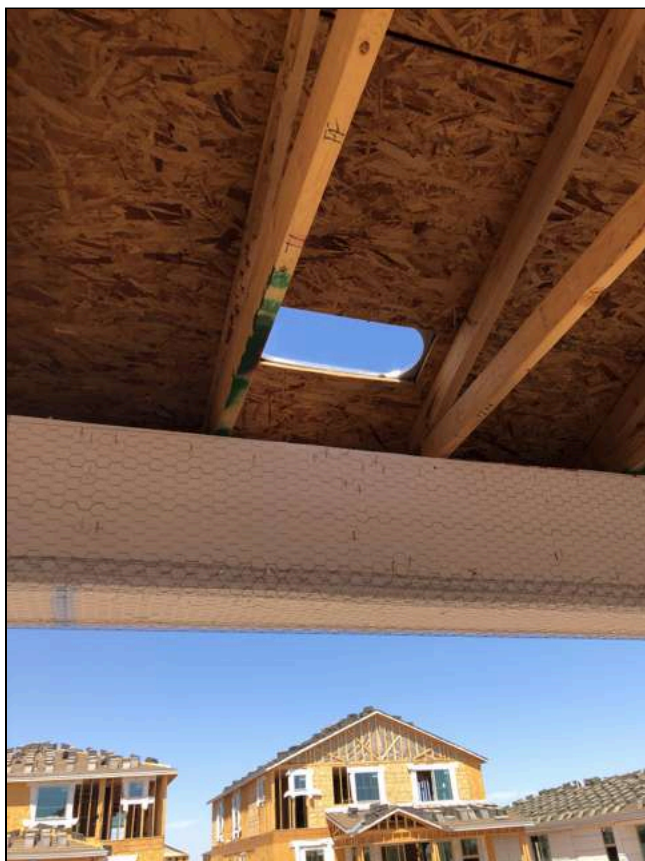
13.3 Item 1(Picture)

13.3 On the date of inspection the garage appears to be slated for insulation and no obvious ventilation. Observing on the back covered patio is supposed to be completed with O'Hagan vents installed with the tile. Over the main part of the house it appears to be sealed and ready for a permanent, sealed attic insulation types such as foam. I recommend discussion with the builder to understand which insulations will be used in which areas. **Monitor**
