Inspection Report

John and Jessie Doe - SAMPLE REPORT ONLY

Property Address:
9954 S Main Ave
Surprise AZ 85379

Shining Light Home Inspection Services, LLC

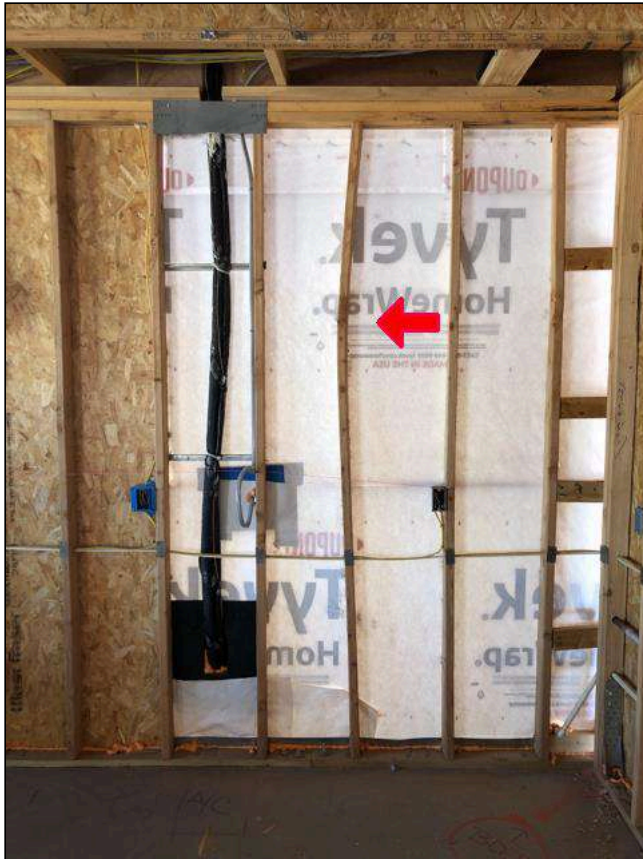
1.1 Item 1(Picture)

(2) On a date of inspection I am observing more than one wall stud, including those for load-bearing walls, that are warped, bowed, torqued, or have significant cracks in them. Some of these are significant enough such that nails that were supposed to attach to them from the outside or unable to. I recommend discussion with the builder to determine appropriate remediation which may include adjustments, Repairs, or replacement. **Attention**

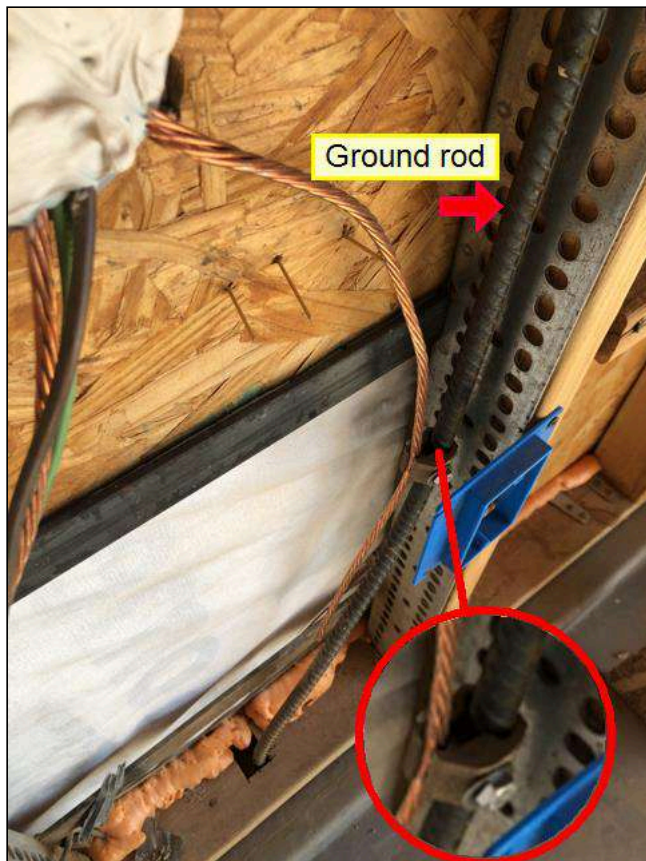
2.1 Item 2(Picture)

(2) There are two main grounds from the panel into the property which should go to the grounding rod. However only one is connected to the grounding rod. The other one appears to be set for a gas pipe which is not here. I recommend that this be a discussion with the builder to find out how these are going to be taken care of prior to drywall and stucco. **Attention**

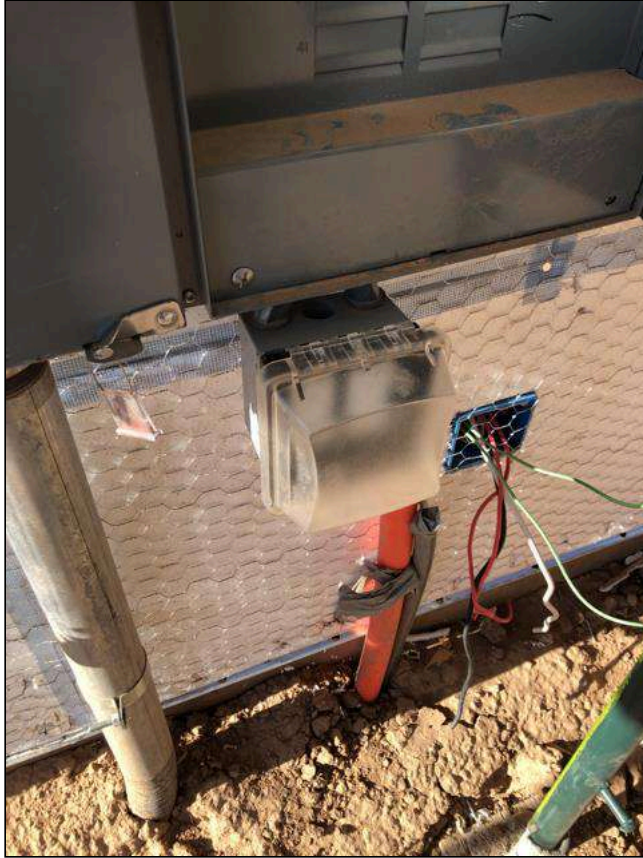
2.4 Item 1(Picture)

(2) On the date of inspection, the receptacle box on the bottom of the main panel was loose. I recommend discussion with the builder to assure that this is tighten down prior to closing. **Attention**

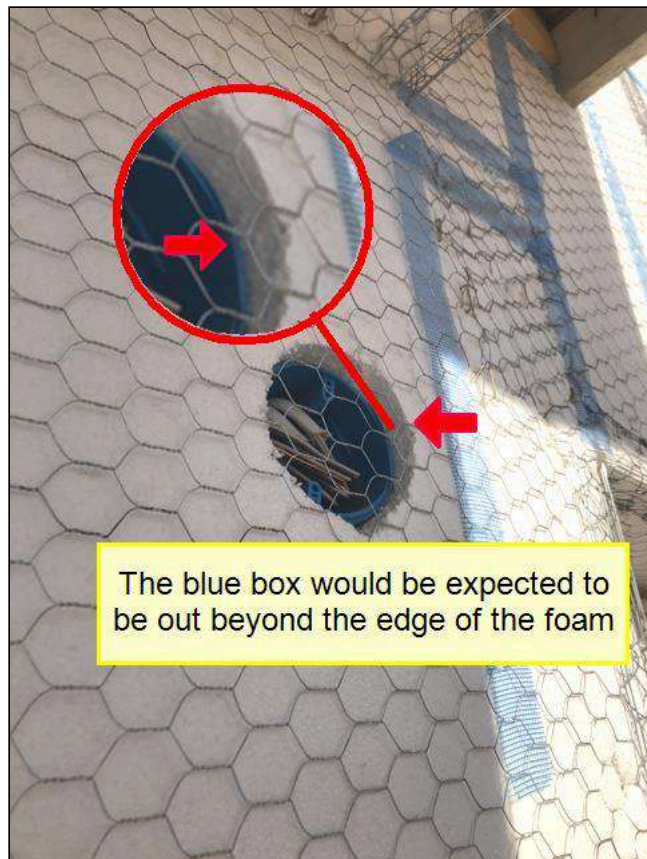
2.6 Item 1(Picture)

(2) Exterior lighting fixture on the front porch column is not showing the quarter inch from final finish as is expected. This may cause an issue with the fixture adhering properly to the wall so that no moisture or insects can get behind it. I recommend that this be discussed with the builder to bring this out such that it is at the proper length or that an additional fixture can be applied to bring this to standard. **Attention**

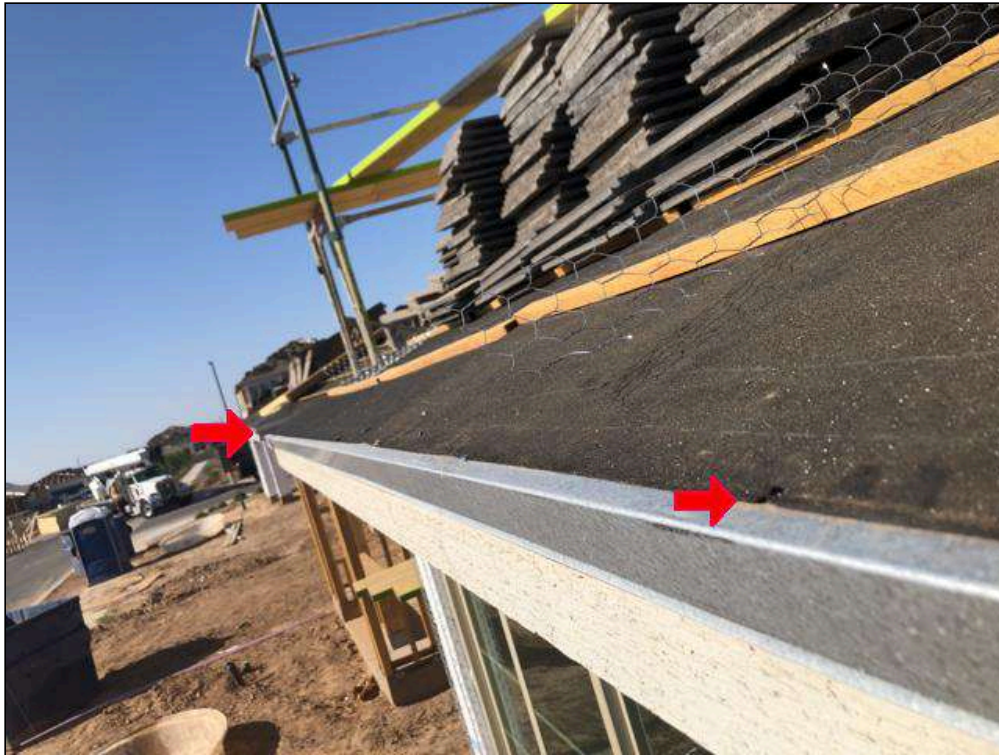
3.1 Item 1(Picture)

Underlayment that is visible on the roof is not yet sealed at all edges as would be expected and are not properly nailed down. It is also standing up from the metal drip edge in some places. It should be installed over the metal drip edge and then sealed once it is in place. I recommend asking the builder when the final sealing for the underlayment will occur for this property. **Attention**

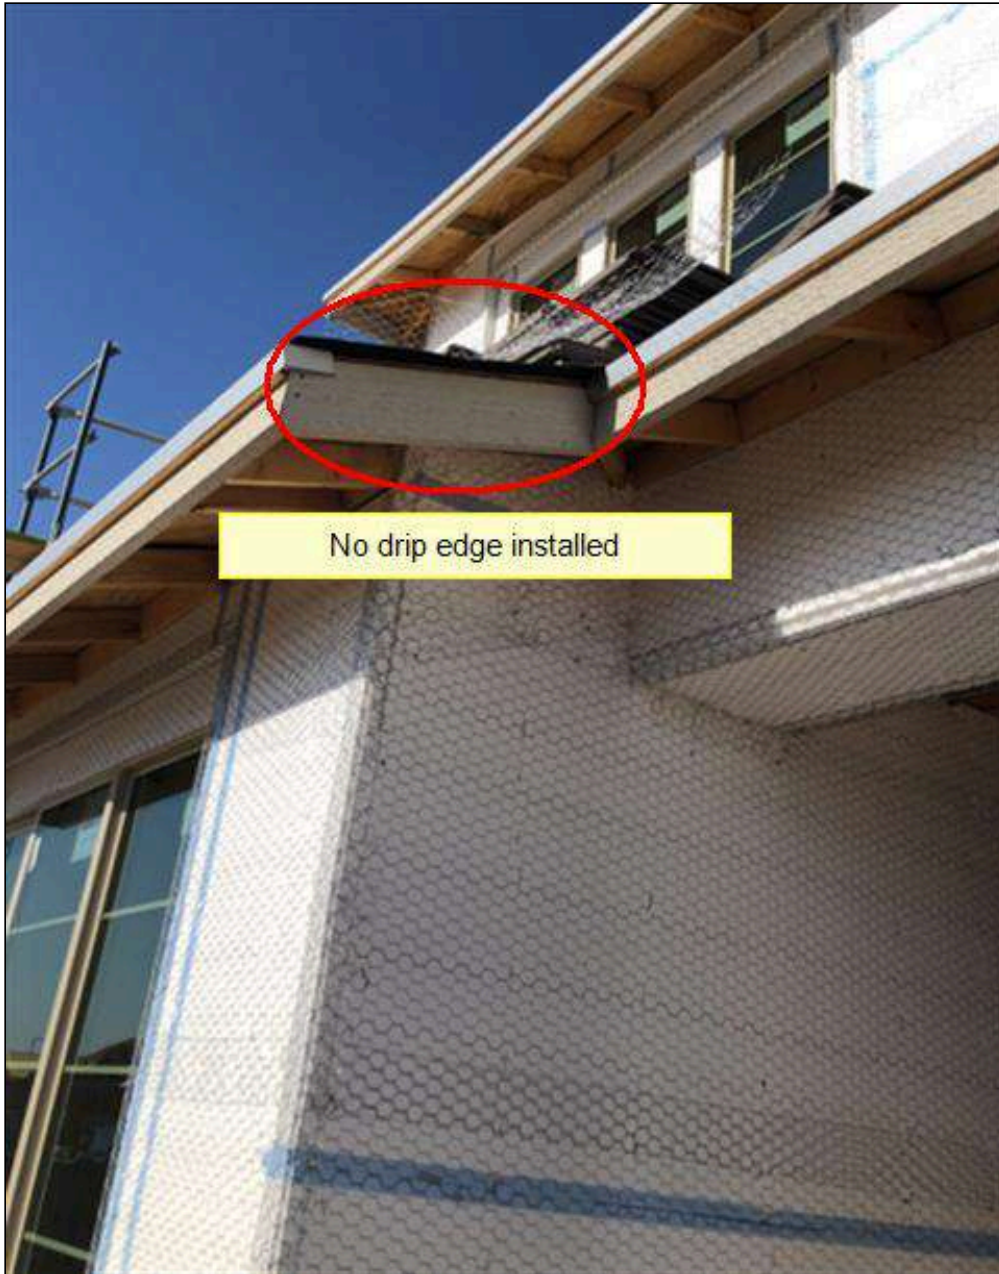
3.6 Item 1(Picture)

Metal drip edge is missing or open in some locations. In other locations it is well wrapped and overlapped. I recommend reviewing this with the builder to a sure that it is properly and fully install. **Attention**

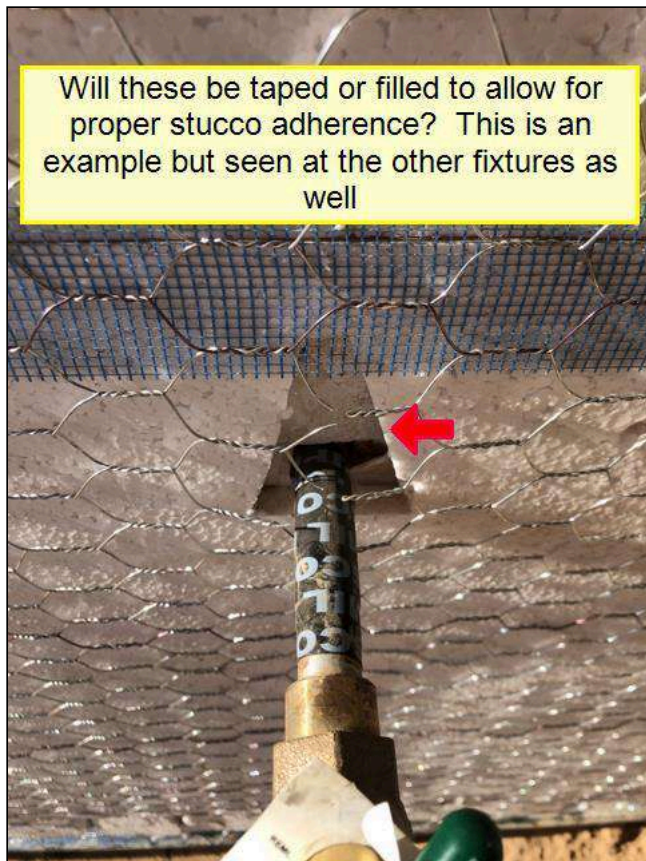
4.1 Item 1(Picture)

(2) Taping of all stucco joints or holes in the styrofoam sheeting under the lathing is not completed. Observing some holes around fixtures that are also larger than expected. I recommend discussion with builder regarding these joints that are not currently taped. **Attention**

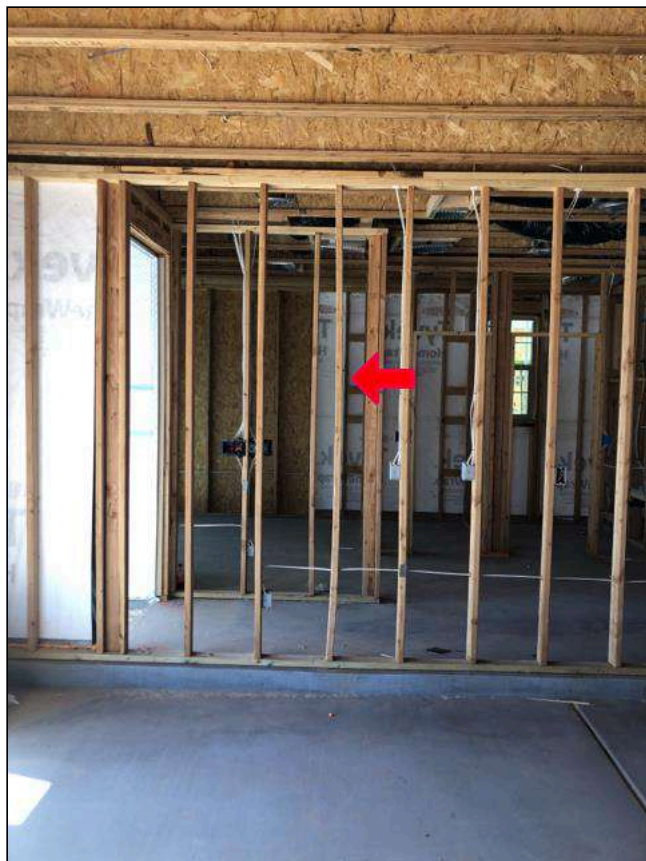
5.1 Item 1(Picture) Garage

(2) There are a number of studs in the home that are warped, significantly cracked or torqued. I recommend that these be reviewed with the builder for repair or replacement as needed. **Attention**

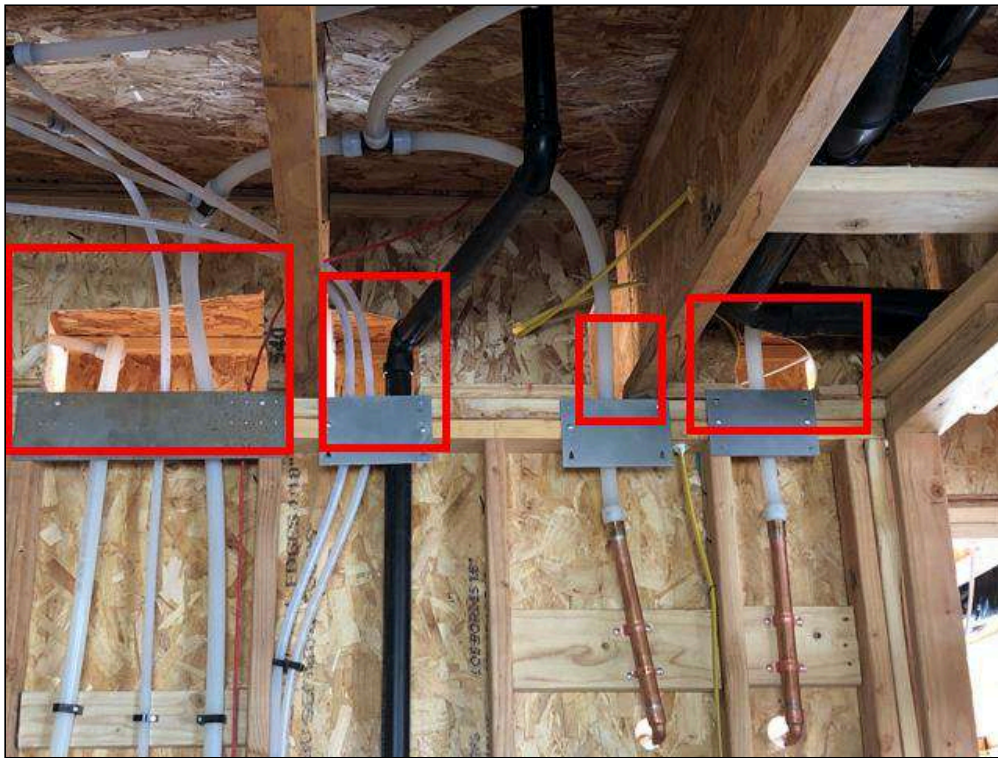
5.3 Item 1(Picture) Kitchen area

(2) On the date of inspection, I am observing a few of the I-beam flanges that have been cut away and are no longer in place. These are not just minor or allowed notching: the entire flange has been cut away. This will deteriorate the load carrying capability of these I-beam flanges. I recommend discussion with the builder on why these flange cuts are allowed in this circumstance, what they will do to restore the load carrying capability of these joists (if this is needed) and if these cuts were approved by a structural engineer. **Attention**

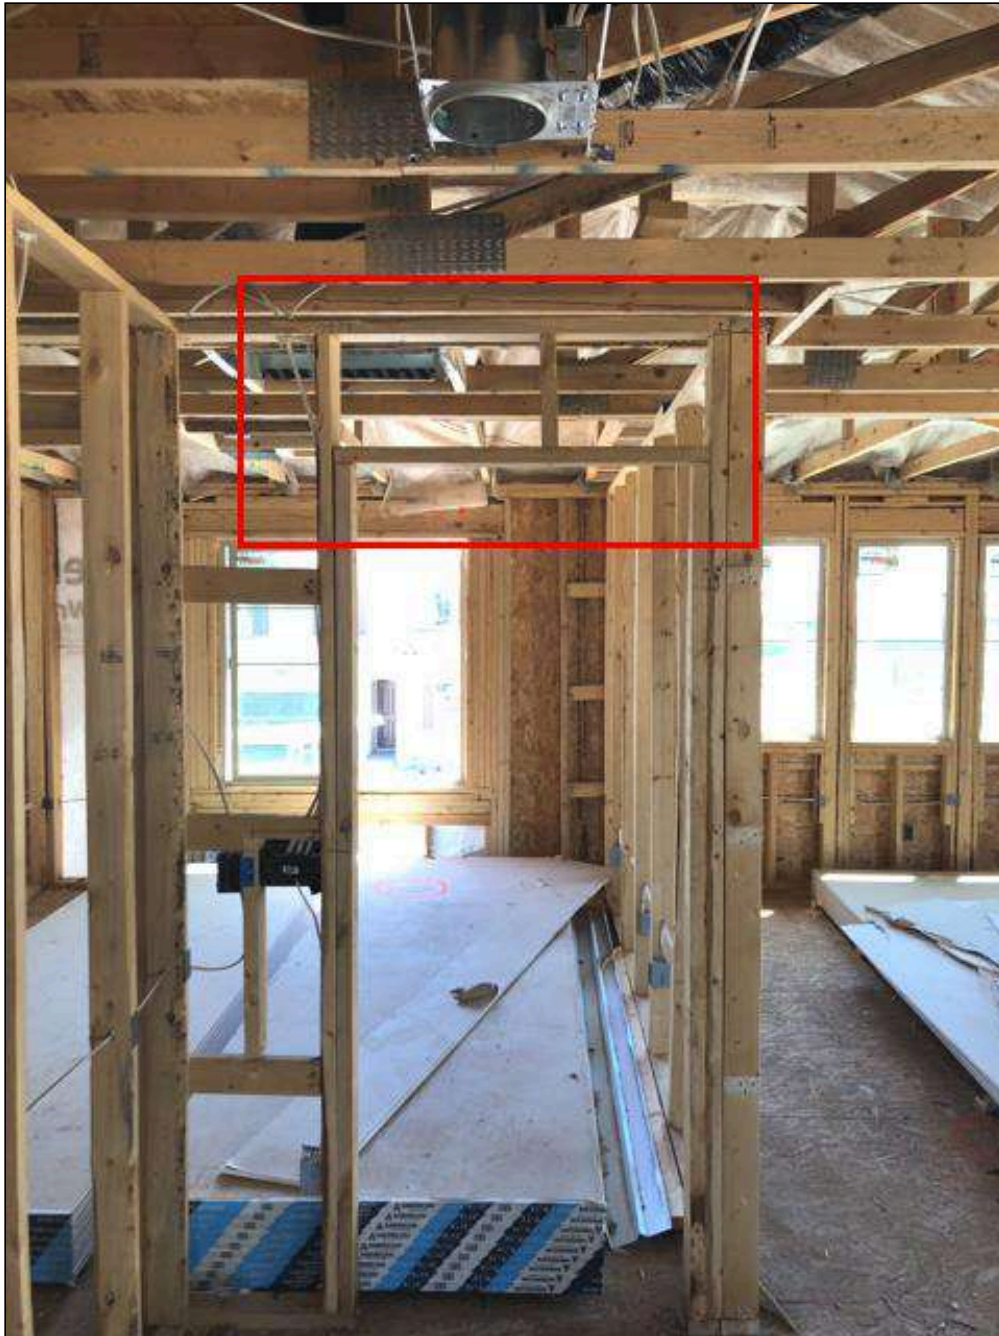
5.11 Item 1(Picture)

Interior door headers on the home are only one, flat 2 x 4 versus the expected two 2 x 4 laid flat. Exterior doors appear to be framed properly with at least a 2 x 8 header. These interior door jams are framed the same as would be typical into an archway or walkway. This type of door framing is in use today for some interior doors where there is little load. I recommend discussion with the builder to assure that the size and construction of these interior door headers are appropriate to the expected load. **Review**

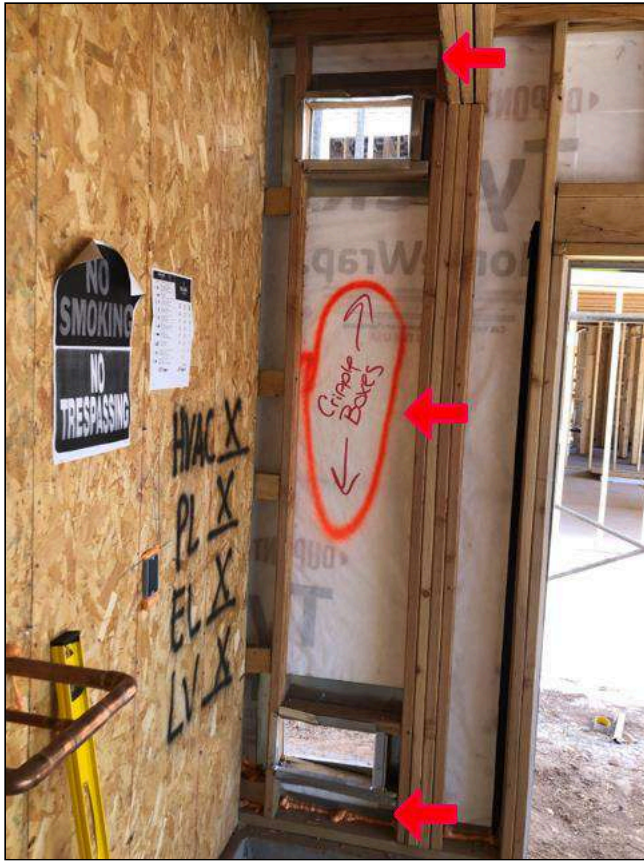
6.7 Item 1(Picture)

(2) On the date of inspection, I noticed that the vent insulations were not crippled and there is a note on the wall to cripple these boxes prior to drywall. Also on the lower vent they support lower support needs to be replaced prior to crippling. Recommend discussing with the builder to ensure this happens prior to drywall. **Attention**

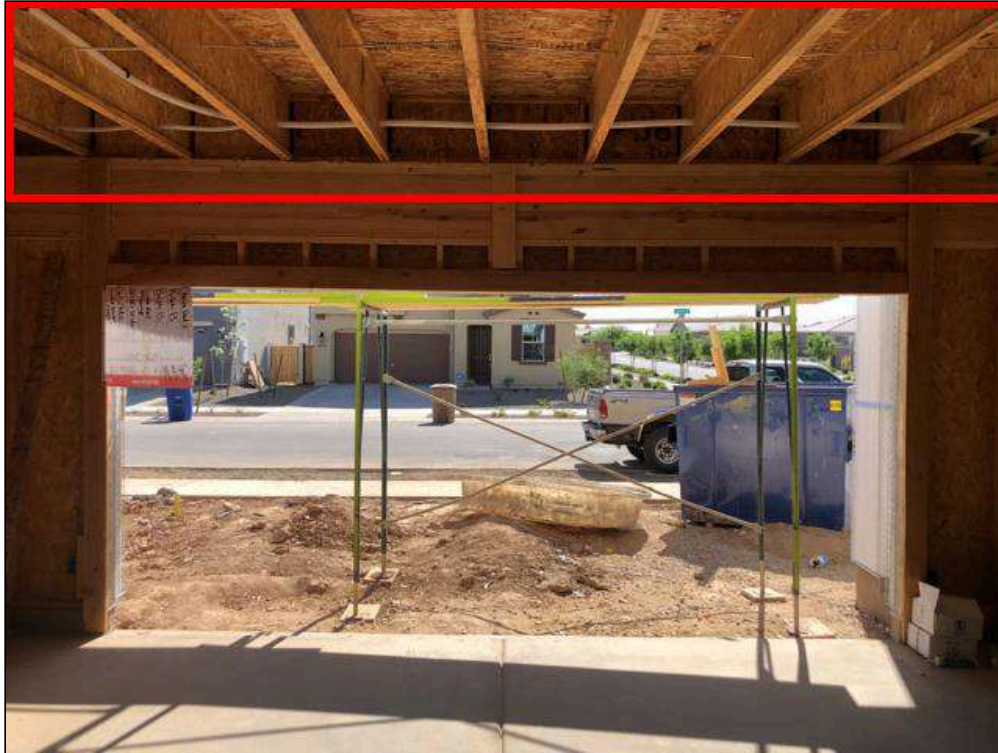
13.1 Item 1(Picture)

Concrete slab. Ask builder what will be used between floors as there is not way to tell on the date of inspection. **Monitor**
