Inspection Report

John and Jessie Doe - SAMPLE REPORT ONLY

Property Address:
9954 S Main Ave
Surprise AZ 85379

Shining Light Home Inspection Services, LLC

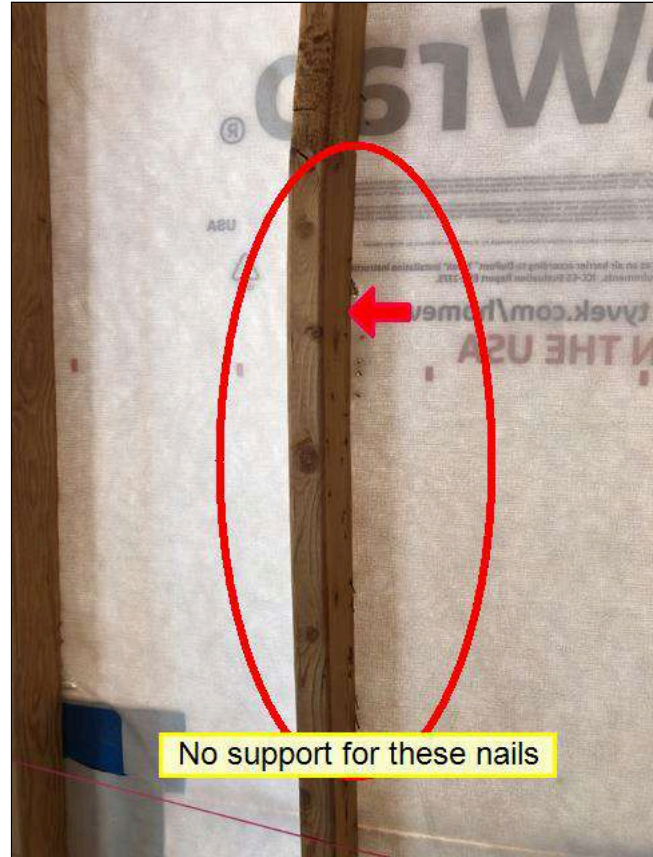
1.1 Item 2(Picture)

1.1 (2) On a date of inspection I am observing more than one wall stud, including those for load-bearing walls, that are warped, bowed, torqued, or have significant cracks in them. Some of these are significant enough such that nails that were supposed to attach to them from the outside or unable to. I recommend discussion with the builder to determine appropriate remediation which may include adjustments, Repairs, or replacement. **Attention**

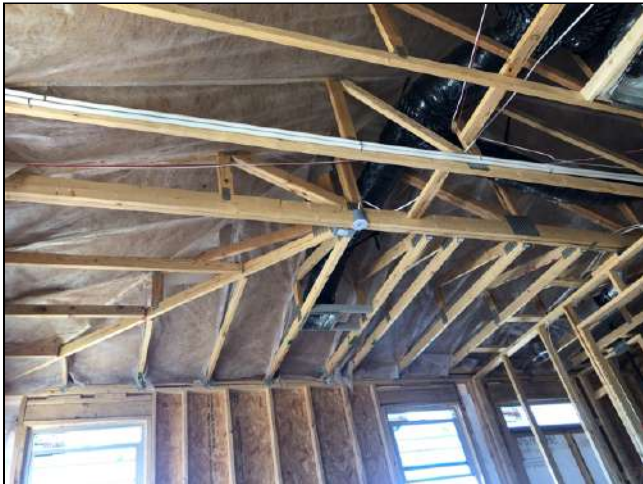
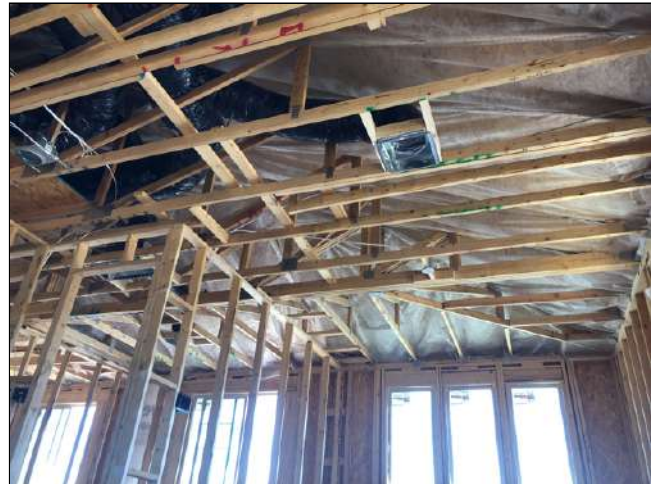
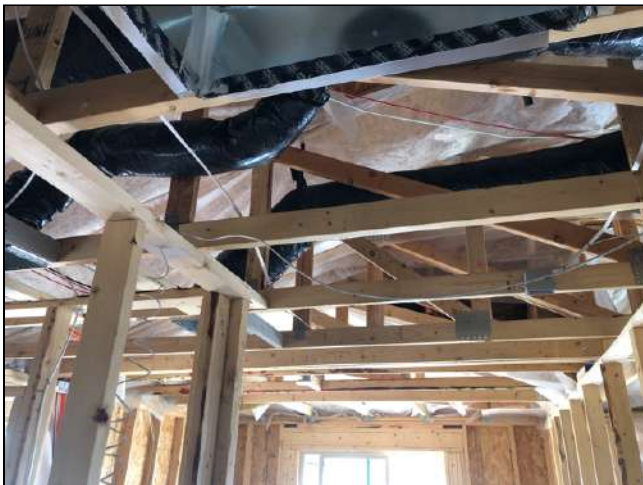
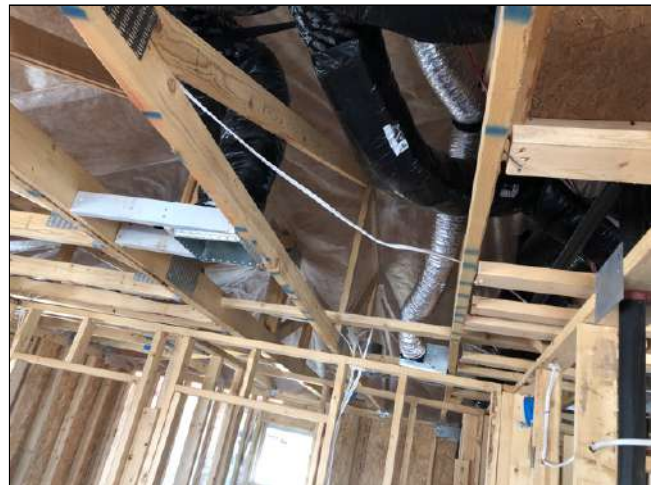
1.9 Roof structure and attic were observed through the attic access provided in laundry room as well as throughout the home without the ceiling drywall yet installed. Engineered trusses were observed to be in satisfactory condition and appear to be functioning as intended on the date of inspection except where noted elsewhere in this report. OSB sheathing viewed from the home's interior appears to be in satisfactory condition where visible and was covered by radiant barrier.

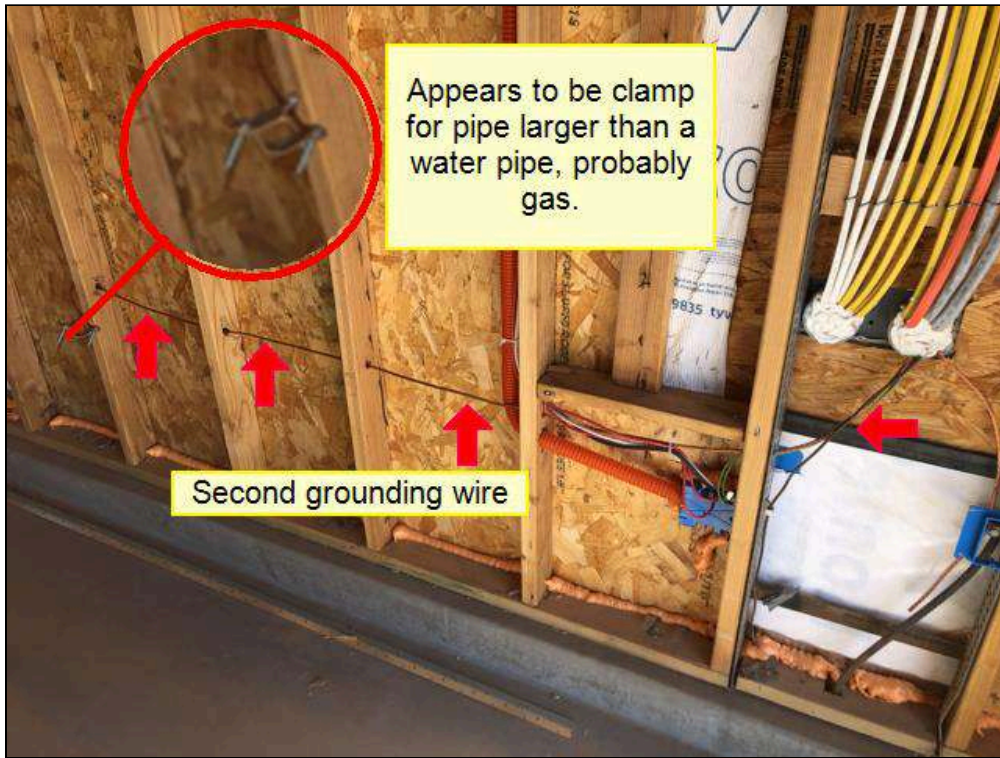
2.1 Item 3(Picture)

2.1 (2) There are two main grounds from the panel into the property which should go to the grounding rod. However only one is connected to the grounding rod. The other one appears to be set for a gas pipe which is not here. I recommend that this be a discussion with the builder to find out how these are going to be taken care of prior to drywall and stucco. **Attention**

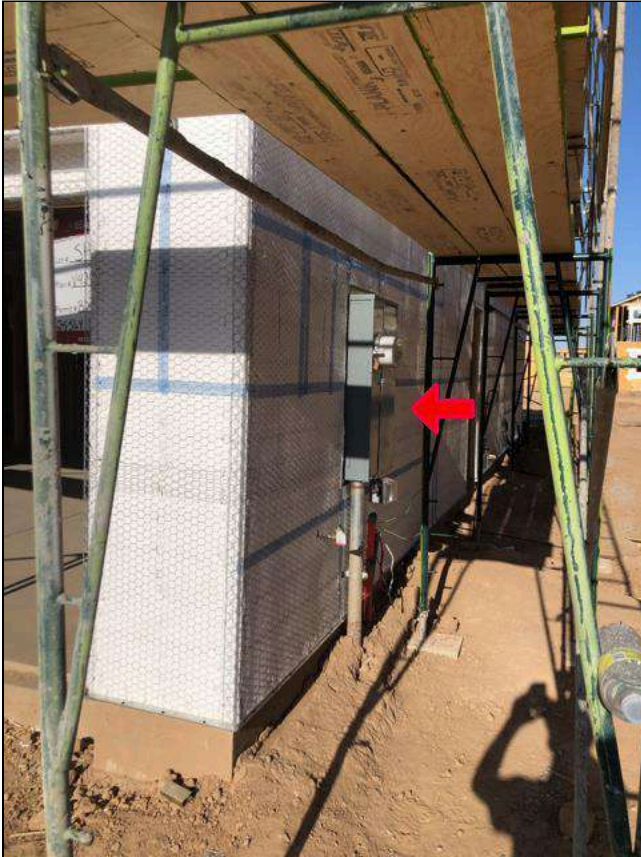
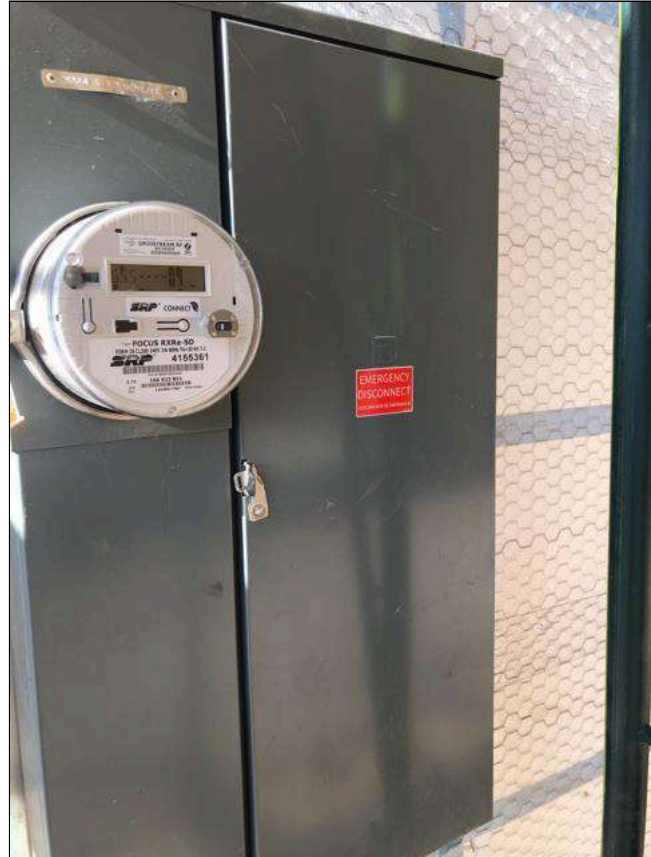
2.10 The main panel box is located on the outside of the North wall of the structure.

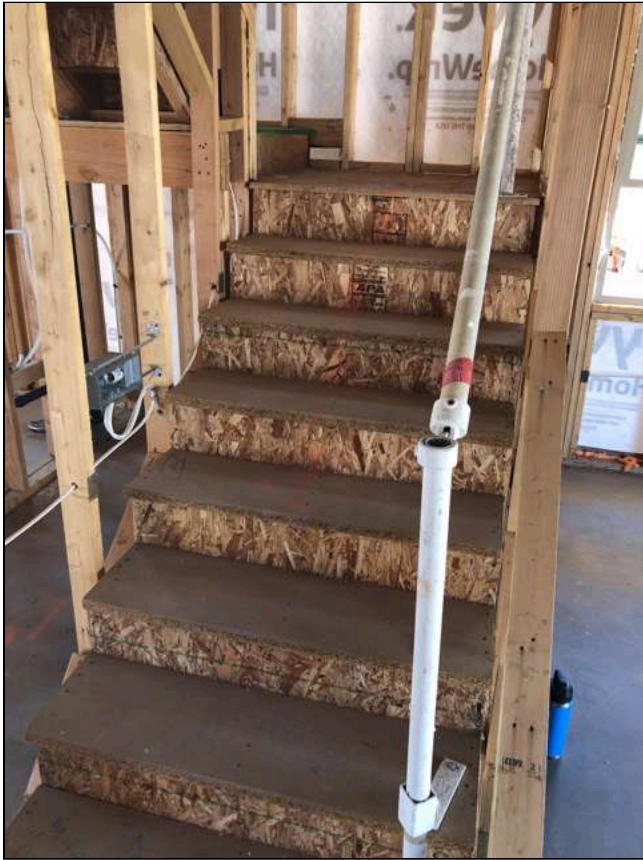
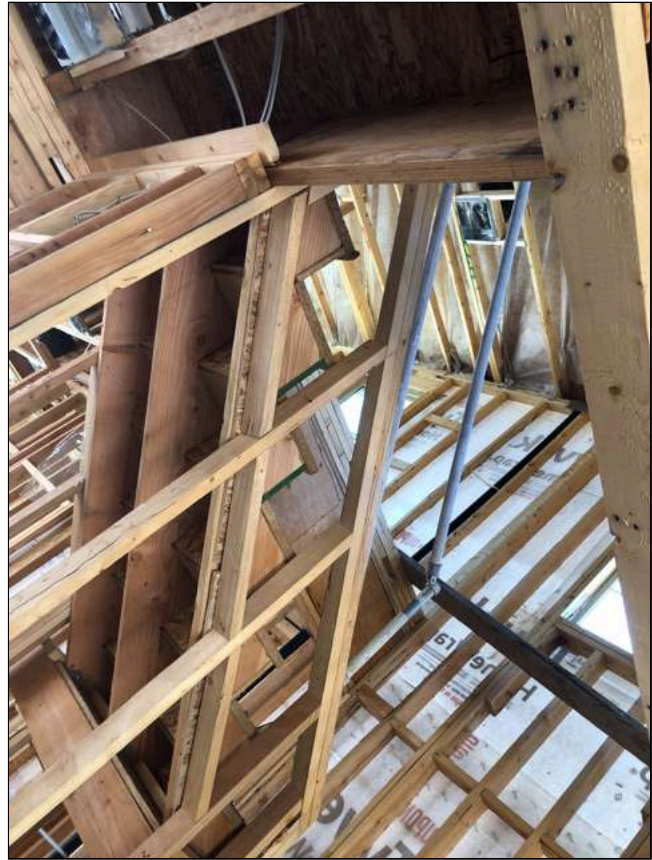
5.4 (1) On the date of this inspection the staircase and landings were roughed in and not completed. They appear to be properly spaced proper treads proper heights that are no more than 3/8 of an inch difference why is it a riser. They have temporary railings installed. This is for your information

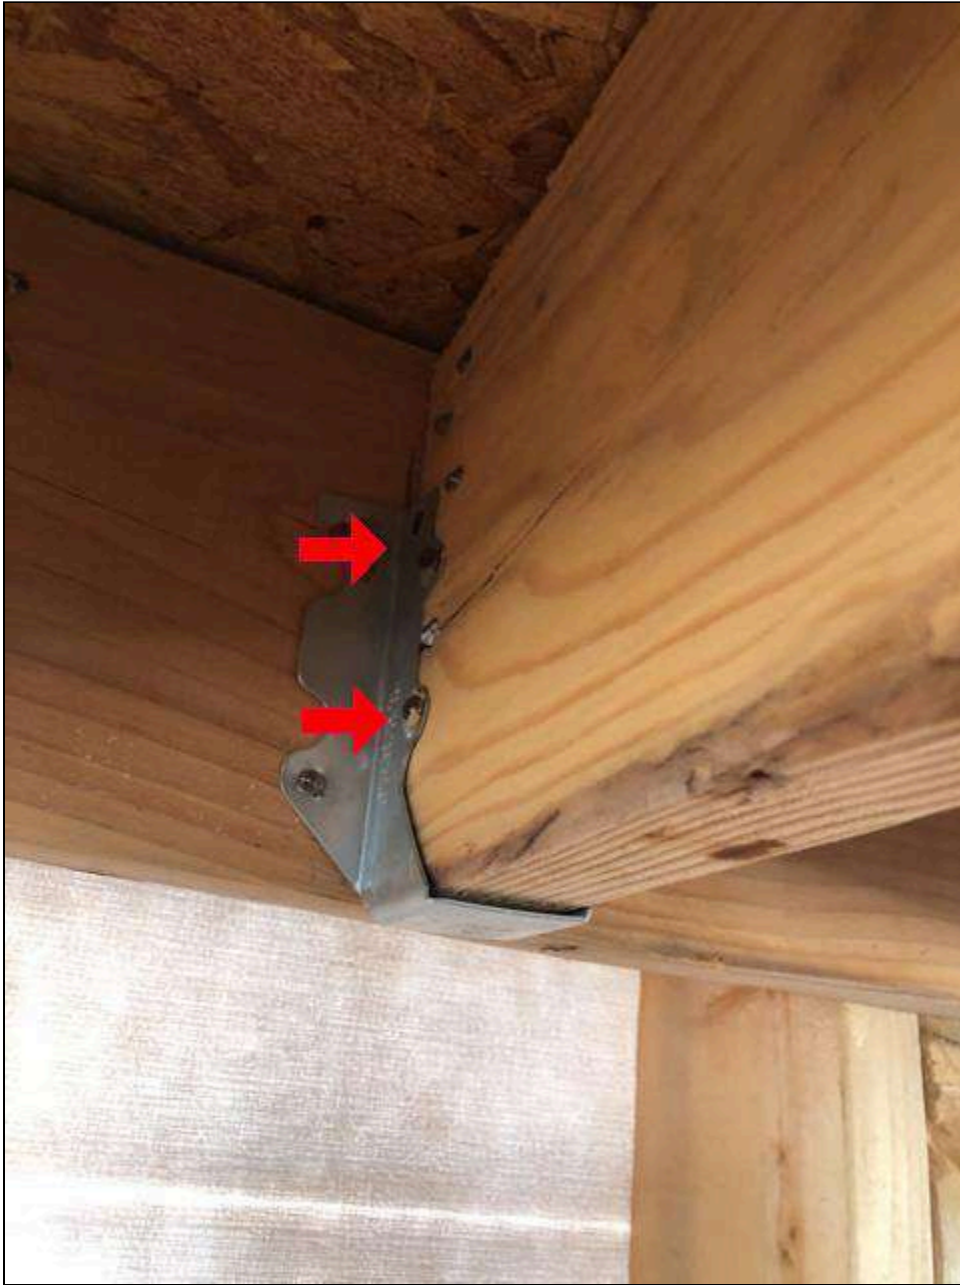
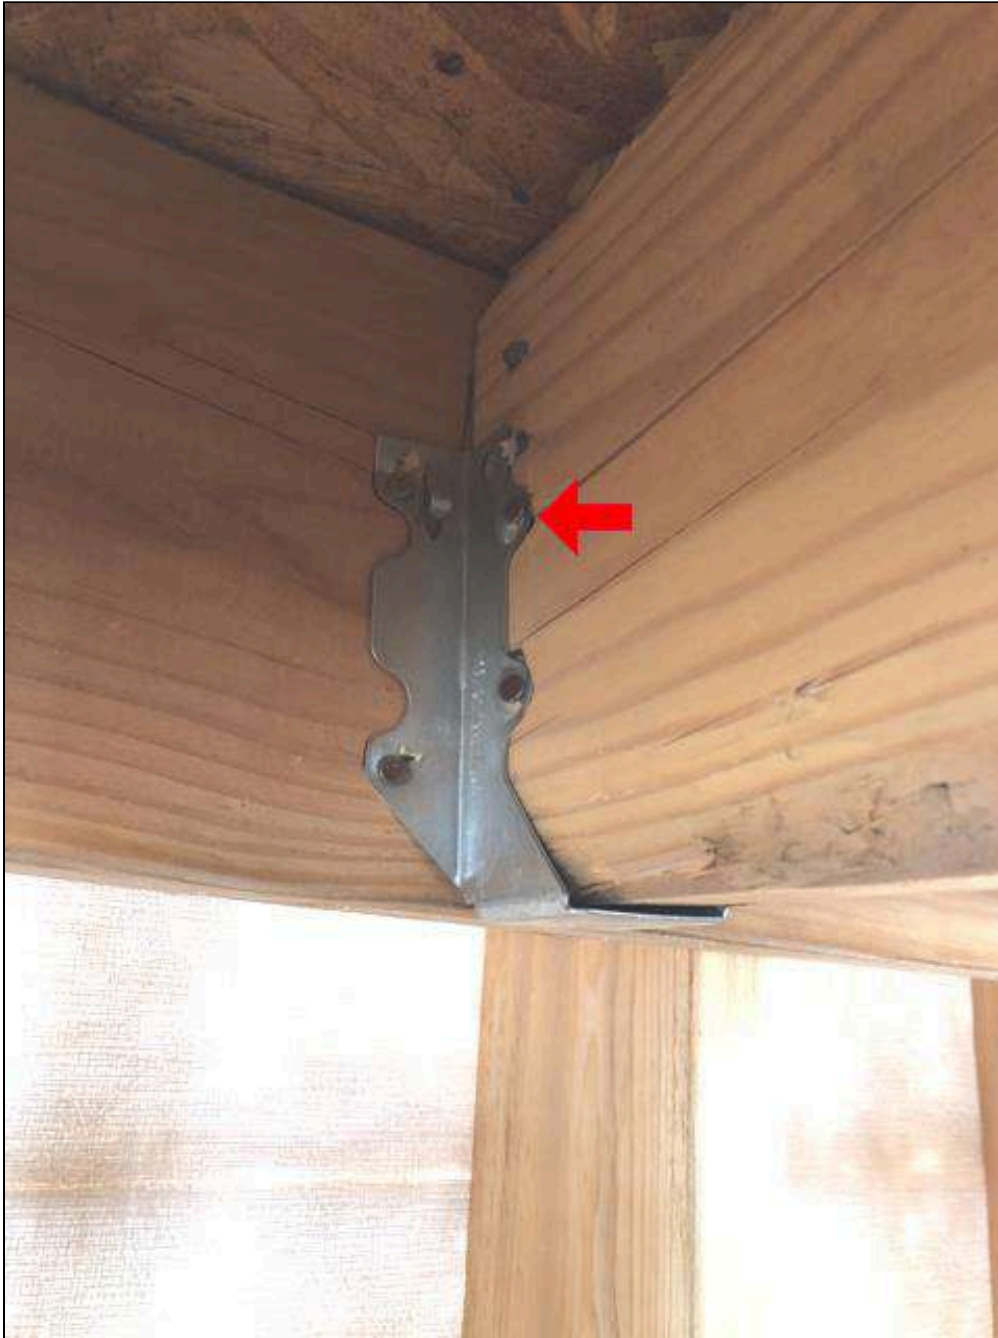
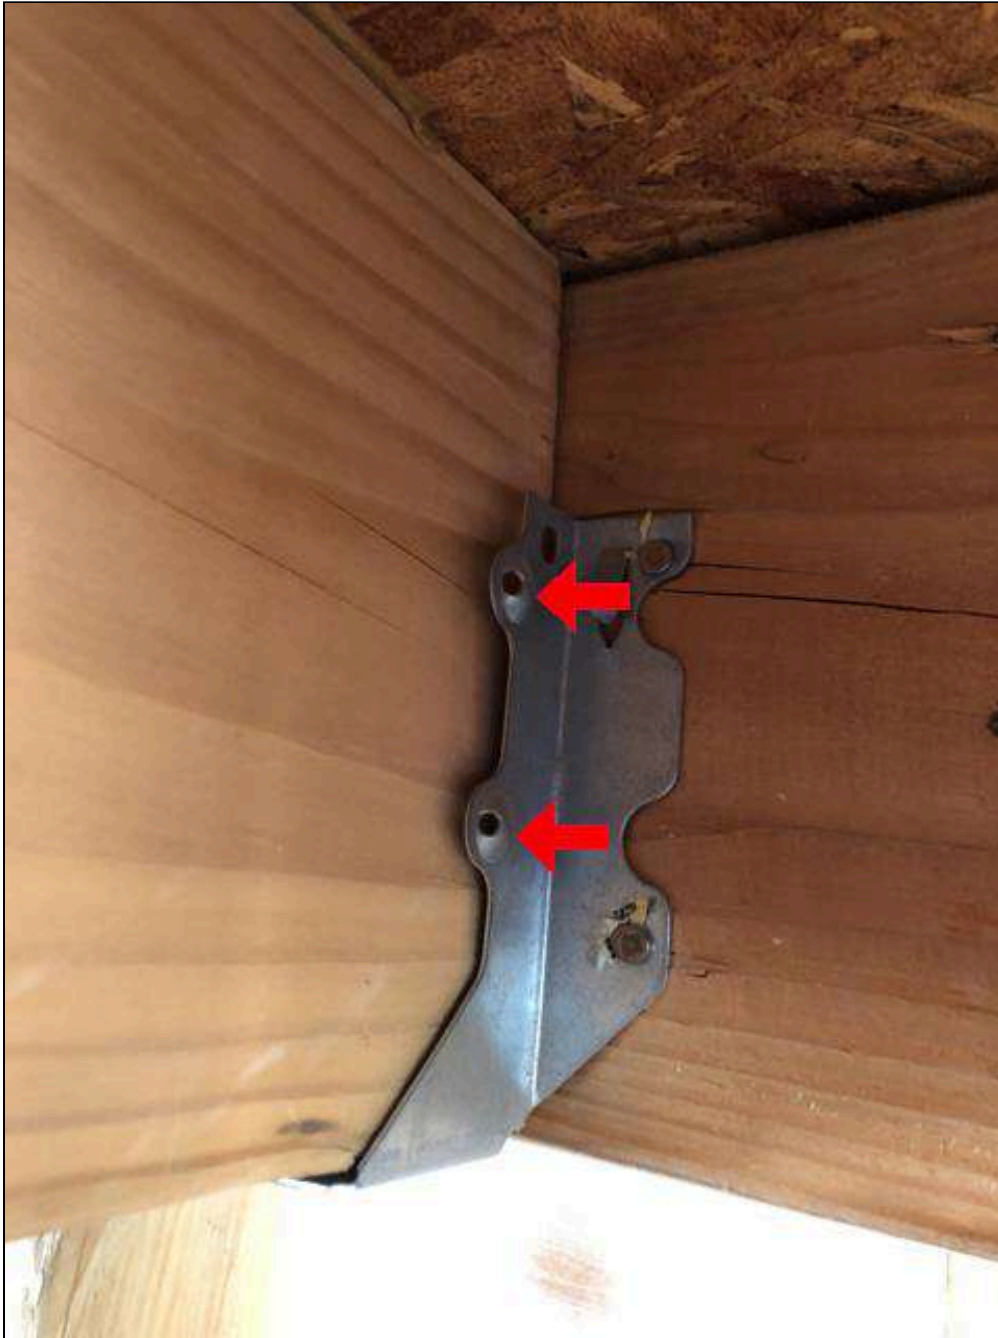
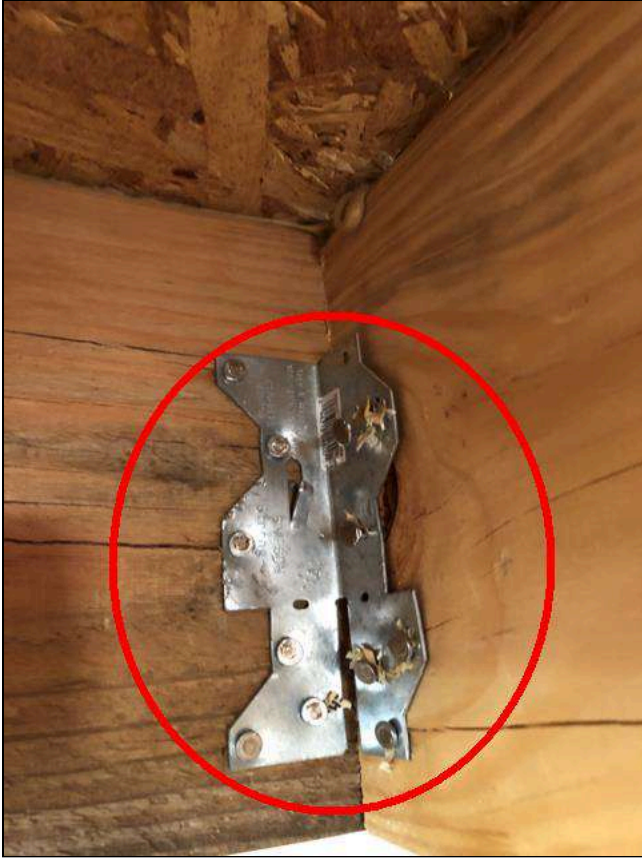
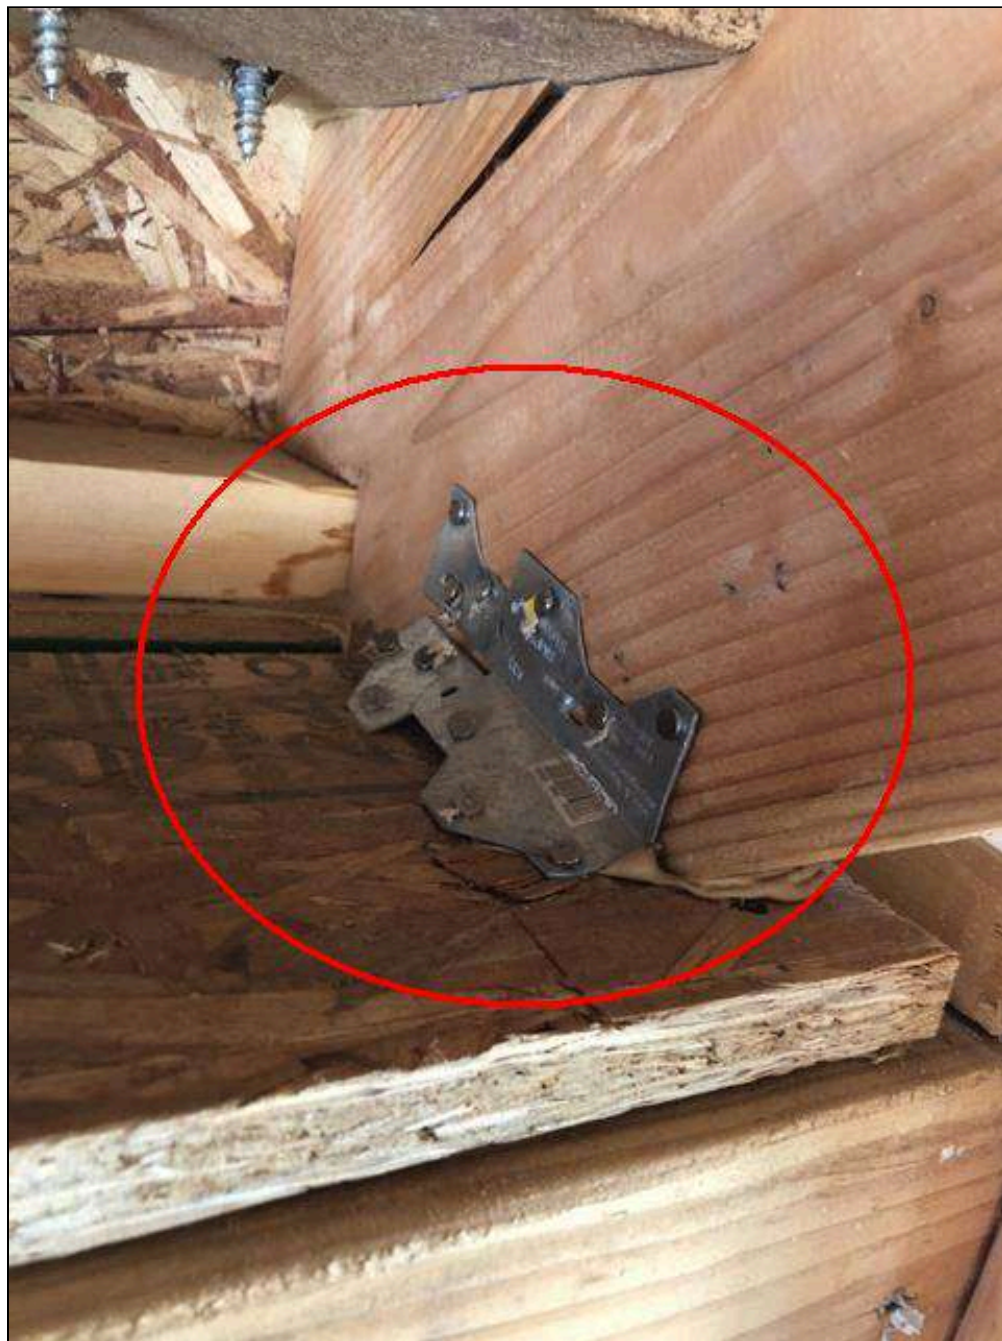
5.4 (2) On the date of inspection, looking at the joist hangers being used for the steps and the landing, I am observing a similar situation to the patio cover joist hangers where not every hanger hole that should have a nail in it has been nailed. Also a few that appear to be deformed. I recommend this be discussed with the builder for remediation. **Attention**

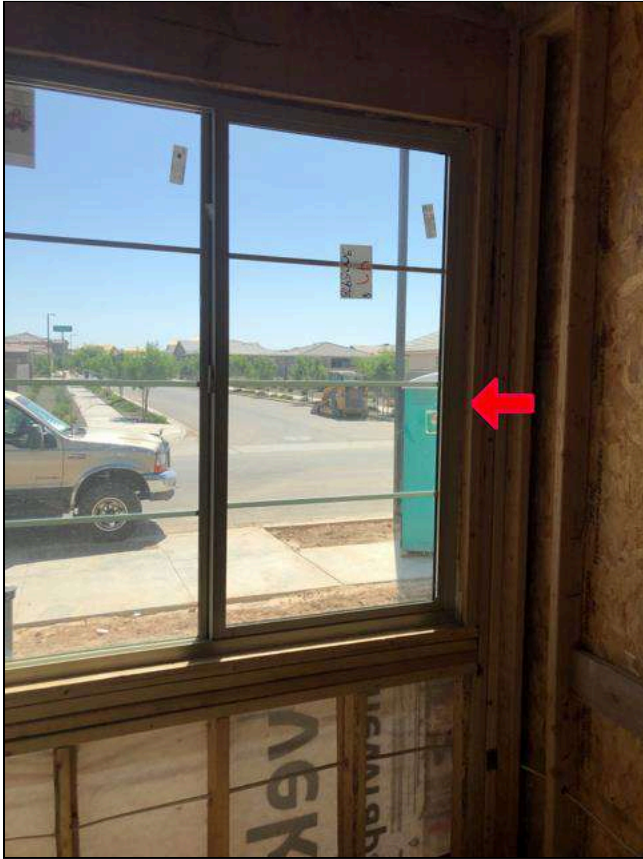
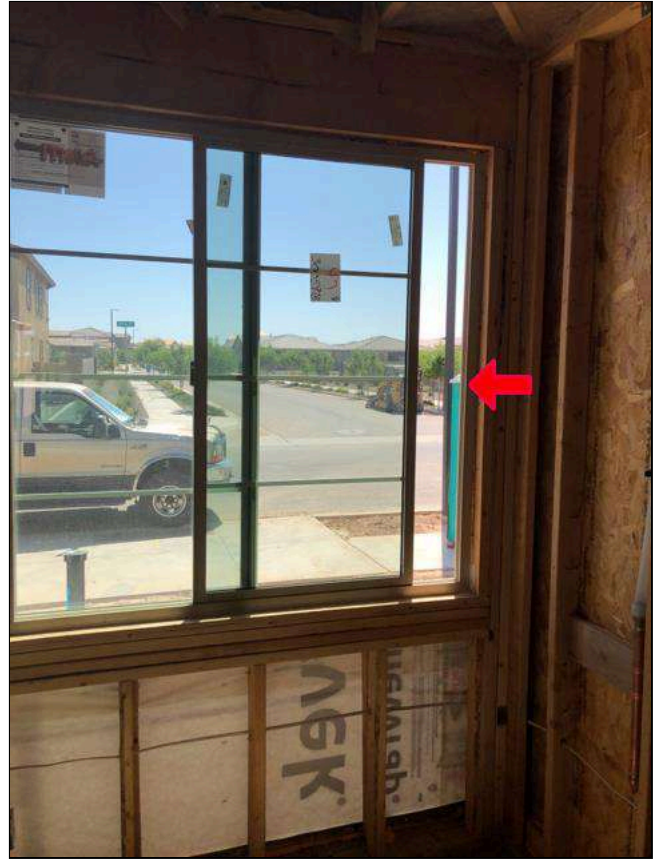
evaluation of this window for proper operation to determine if adjustments, repairs or replacement is indicated.

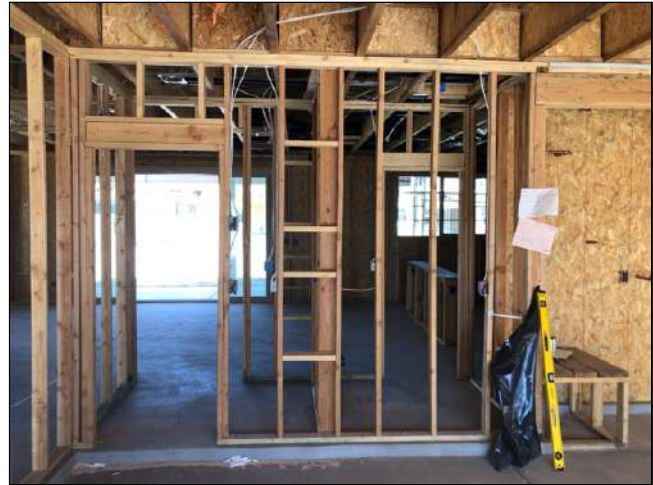
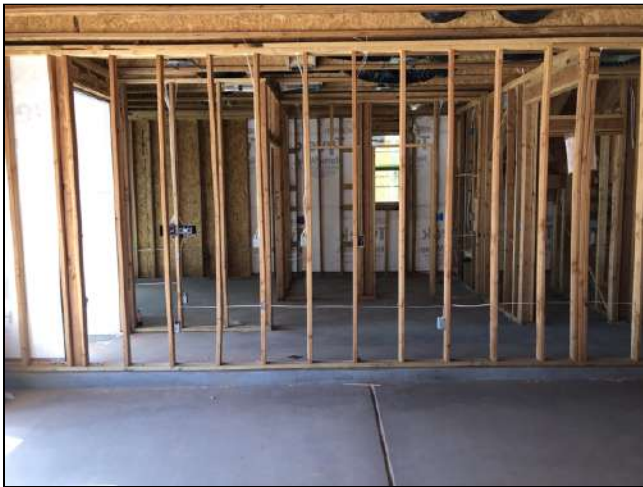
6.1 Garage walls were visually observed and appeared to be functioning as intended on the date of inspection for the period of construction. Firewall separation between house and attached garage is framed in and will be reviewed once drywall is in and finished.

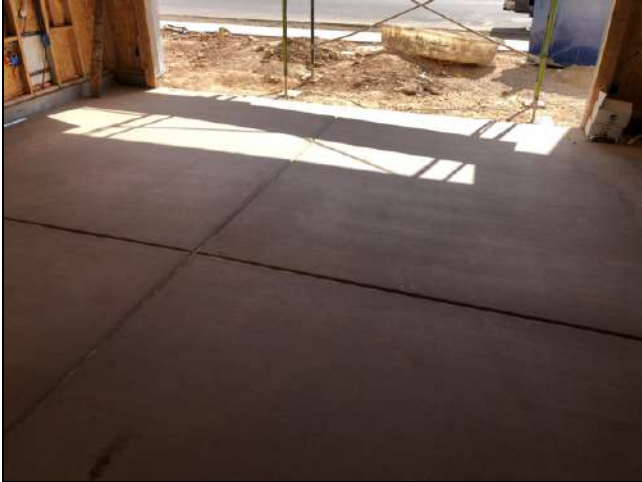
6.2 Item 1(Picture)

6.2 Garage floor appears to be of untreated concrete, appears to be functioning as intended and clearly shows the post tension designation. Normal wear, tear and stains are allowable if considered cosmetic.

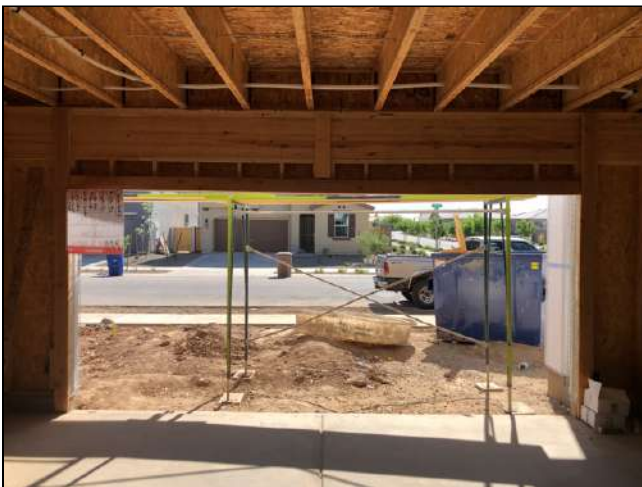
6.3 Item 1(Picture)

6.3 On the date of inspection the garage door was framed in with an appropriate header. This is for your information will be known once the installation is complete.

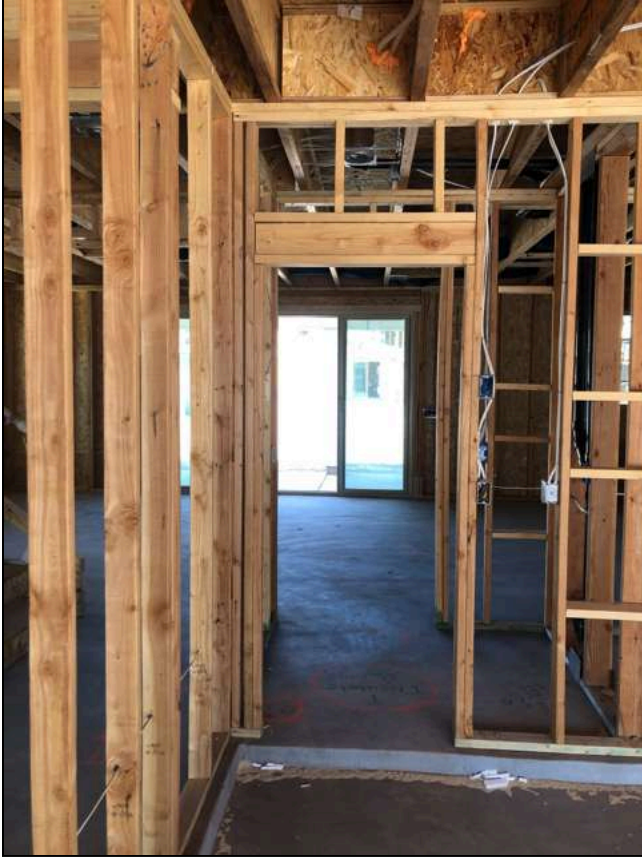
6.4 Item 1(Picture)

6.4 Another inspection the occupant door from the garage to the Main part of the house was framed in with a proper header and crippling as necessary. The door will likely be installed after drywall. Just for your information

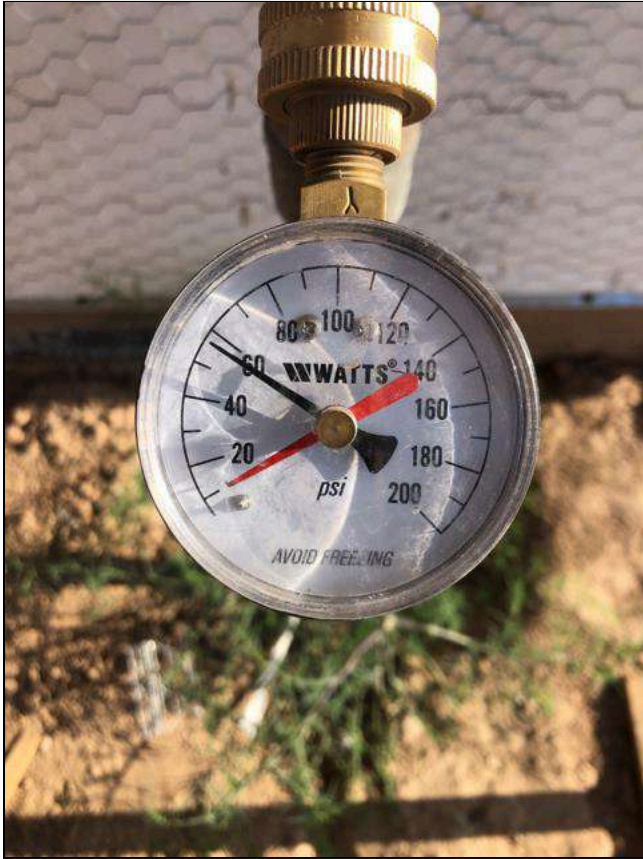
8.4 Item 1(Picture)

8.4 (1) The water pressure was checked at an outside hose bib and registered within the acceptable range of 40 - 80 psi at approximately 55 psi.

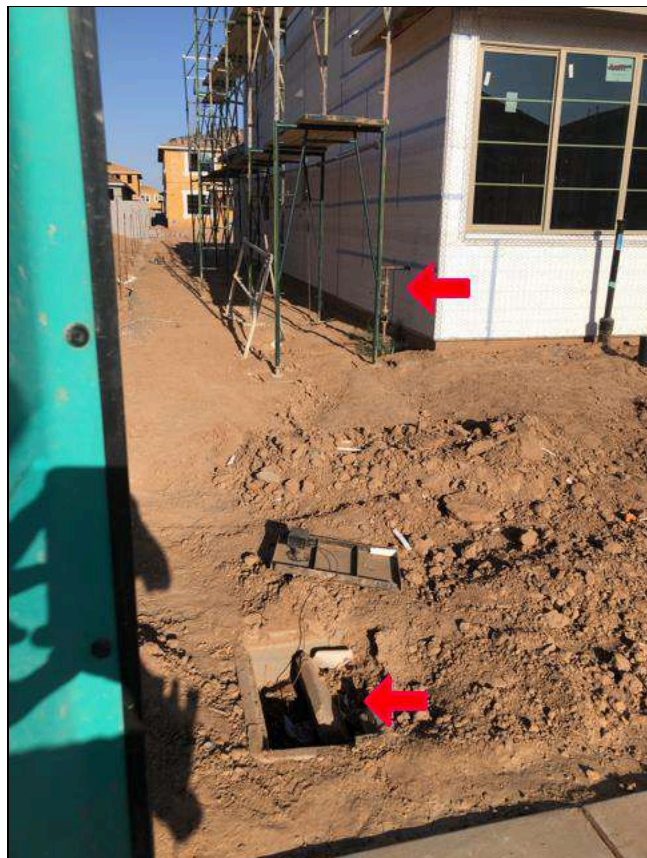
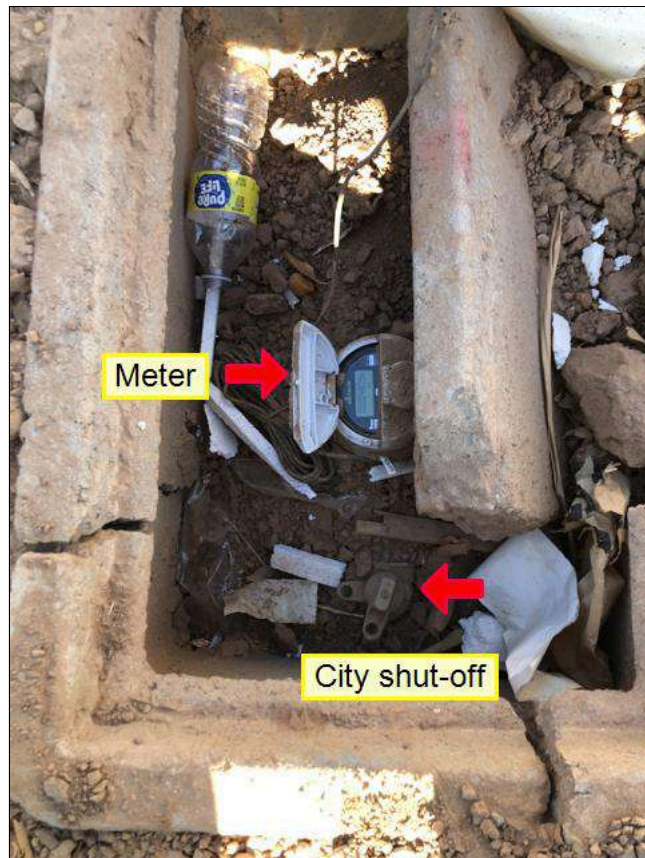
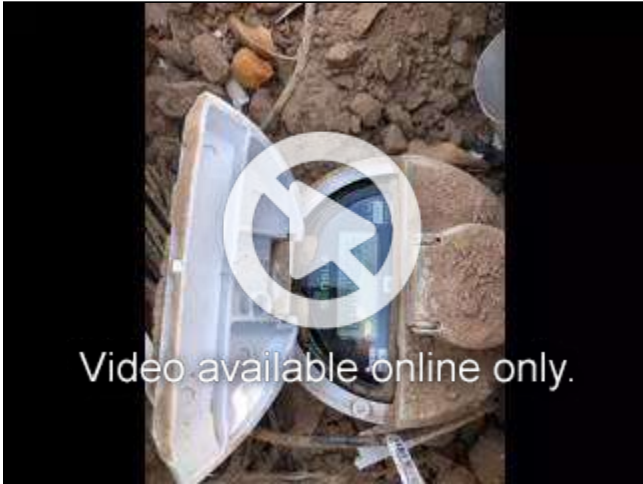
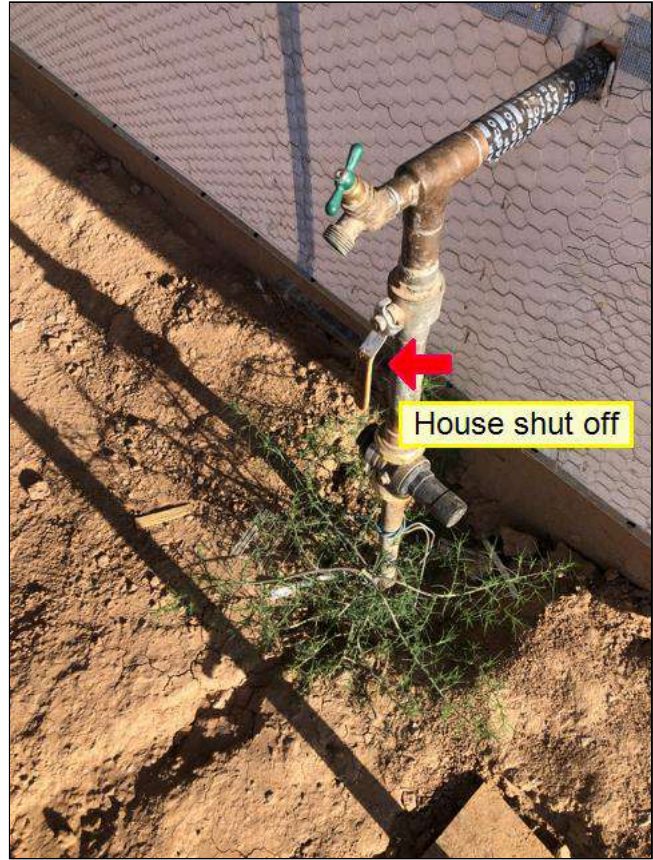
8.4 (2) The main shut off is the lever located at the hose bib by the front entry door on the South side of the property. This is for your information.

The main water meter and the main public shut off value are on the East of the house near the street. Noted that the water meter did not appear to be running at the time of the inspection. This typically indicates no significant water use on the property.

8.4 (3) On the date of inspection the concrete retaining walls around the meter and main shut off valve is broken in numerous places. This will not work as the final to set the meter or to set up for the long term. I recommend discussion with the builder on when this containment will be replaced by the builder. **Attention**

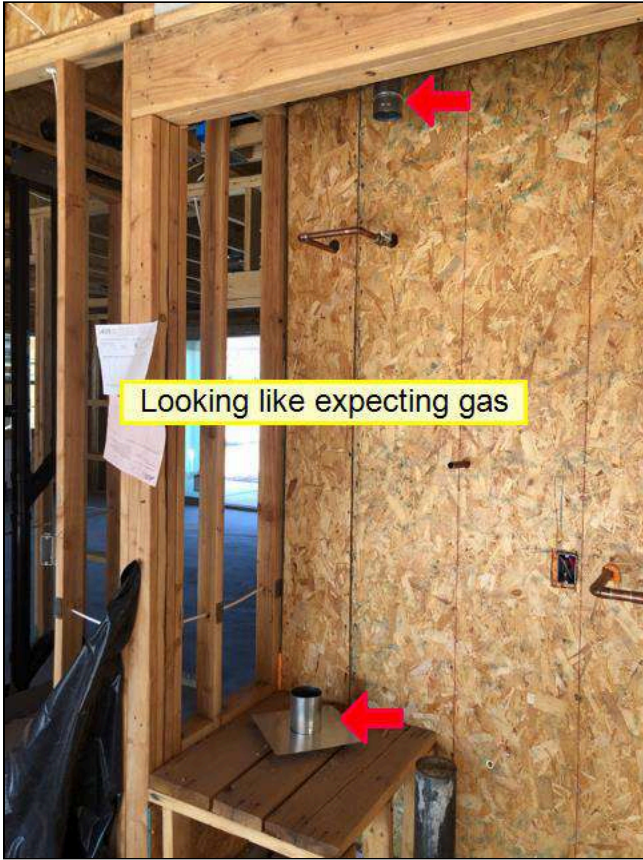
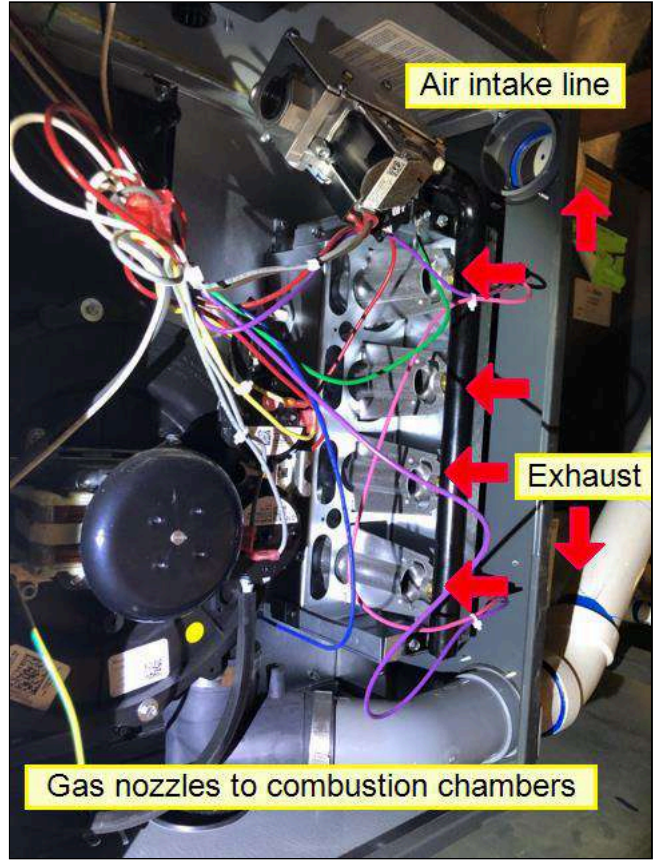
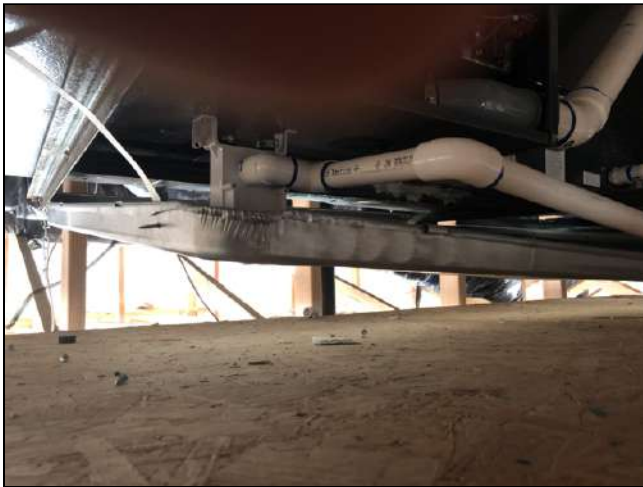
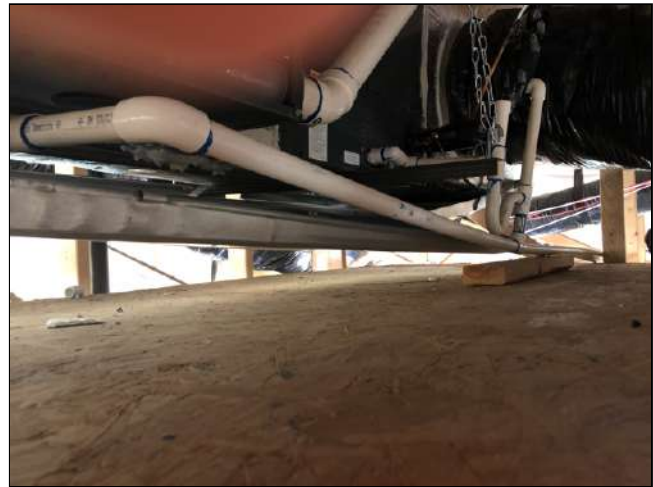
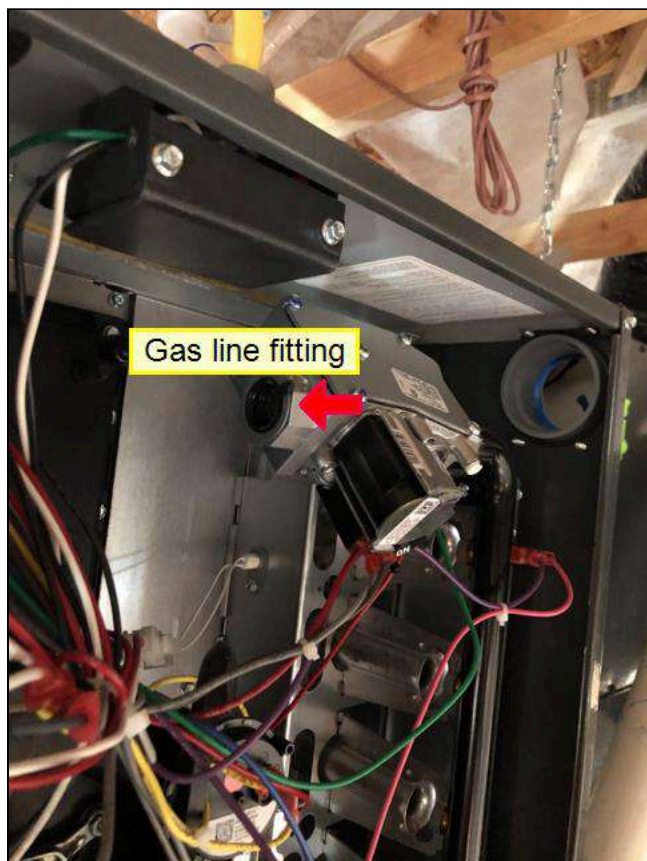
8.5 On the date of inspection, I am not observing the presence of a gas line to the property nor a gas installation within the home even though I am seeing others in the neighborhood. I do, however, observe some yellow PVC or plastic piping that would appear to be used for gas pipe. I am also seeing the beginnings of installation for a gas water heater as well as a gas furnace in the attic. This appears to be a rather large missing. I recommend discussion with the builder to determine how this is to be resolved. **Attention**

8.5 Item 4(Picture) Gas furnace but no gas line?

8.5 Item 5(Picture) No gas lines seen

8.5 Item 6(Picture) Still none

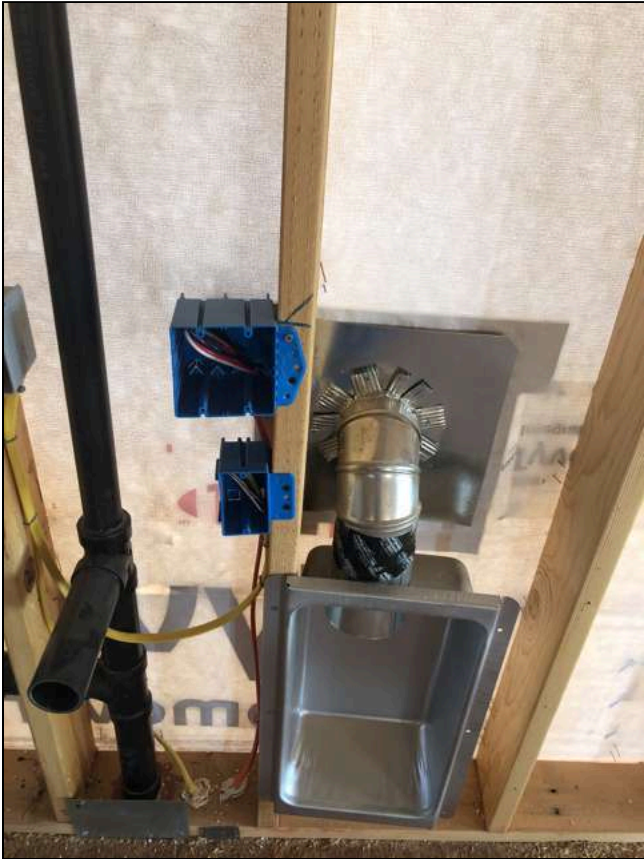
11.1 Item 1(Picture)

11.1 There is no connection for a gas dryer, only electric. The electric connection appears to be setting for 220 V and

not yet functional.

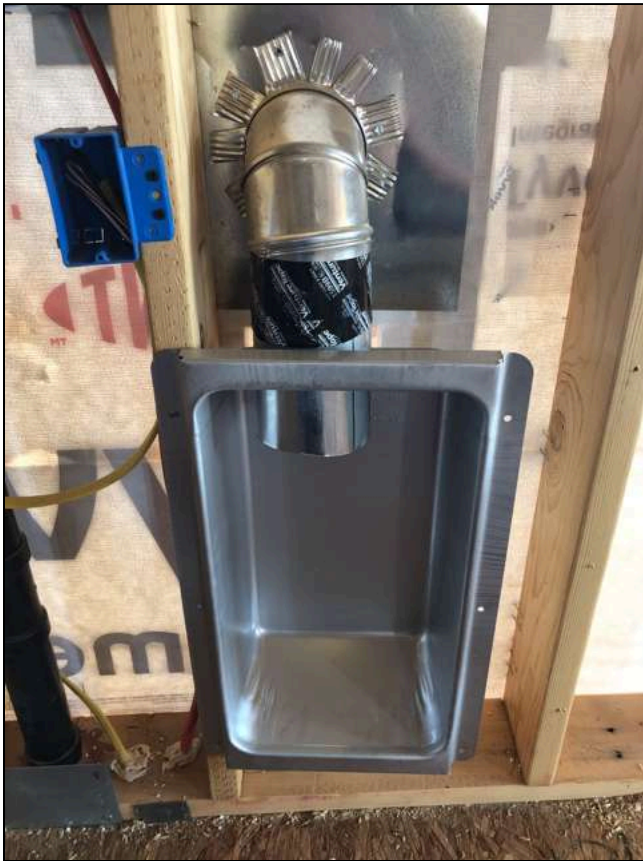
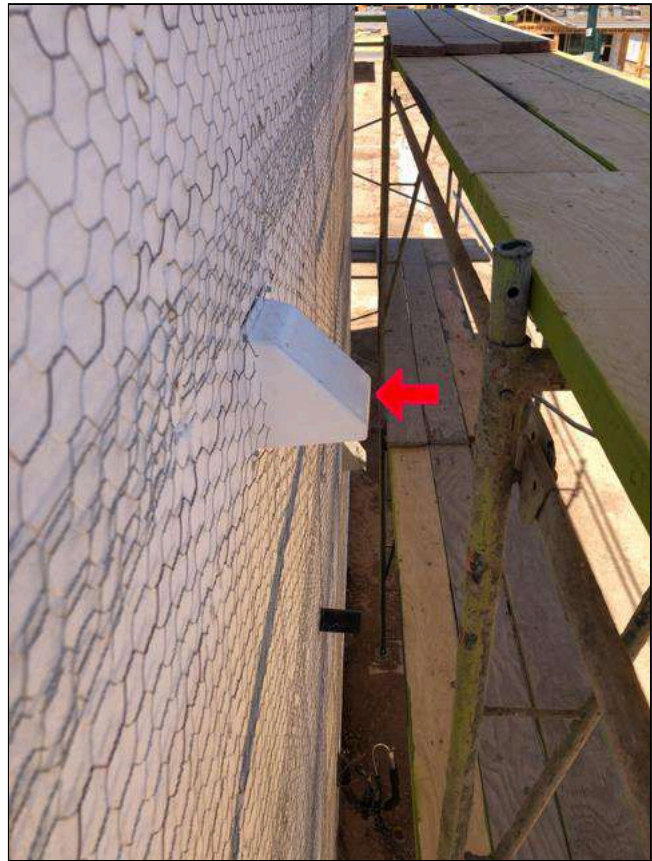
11.2 Dryer exhaust is metal, installed and in place
