Inspection Report

John and Jessie Doe - SAMPLE REPORT ONLY

Property Address:
9954 S Main Ave
Surprise AZ 85379

Shining Light Home Inspection Services, LLC

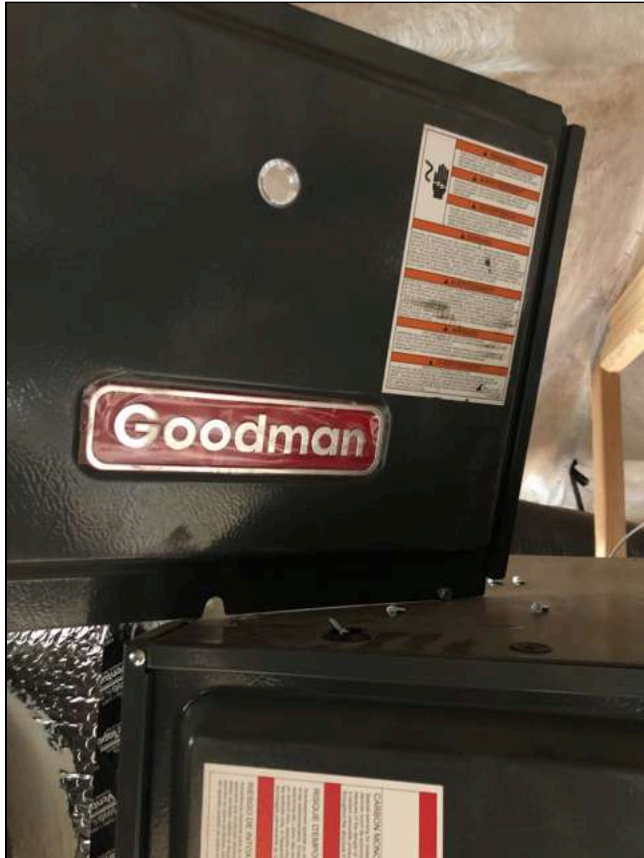
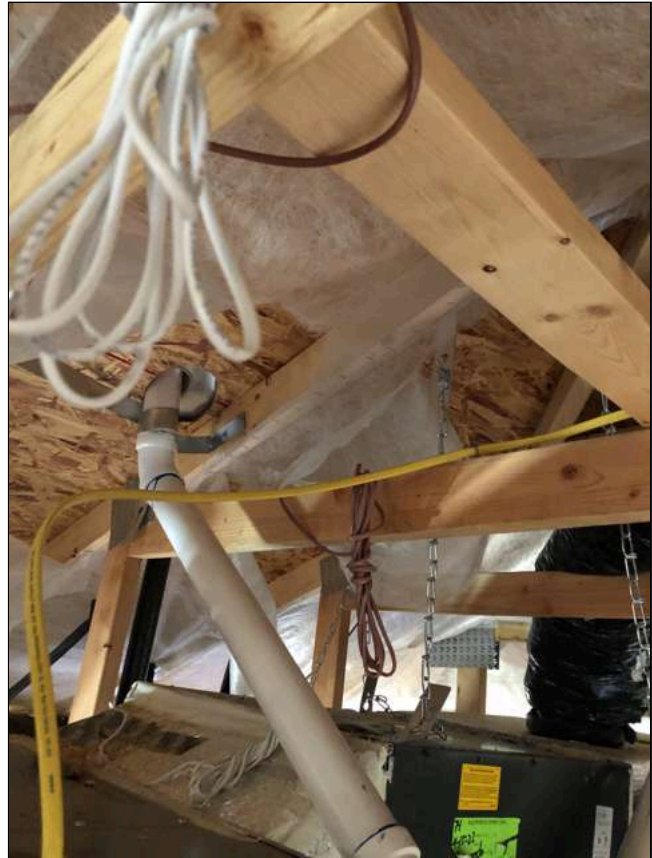
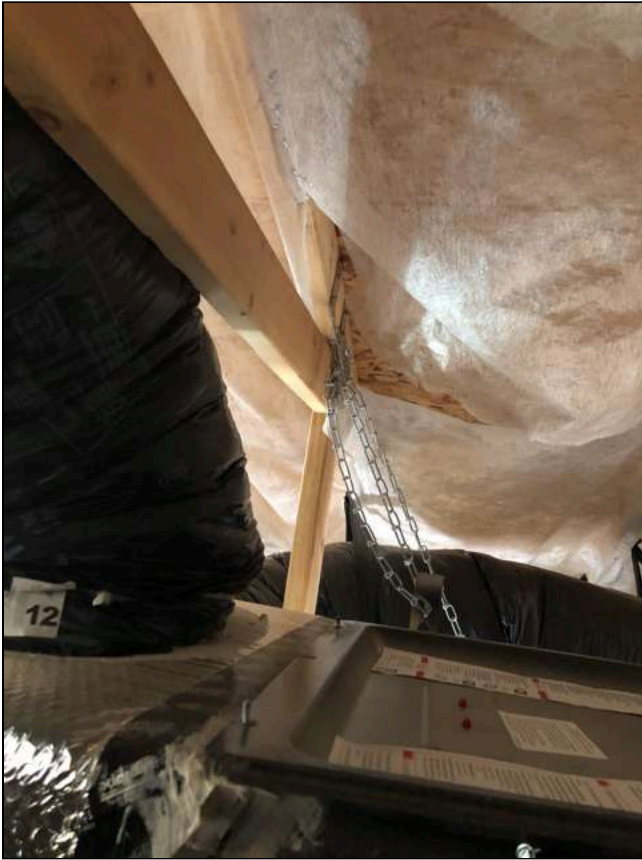
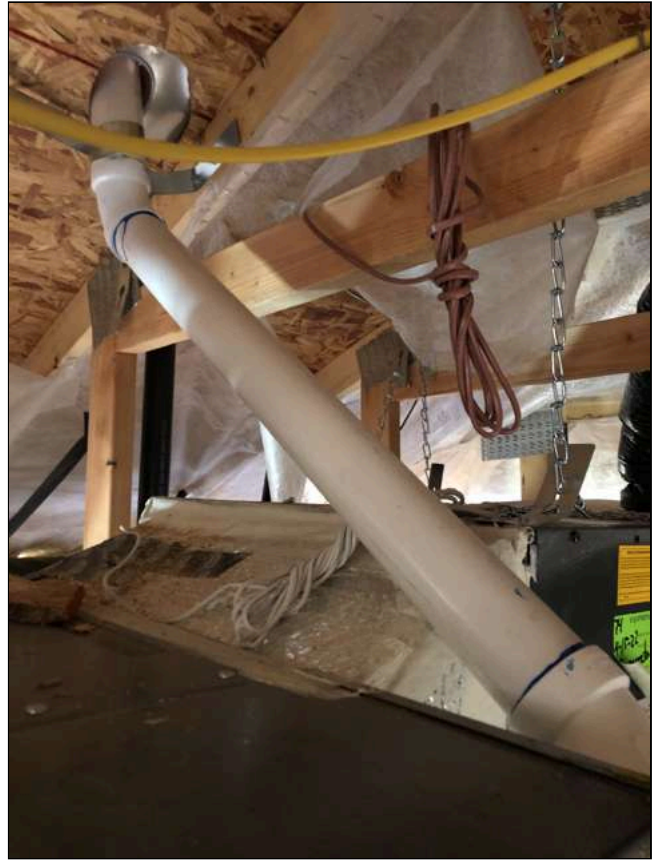
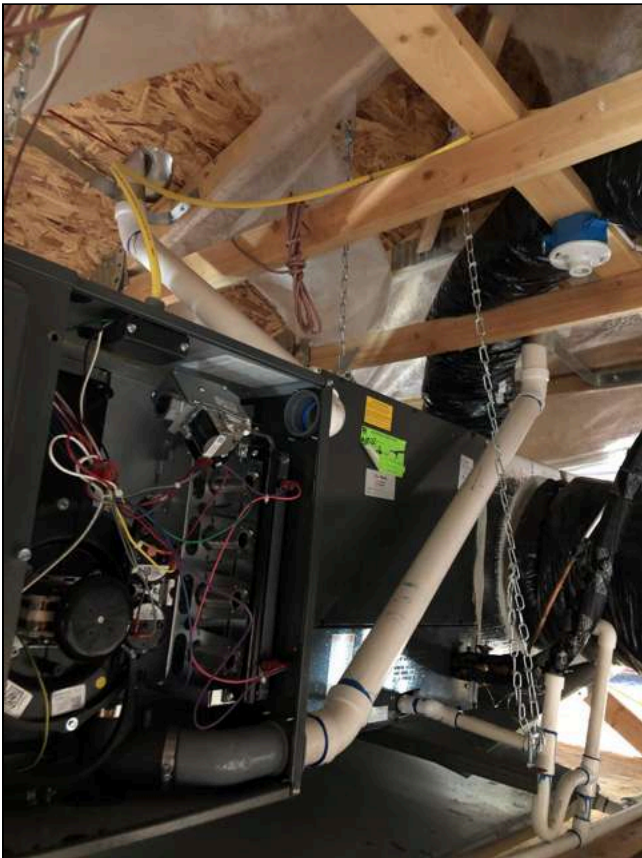
12.0 (1) Air handling, evaporation and heating equipment appears to be properly installed in the attic. They are hung from the top of the engineering trusses that are able to support them. At this point they are not functional as it is still in pre-build.

12.0 (2) On the date of inspection there is no gas in this home therefore there is no gas hook up to the furnace. This will have to be corrected prior to stucco and drywall or final framing inspection. **Attention**

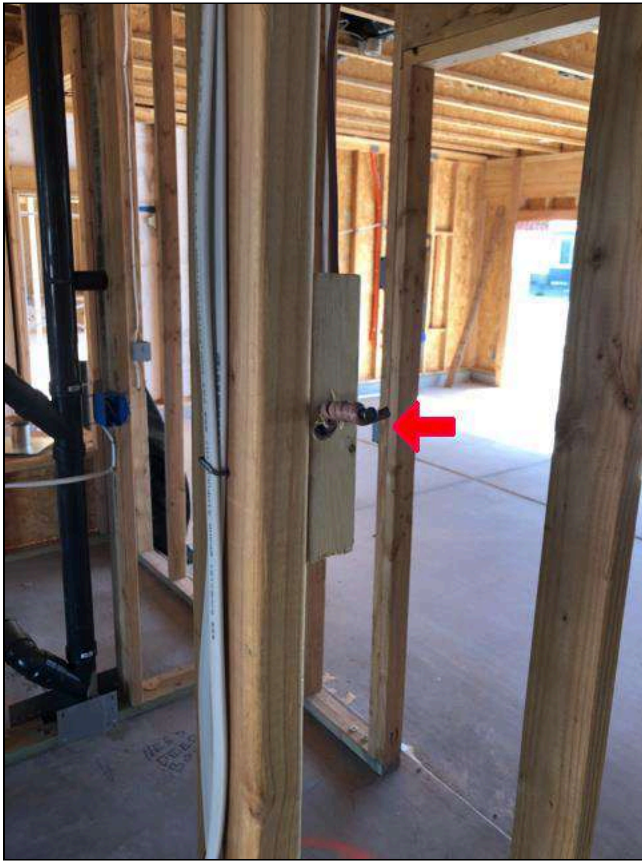
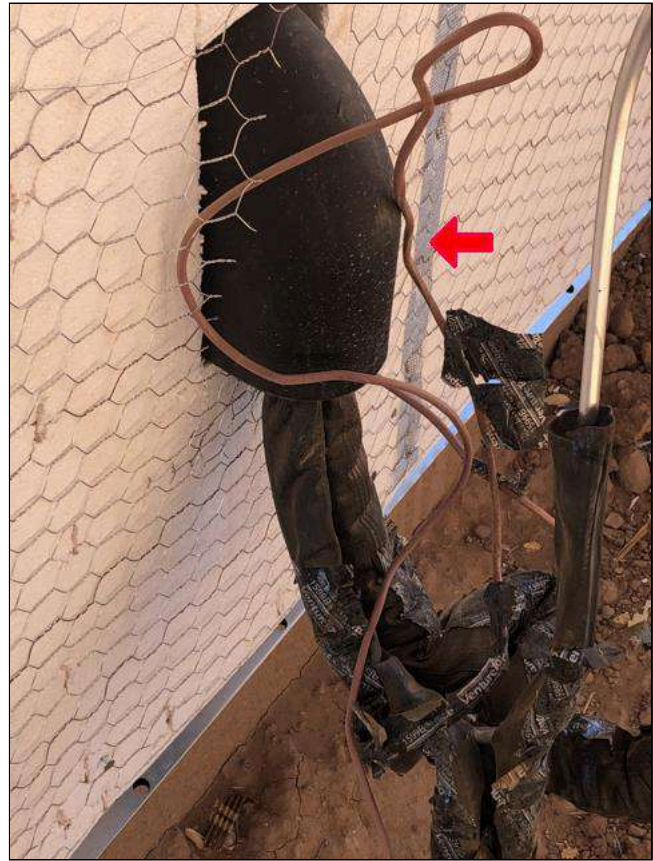
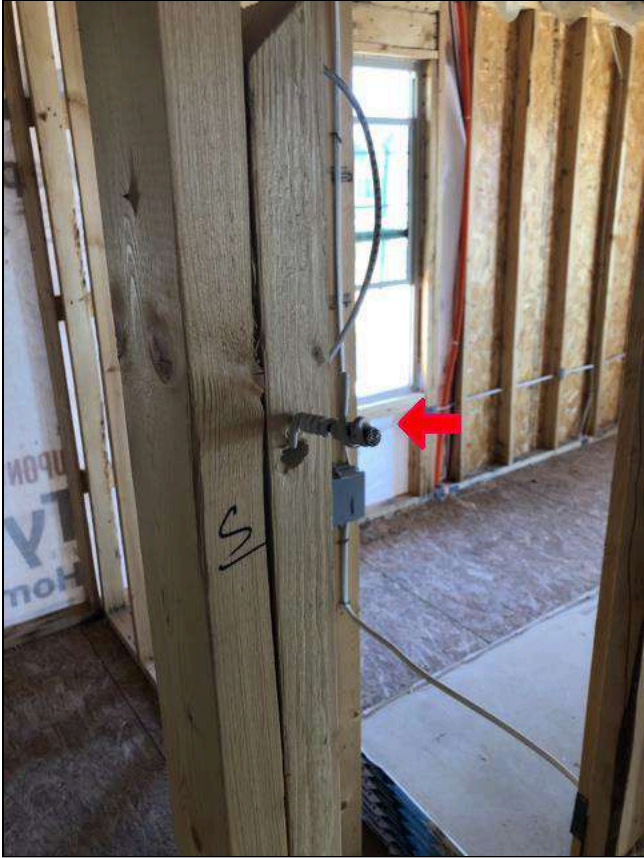
12.1 Thermostat wiring on the interior are in place, awaiting the installation of the thermostats (up stairs and down) and the rest of the heating / cooling equipment. The line running to the exterior unit is in place.

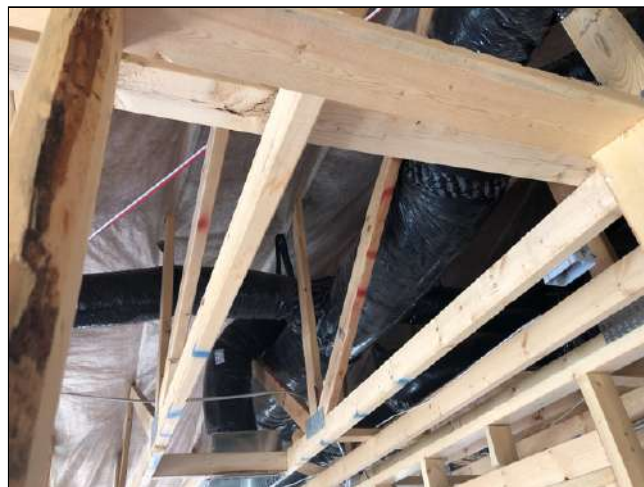
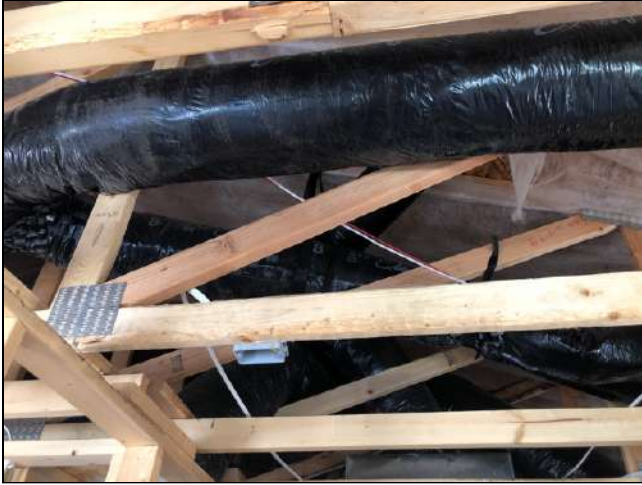
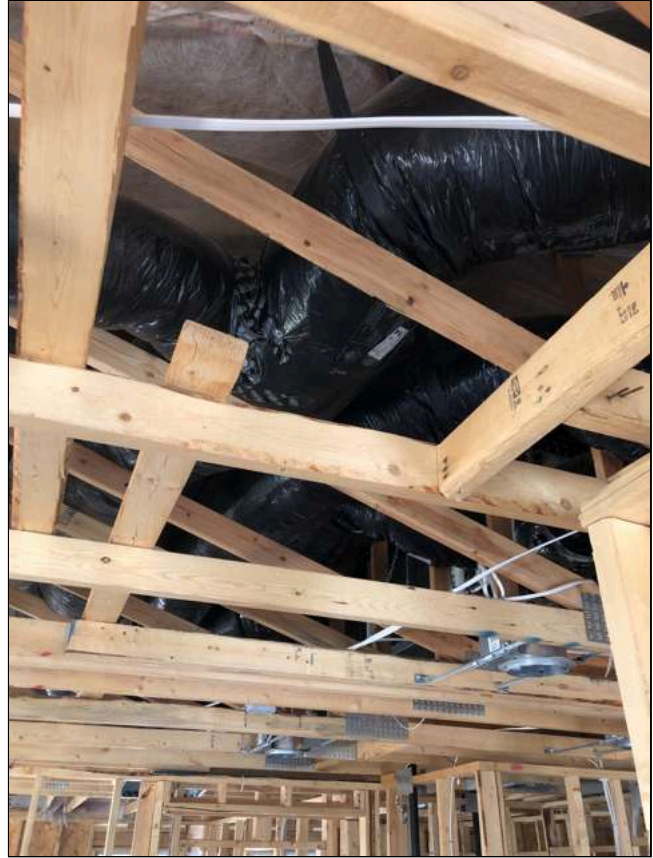
12.4 Visually observed the integrated heating / cooling distribution system within the property. All appears to be installed for functioning as intended on the date of the inspection and the stage of construction. All heating / cooling registers appeared to be in place in all habitable rooms. Flexible, insulated ducts are installed in the attic to all registers. I recommend that the distribution system, especially the filters and ducts, are regularly changed (filters) and cleaned (ducts) to continue to function as intended.

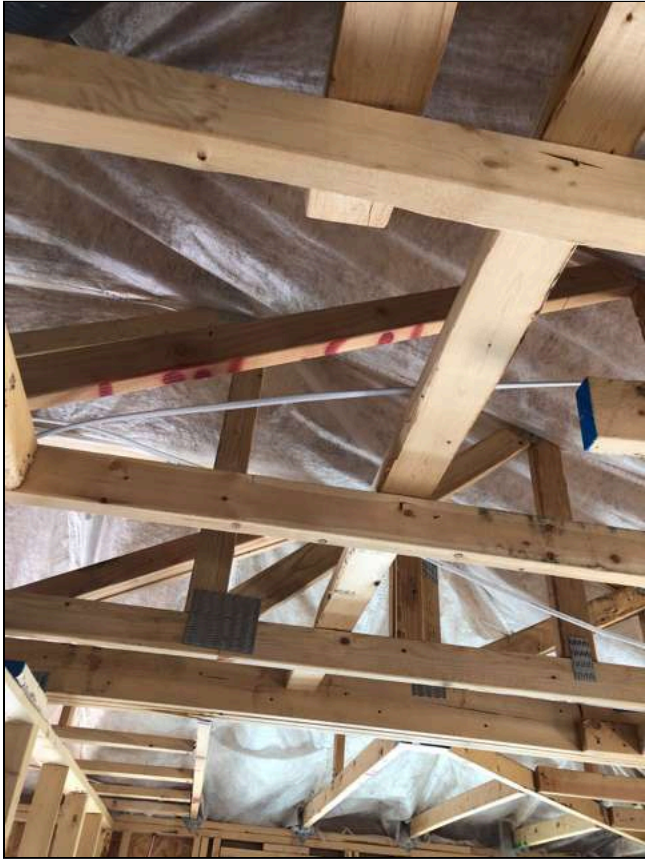
13.0 Item 1(Picture)

13.0 Home appears to be roughed in for having insulation sprayed in with closed foam, especially with the attic over the home prepped for complete seal with no attic ventilation visible outside of the covered patio

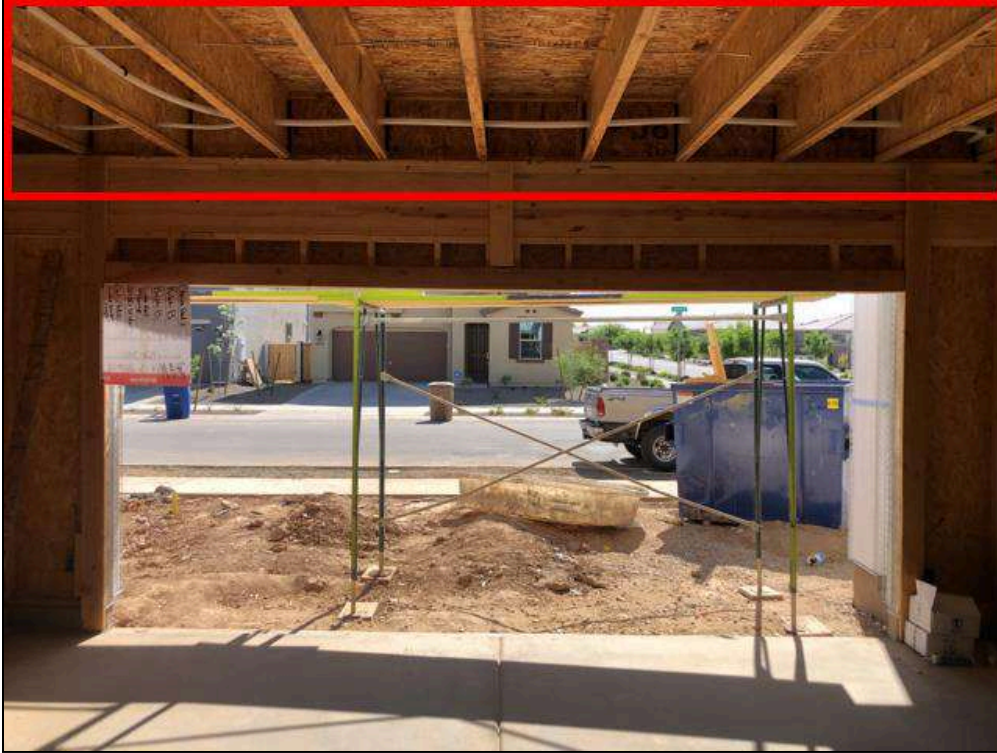
13.1 Item 1(Picture)

13.1 Concrete slab. Ask builder what will be used between floors as there is not way to tell on the date of inspection.

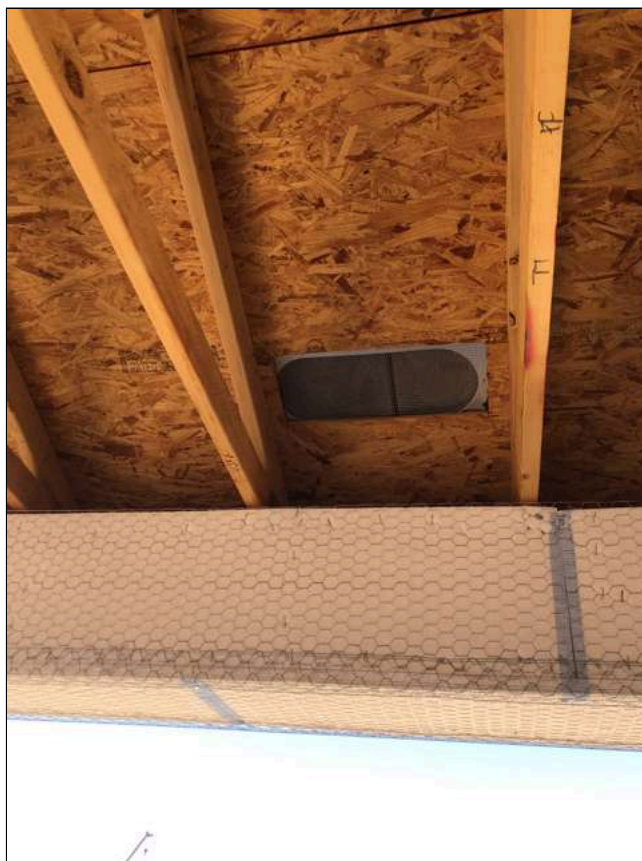
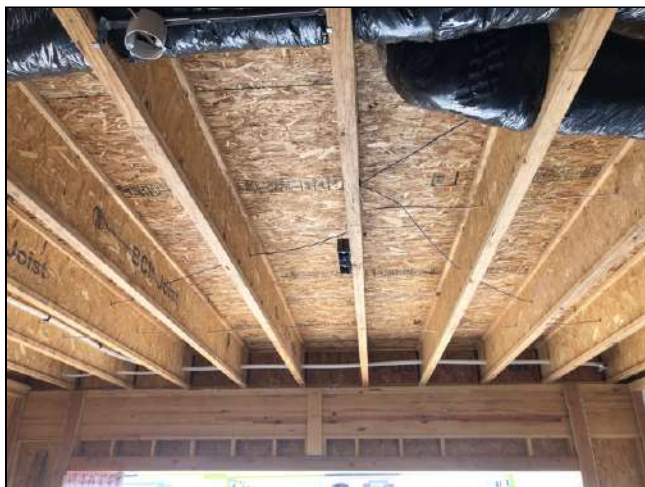
13.3 On the date of inspection the garage appears to be slated for insulation and no obvious ventilation. Observing on the back covered patio is supposed to be completed with O'Hagan vents installed with the tile. Over the main part of the house it appears to be sealed and ready for a permanent, sealed attic insulation types such as foam. I recommend discussion with the builder to understand which insulations will be used in which areas. **Monitor**

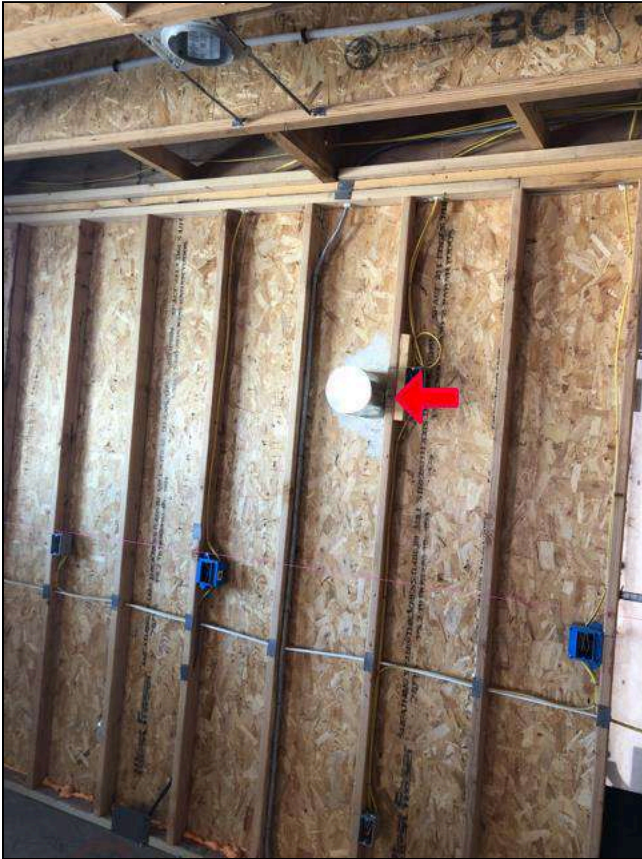
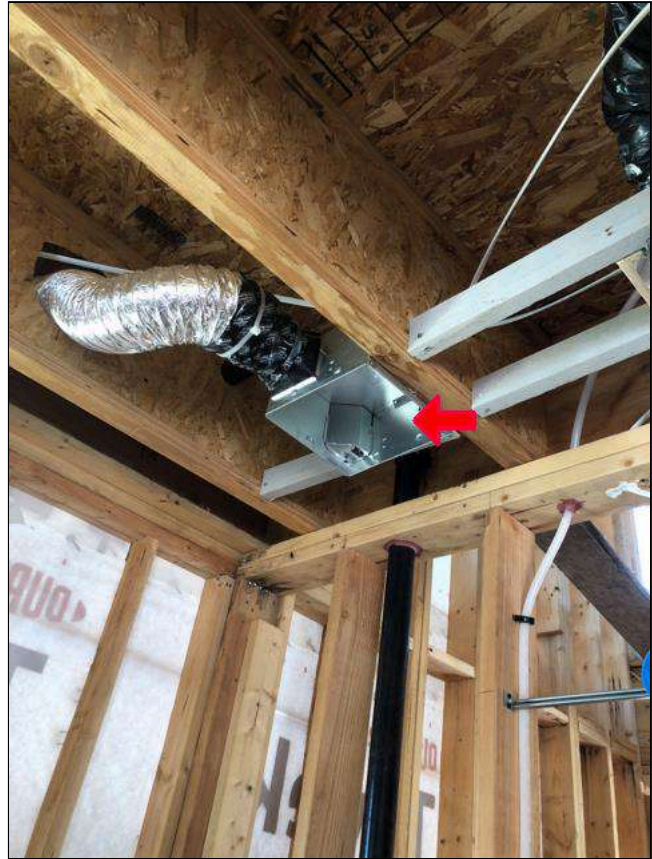
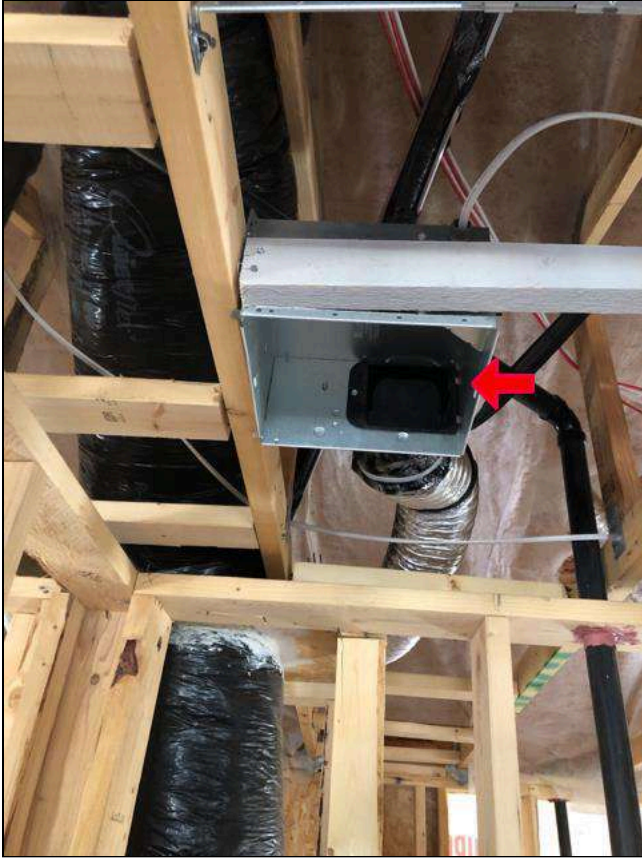
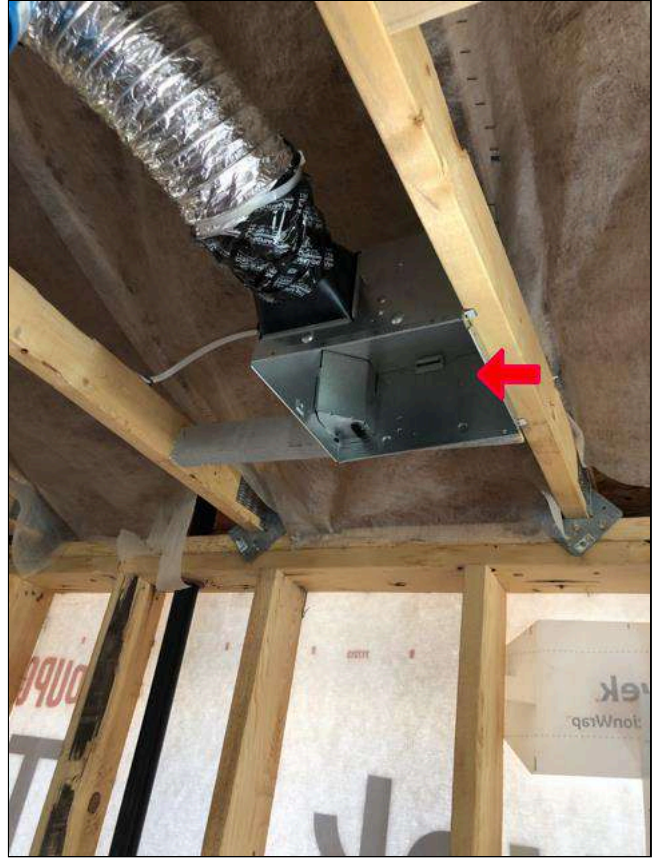
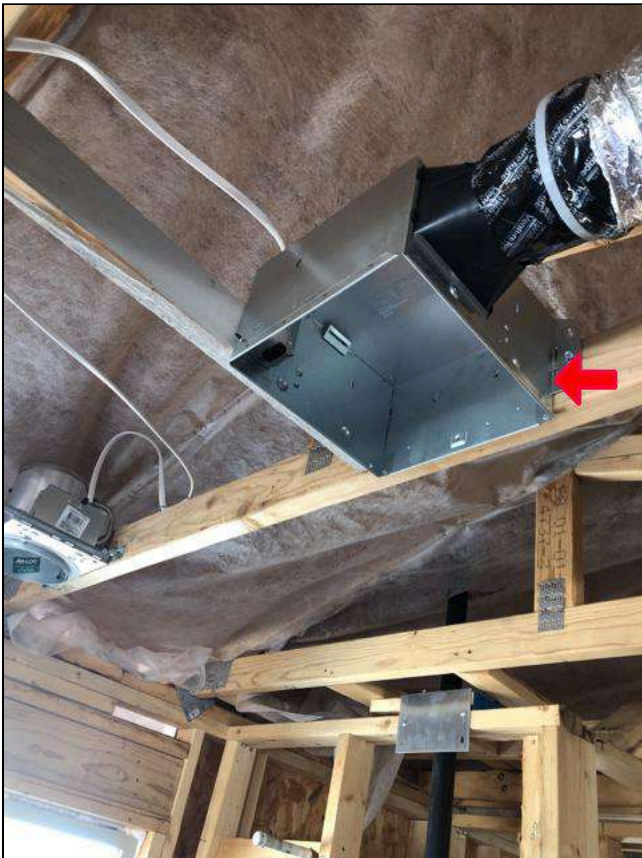
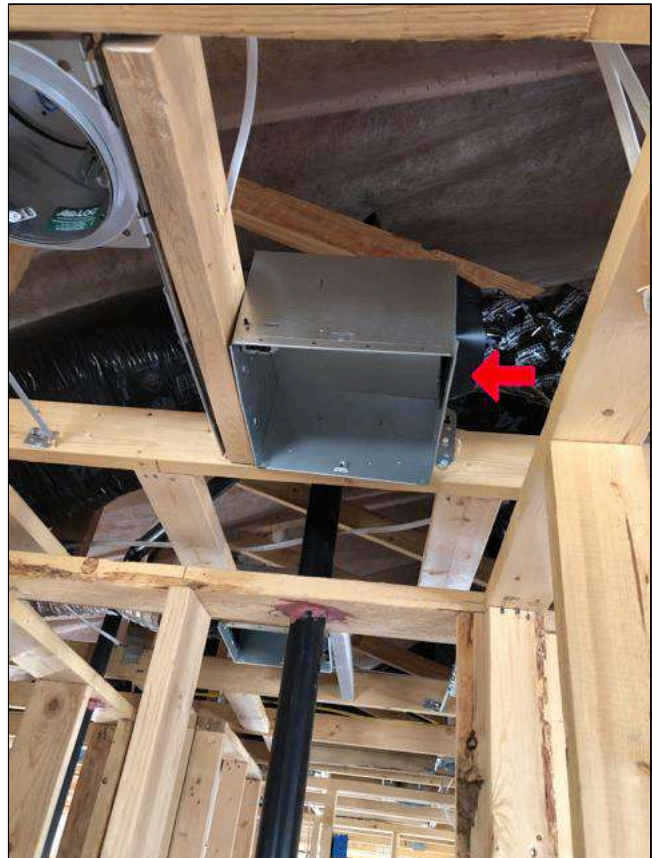
13.4 Vent locations installed but not operational at pre-drywall. About 1/2 appear to be waiting to be outfitted.

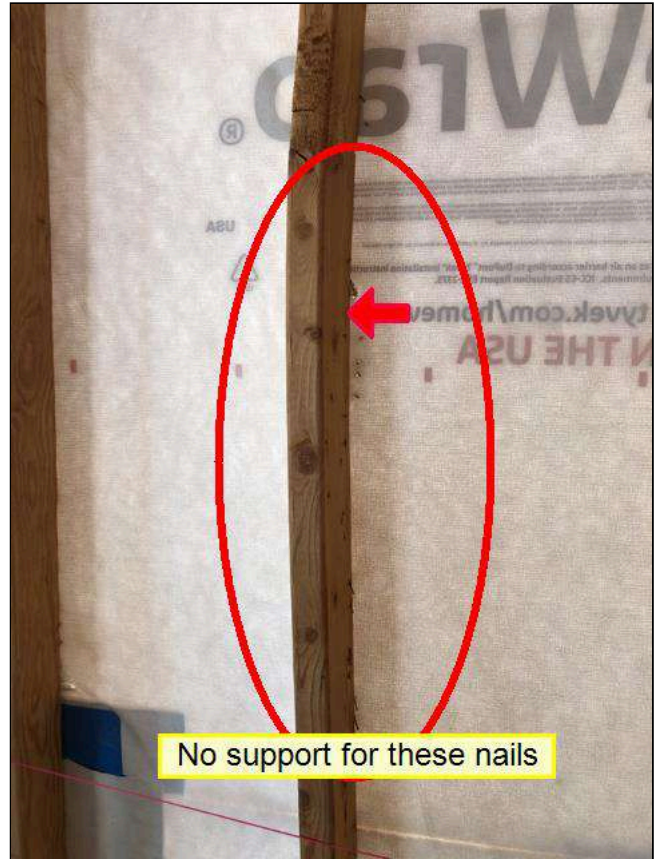
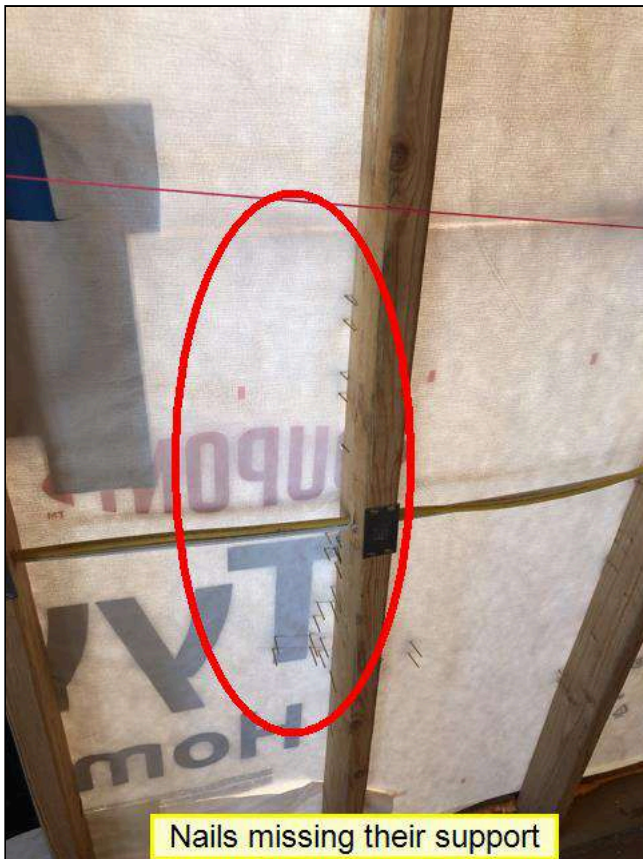
(2) On a date of inspection I am observing more than one wall stud, including those for load-bearing walls, that are warped, bowed, torqued, or have significant cracks in them. Some of these are significant enough such that nails that were supposed to attach to them from the outside or unable to. I recommend discussion with the builder to determine appropriate remediation which may include adjustments, Repairs, or replacement. **Attention**

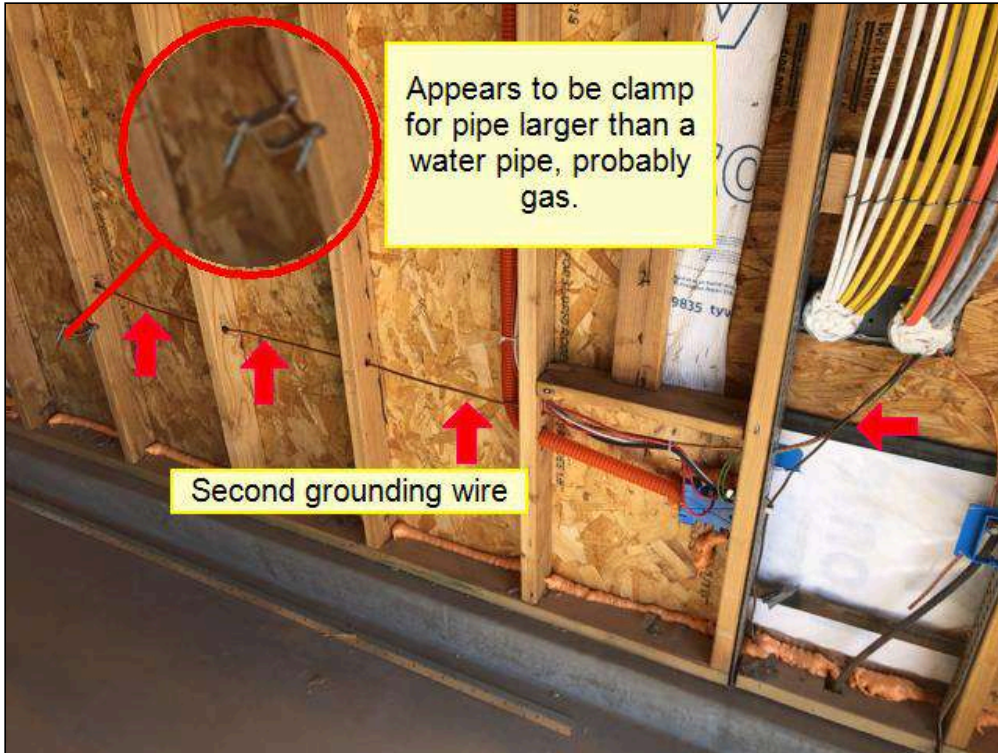
2.1 Item 2(Picture)

(2) There are two main grounds from the panel into the property which should go to the grounding rod. However only one is connected to the grounding rod. The other one appears to be set for a gas pipe which is not here. I recommend that this be a discussion with the builder to find out how these are going to be taken care of prior to drywall and stucco. **Attention**

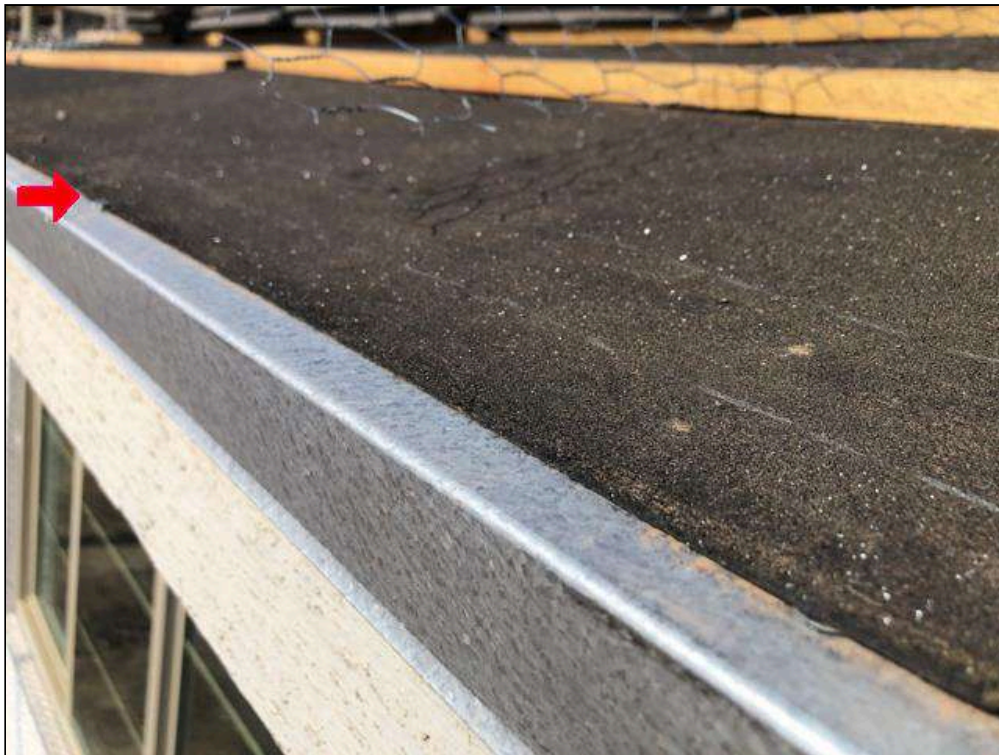
3.1 Item 1(Picture)

Underlayment that is visible on the roof is not yet sealed at all edges as would be expected and are not properly nailed down. It is also standing up from the metal drip edge in some places. It should be installed over the metal drip edge and then sealed once it is in place. I recommend asking the builder when the final sealing for the underlayment will occur for this property. **Attention**

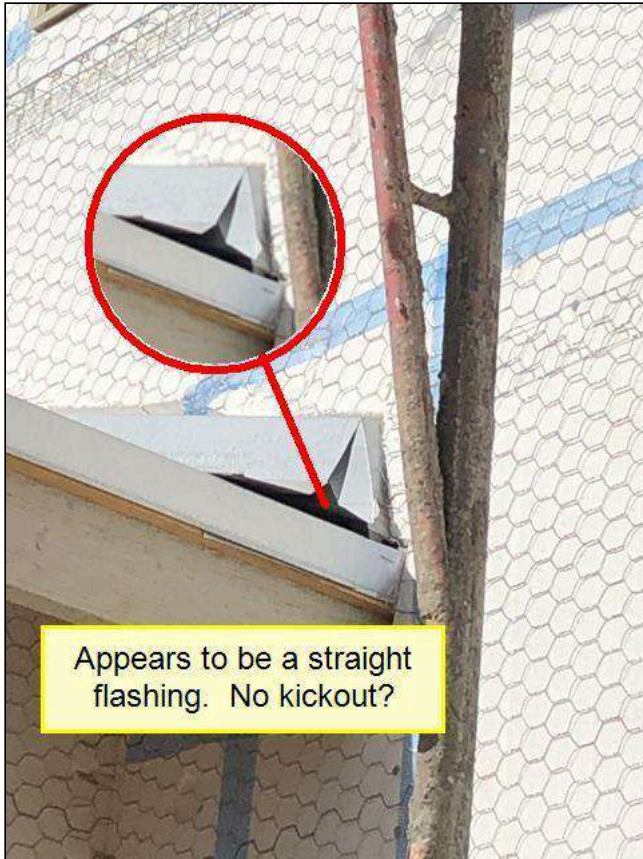
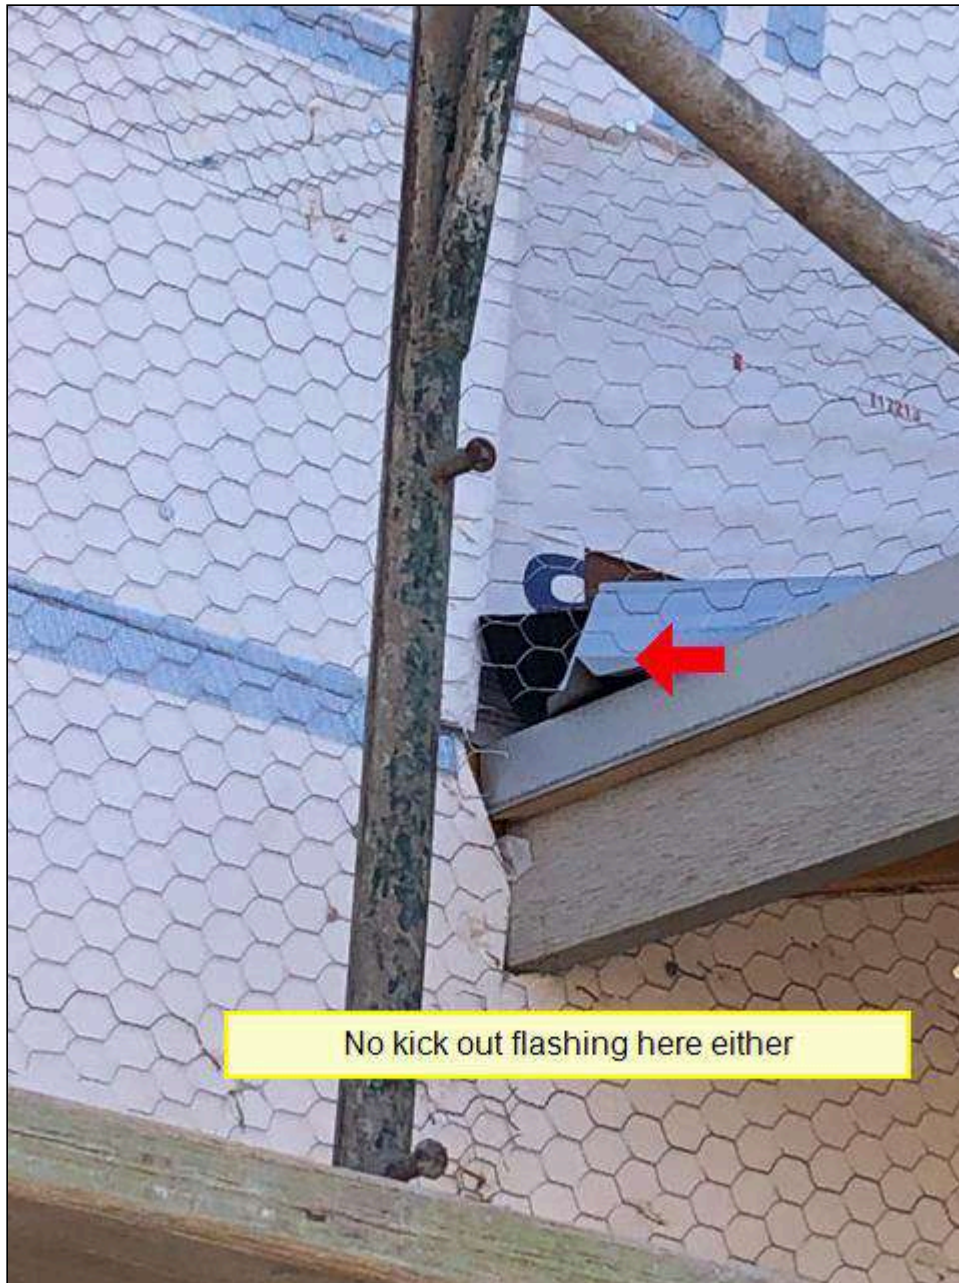
On the date of inspection, I am not observing the use of kick out flashings where a roof to wall interfaces. These are meant to keep water away from a wall interface to a roof such that the wall does not become soaked with water. I recommend discussion with the builder determine when they kick out flashings will be installed prior to stucco.

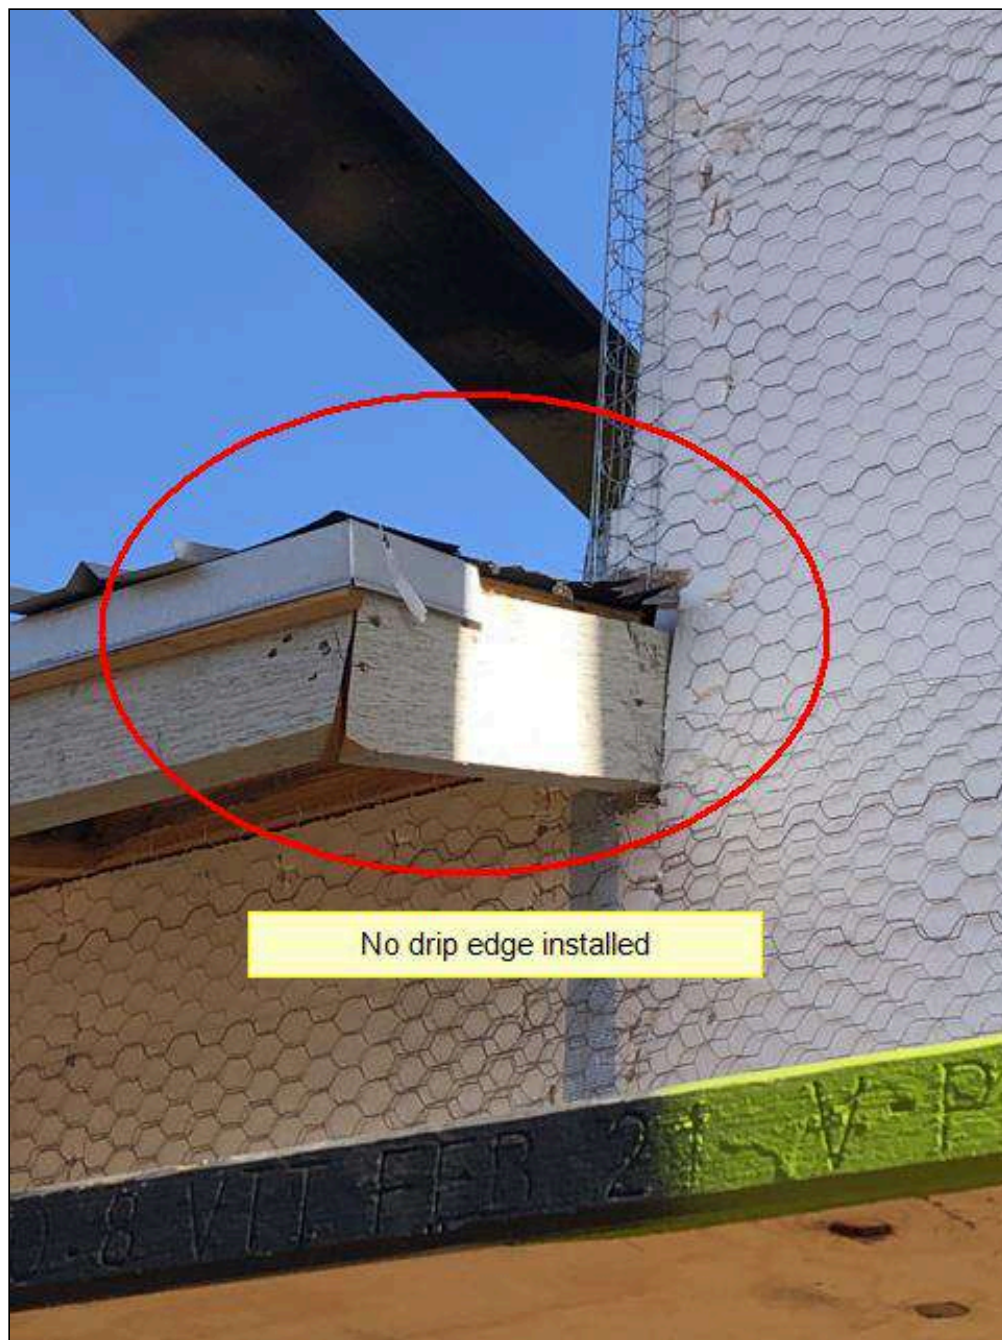
3.6 Item 1(Picture)

Metal drip edge is missing or open in some locations. In other locations it is well wrapped and overlapped. I recommend reviewing this with the builder to a sure that it is properly and fully install. **Attention**

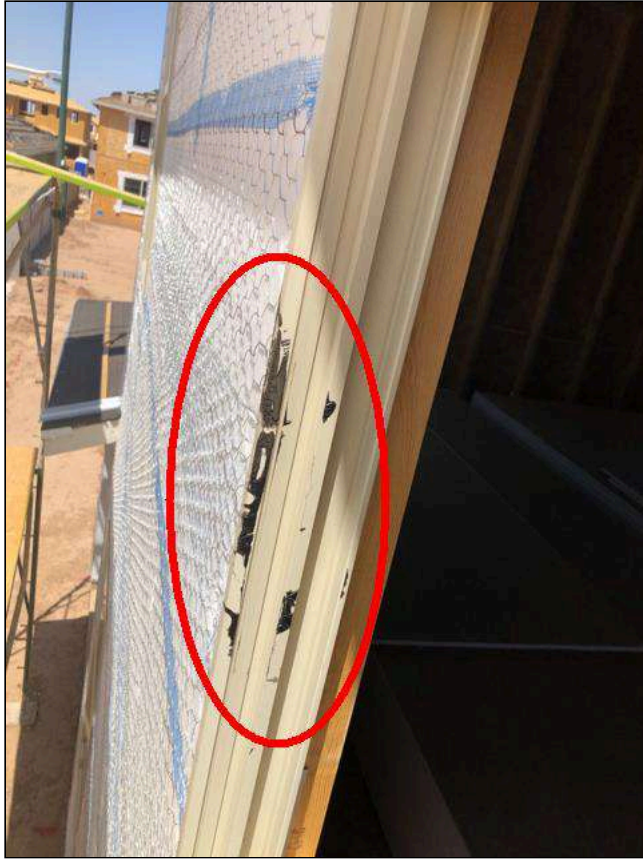
4.3 Item 1(Picture)

(2) Second-floor window in the south west side of the second floor is marred with some kind of tar. It appears to be roof tar of some sort. I recommend discussion with the builder to determine when this will be cleaned or replaced.

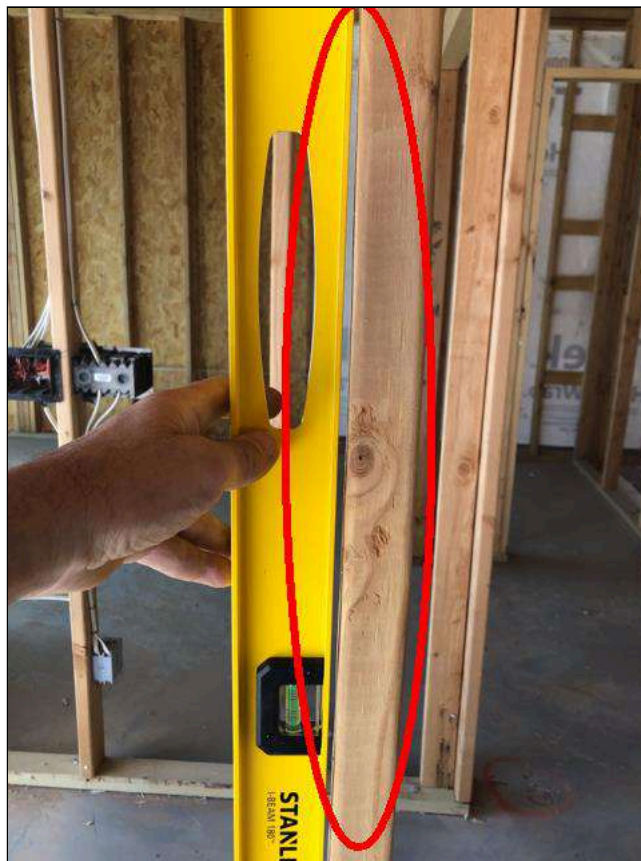
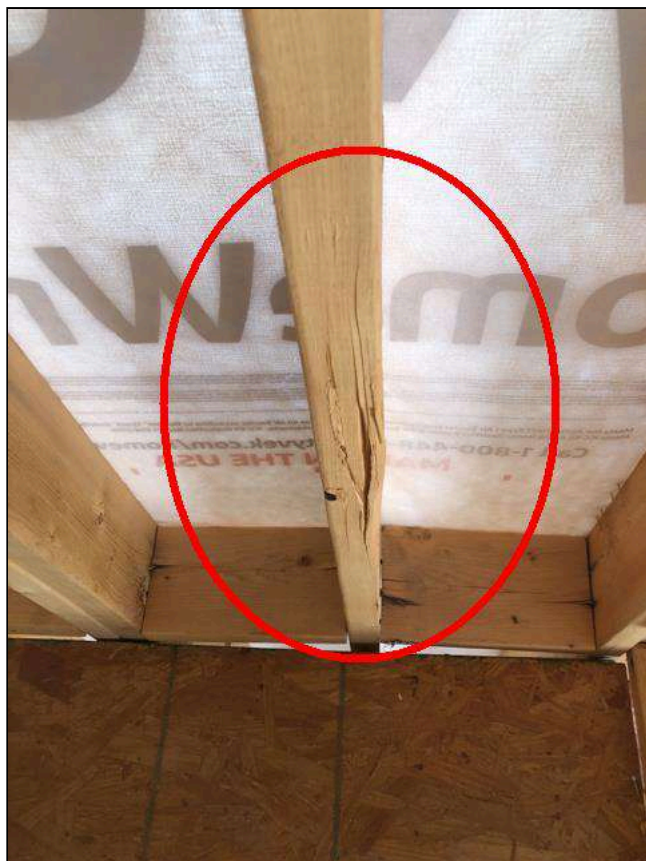
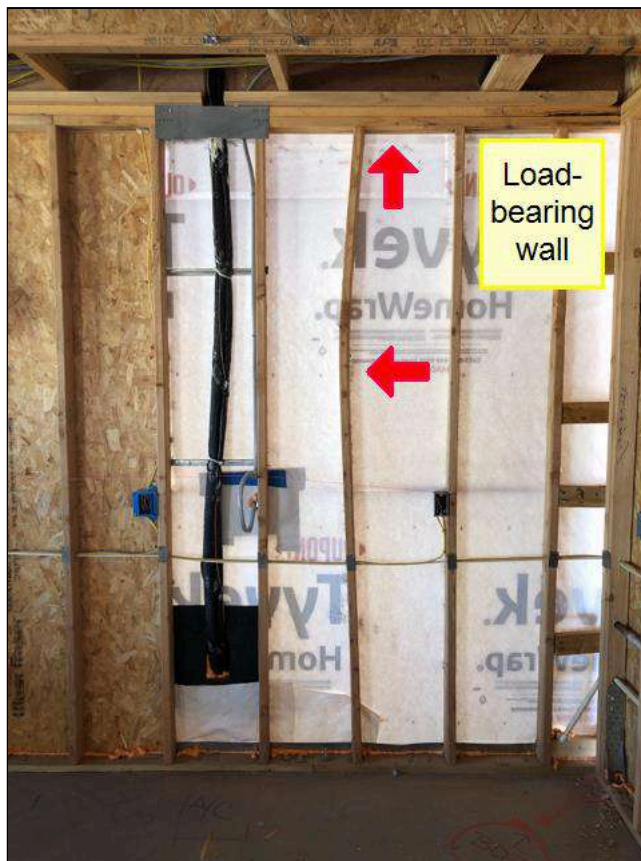
(2) There are a number of studs in the home that are warped, significantly cracked or torqued. I recommend that these be reviewed with the builder for repair or replacement as needed. **Attention**
