Inspection Report

John and Jessie Doe - SAMPLE REPORT ONLY

Property Address:
9954 S Main Ave
Surprise AZ 85379

Shining Light Home Inspection Services, LLC

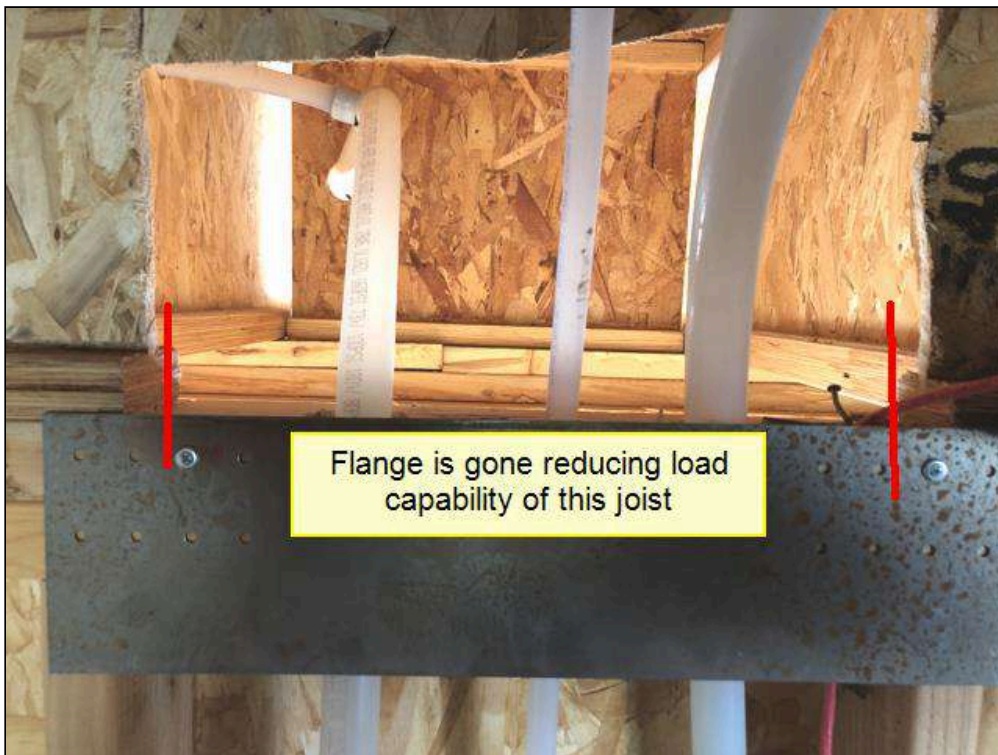
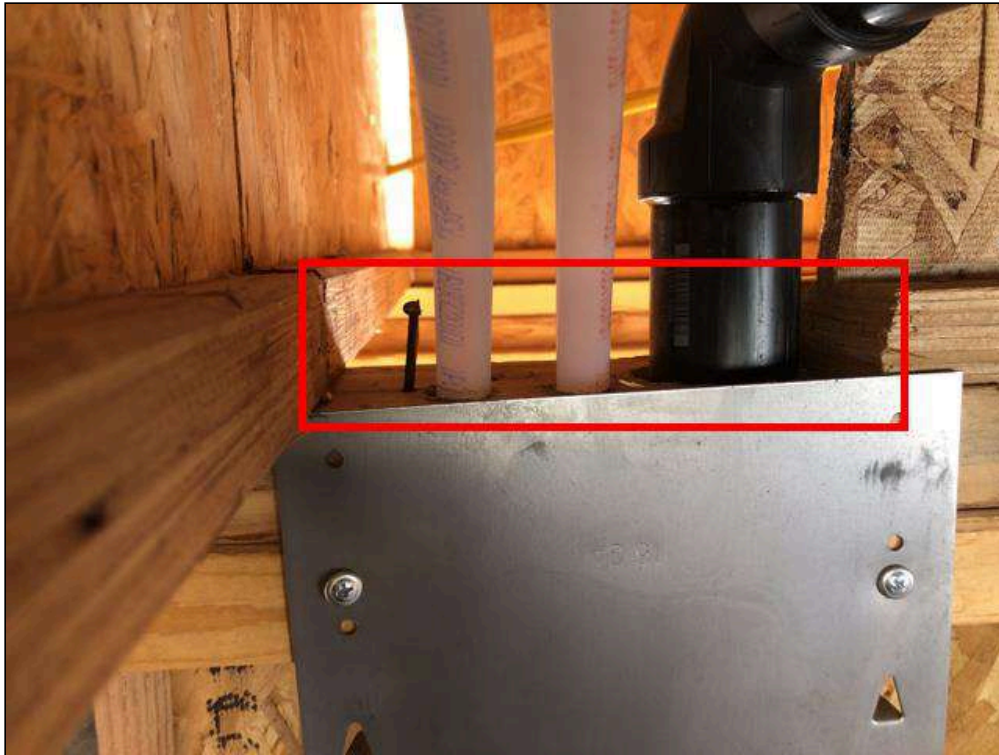
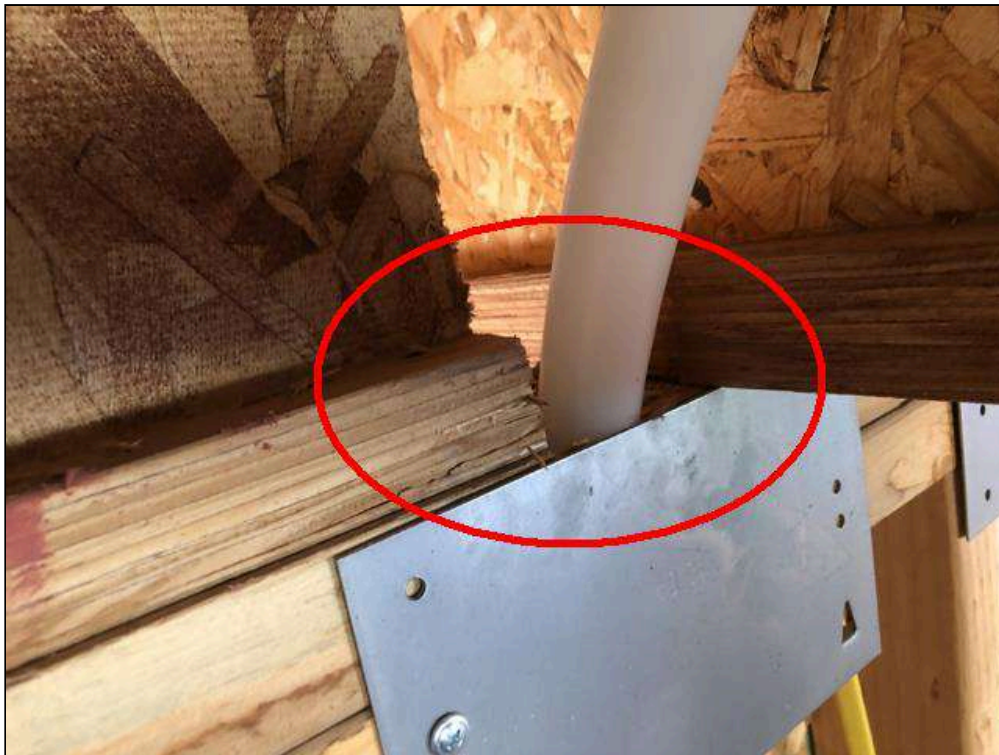
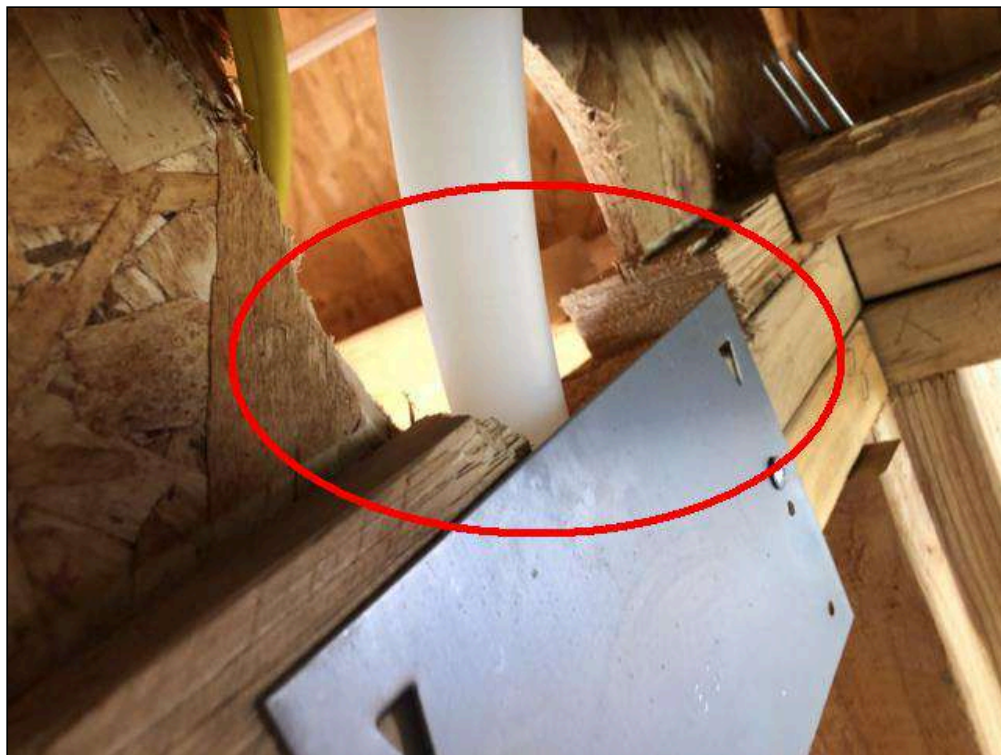
(2) On the date of inspection, I am observing a few of the I-beam flanges that have been cut away and are no longer in place. These are not just minor or allowed notching: the entire flange has been cut away. This will deteriorate the load carrying capability of these I-beam flanges. I recommend discussion with the builder on why these flange cuts are allowed in this circumstance, what they will do to restore the load carrying capability of these joists (if this is needed) and if these cuts were approved by a structural engineer. **Attention**

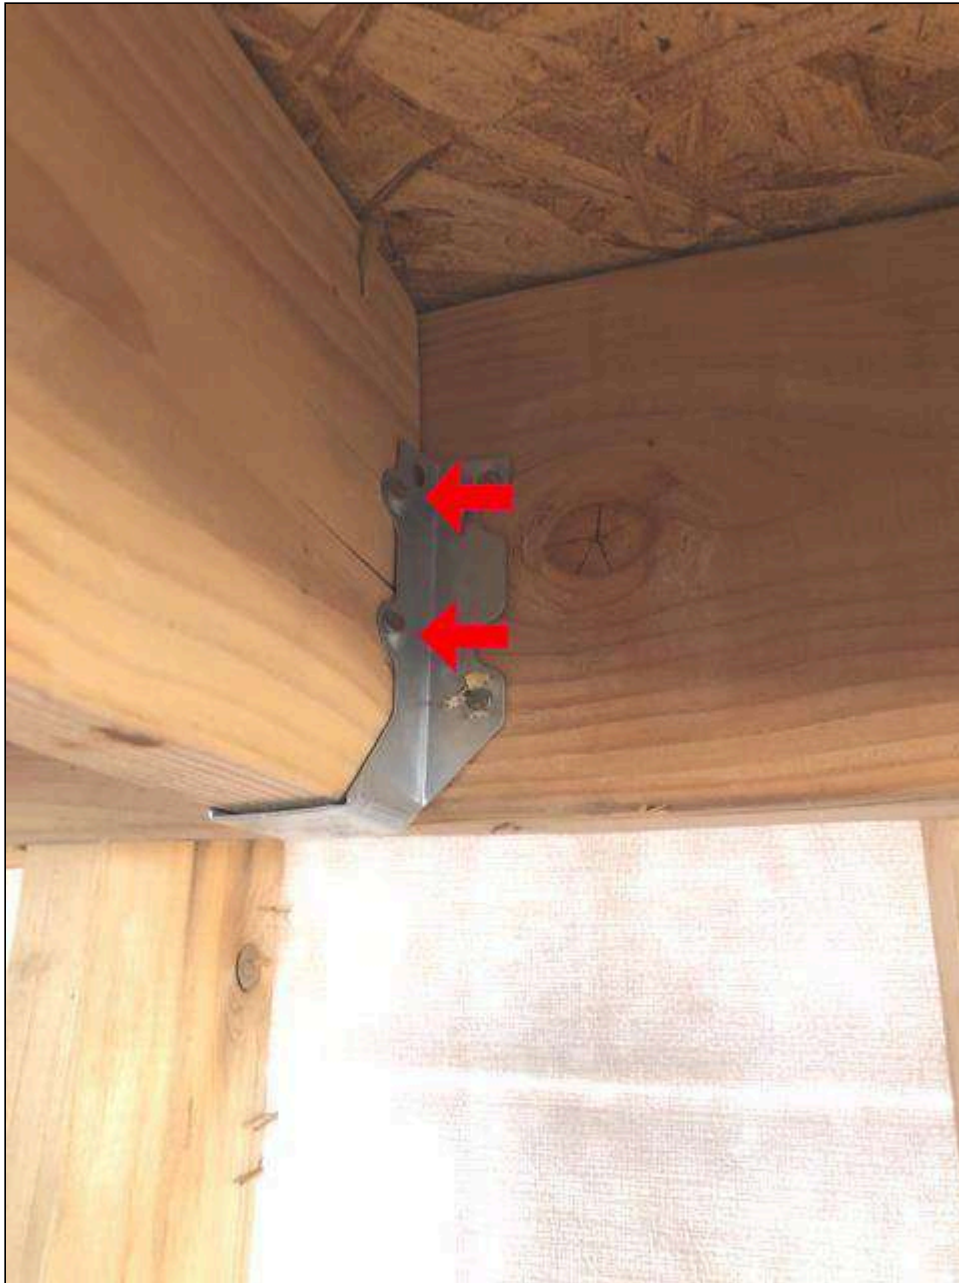
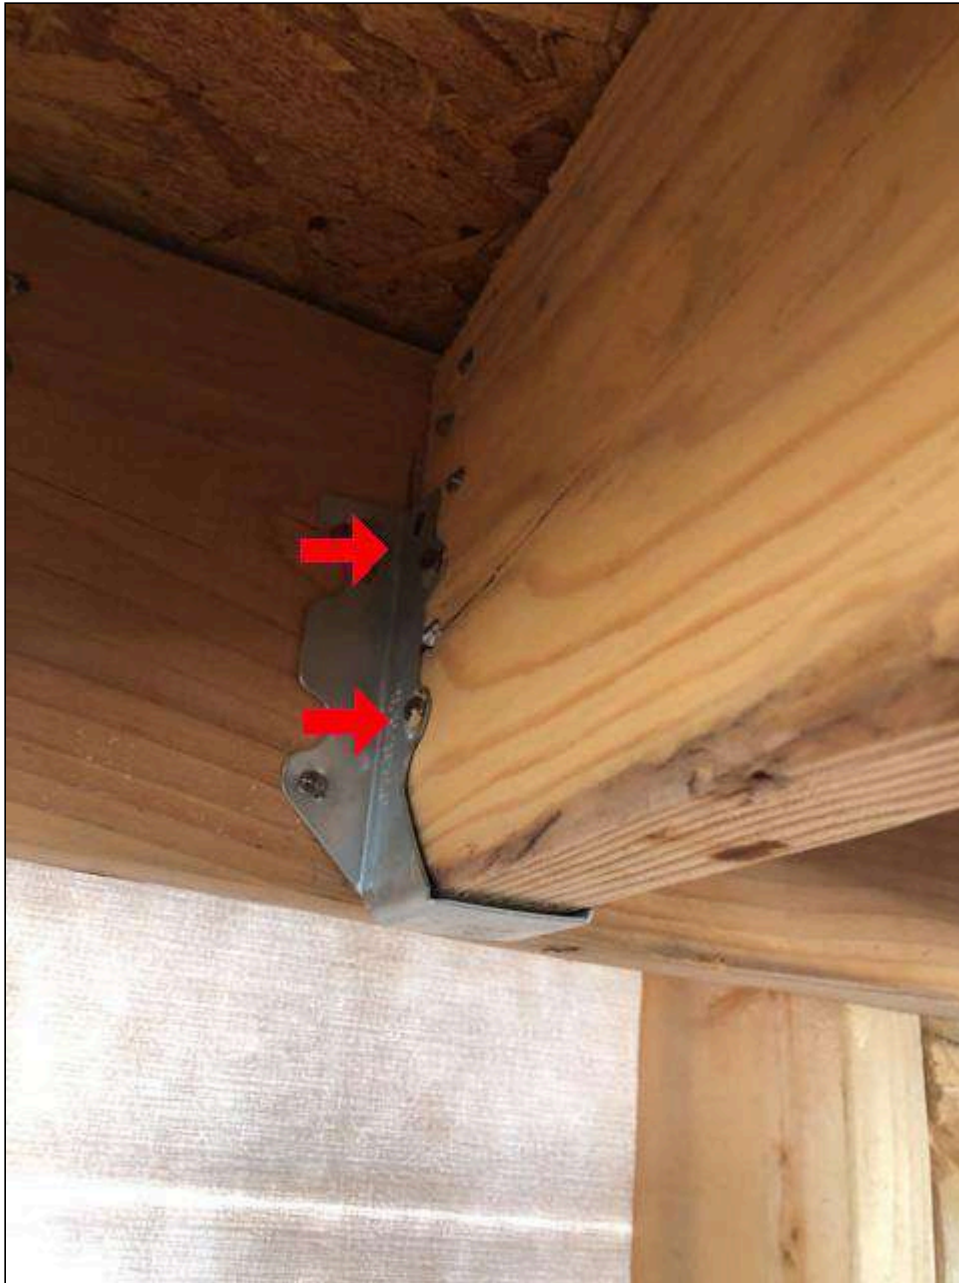
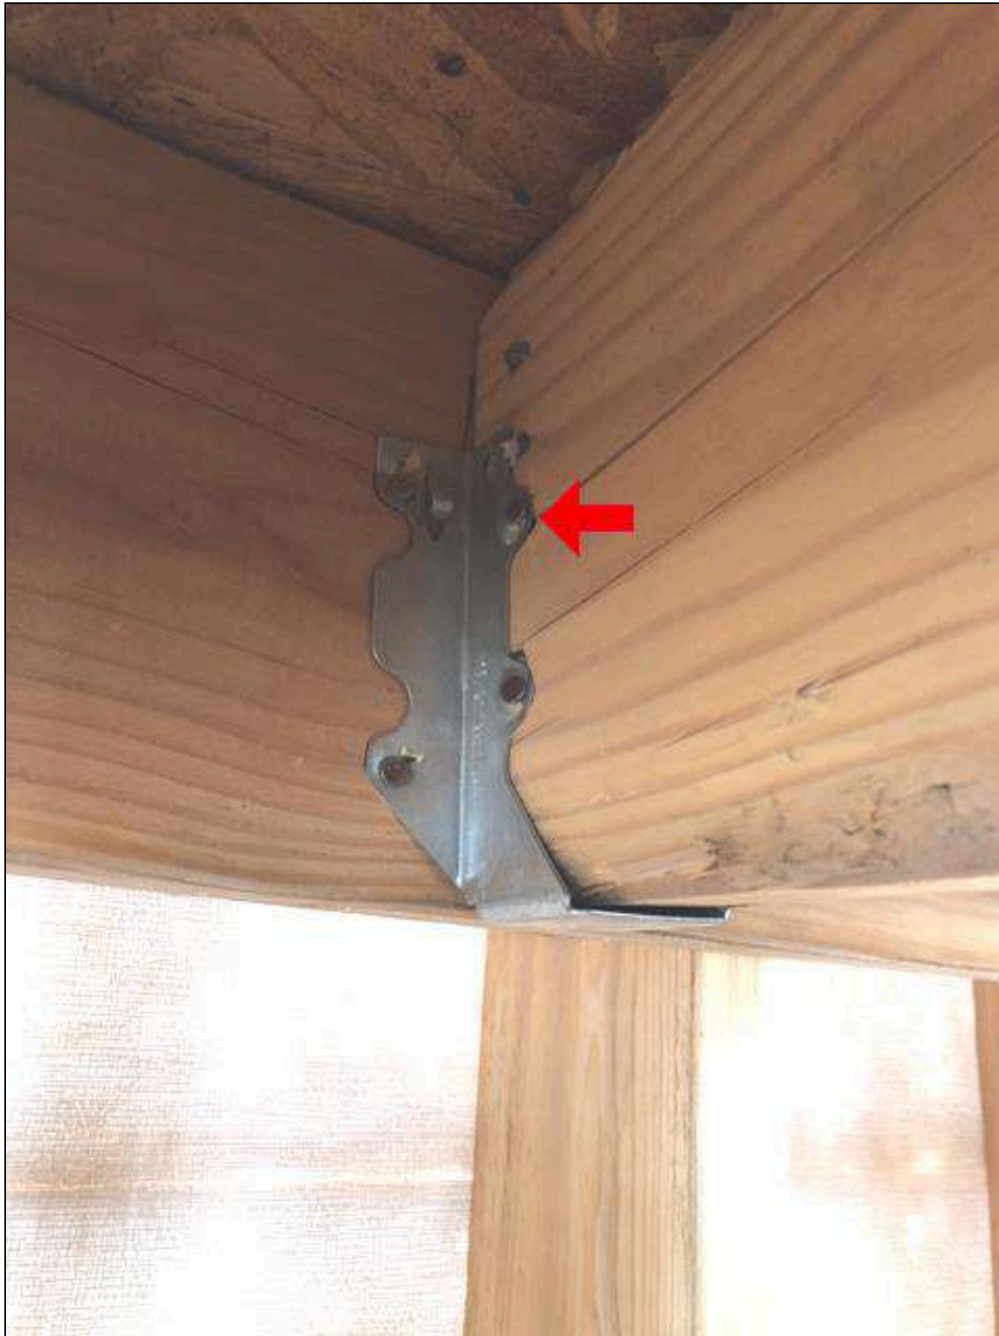
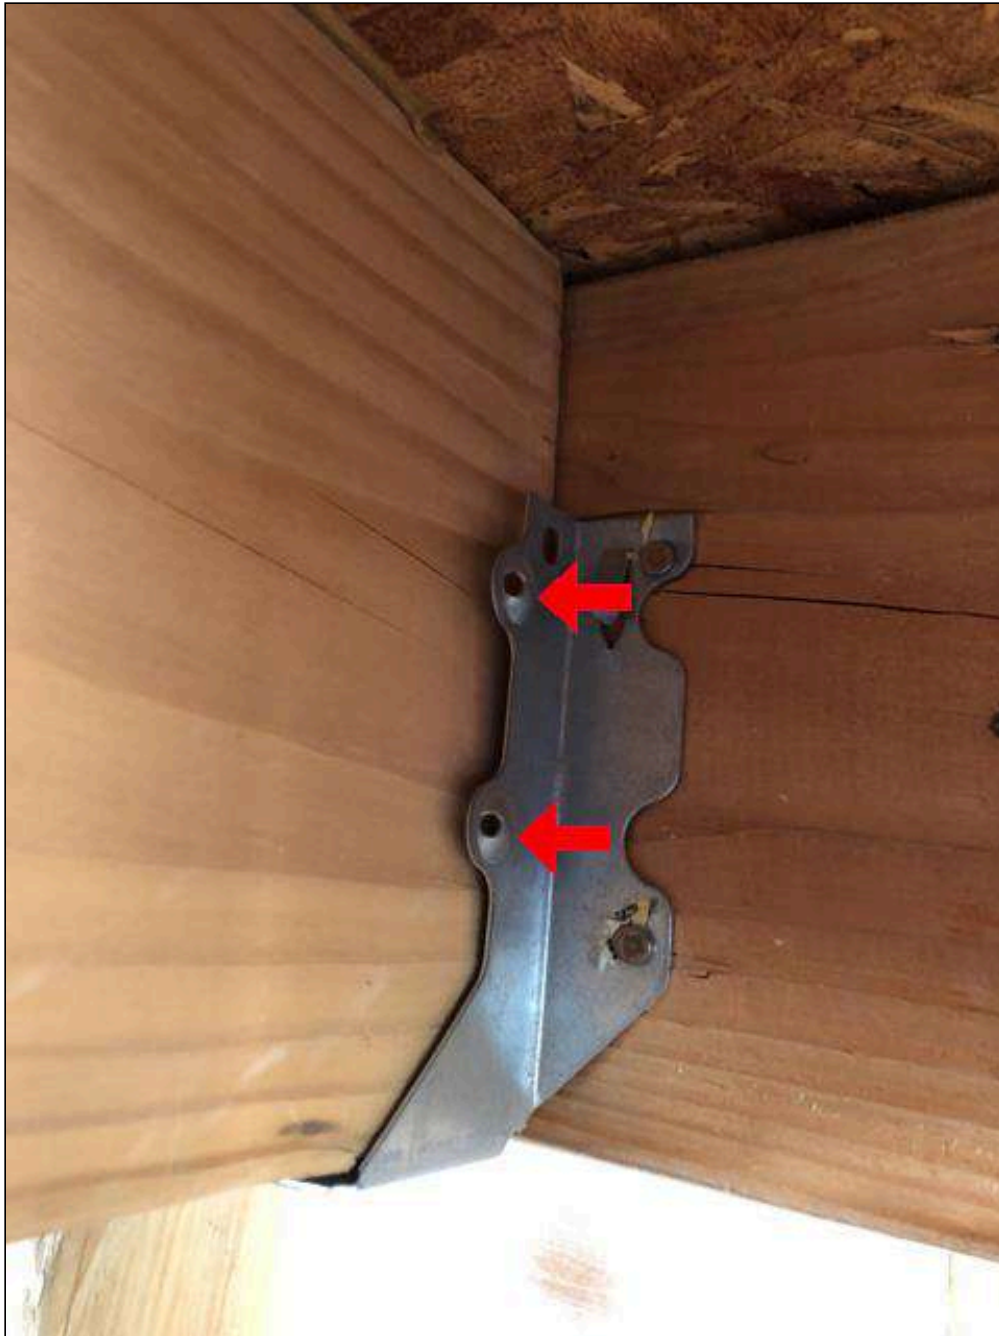
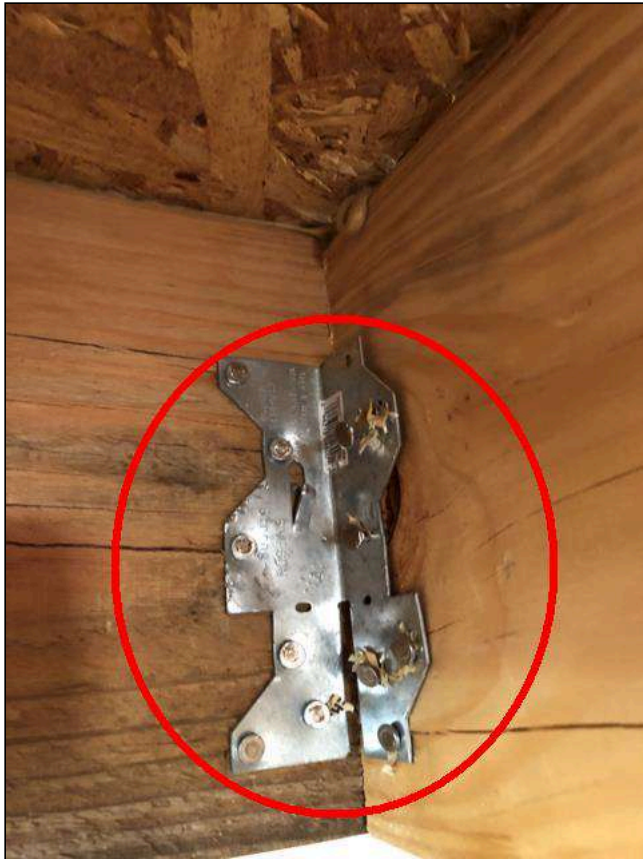
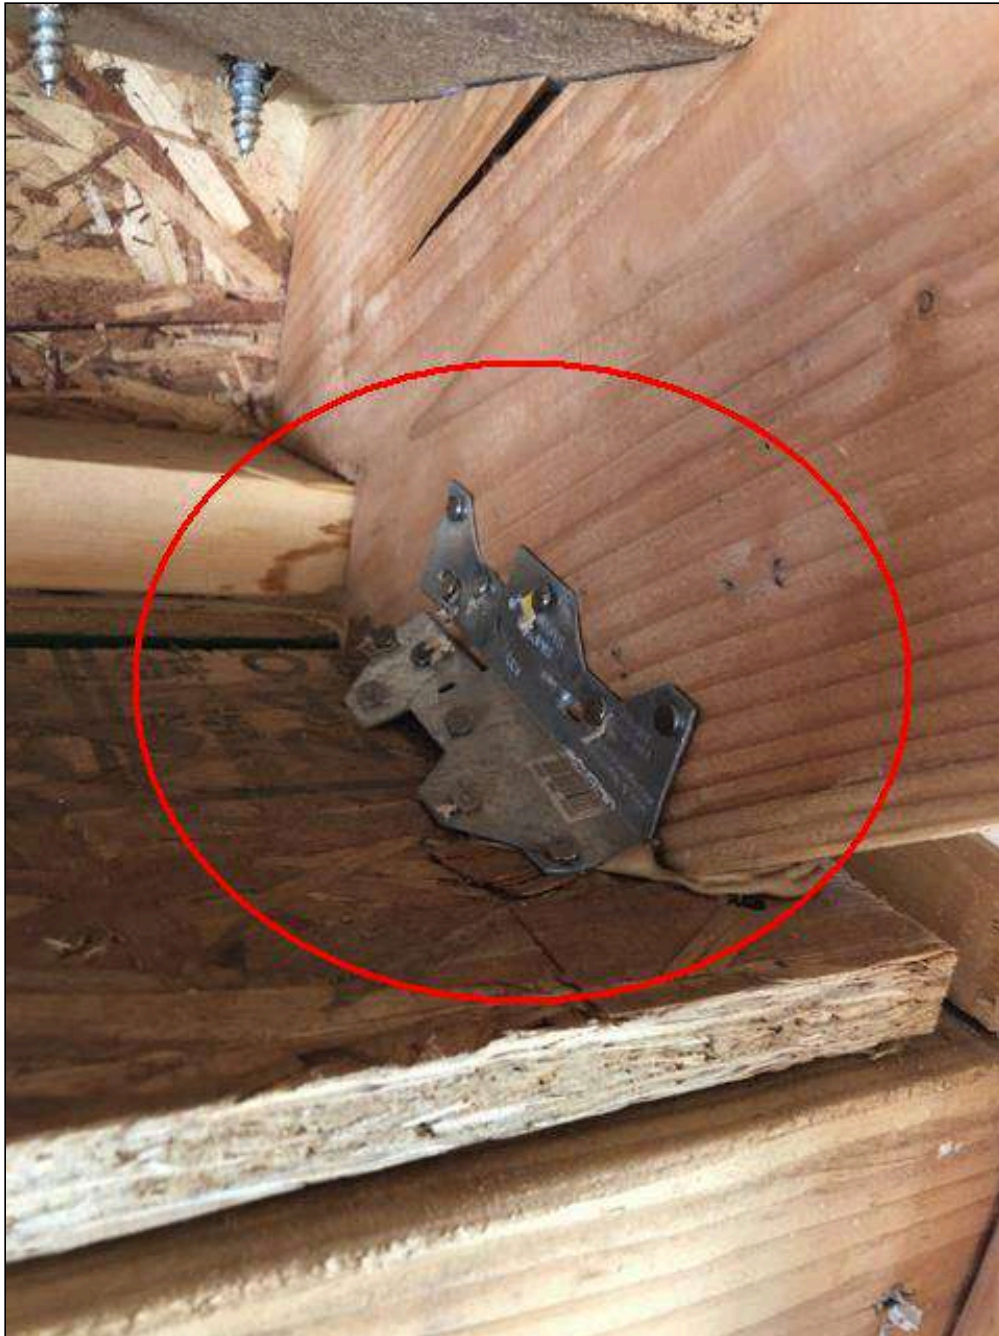
(2) On the date of inspection, looking at the joist hangers being used for the steps and the landing, I am observing a similar situation to the patio cover joist hangers where not every hanger hole that should have a nail in it has been nailed. Also a few that appear to be deformed. I recommend this be discussed with the builder for remediation.

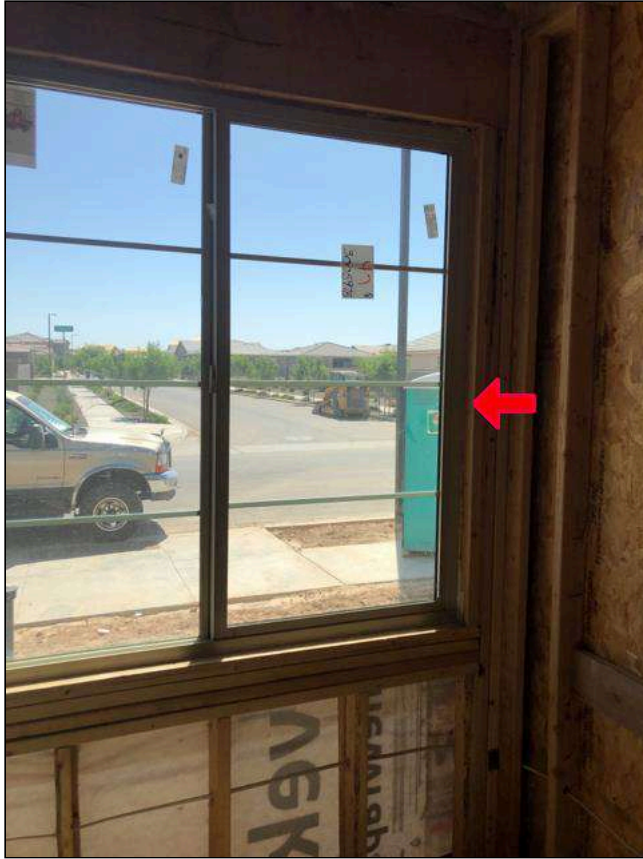
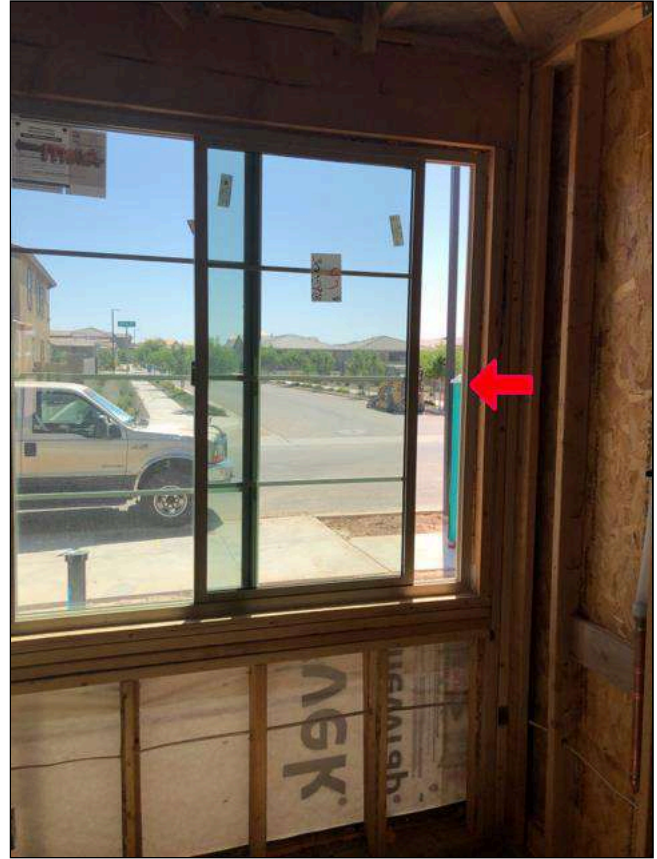
(2) Many of the sliding windows within the home were difficult to operate. However they are also in a construction zone and are really dirty and they may need to be cleaned and adjusted by a qualified, licensed window contractor. I recommend discussion with the builder to determine when this will be completed. **Review**

(3) On the date of inspection the sliding window from the room on the SouthEast corner will not operate fully. When attempting to open it will only open ~1/4 of the way freely. I recommend discussion with the builder for further evaluation of this window for proper operation to determine if adjustments, repairs or replacement is indicated.

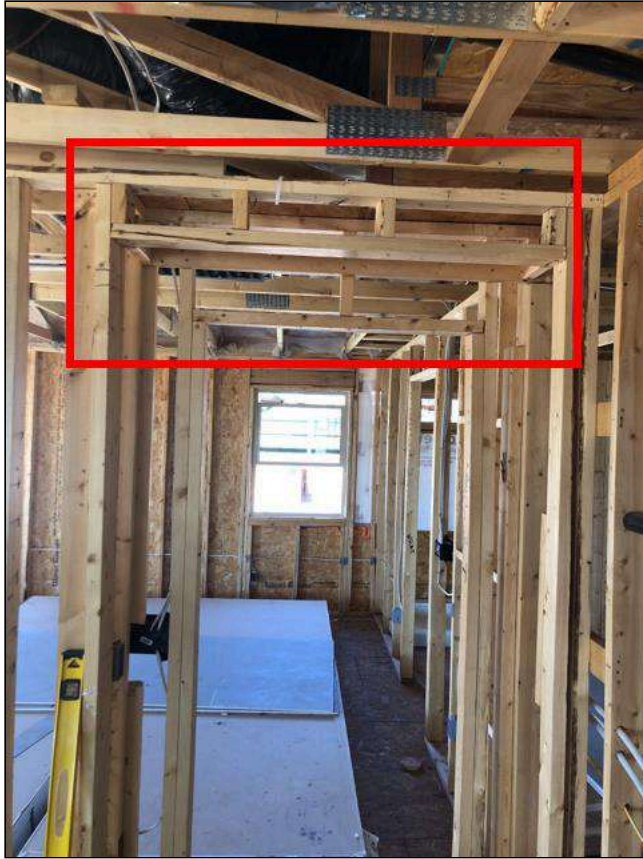
5.11 Item 1(Picture)

Interior door headers on the home are only one, flat 2 x 4 versus the expected two 2 x 4 laid flat. Exterior doors appear to be framed properly with at least a 2 x 8 header. These interior door jams are framed the same as would be typical into an archway or walkway. This type of door framing is in use today for some interior doors where there is little load. I recommend discussion with the builder to assure that the size and construction of these interior door headers are appropriate to the expected load. **Review**

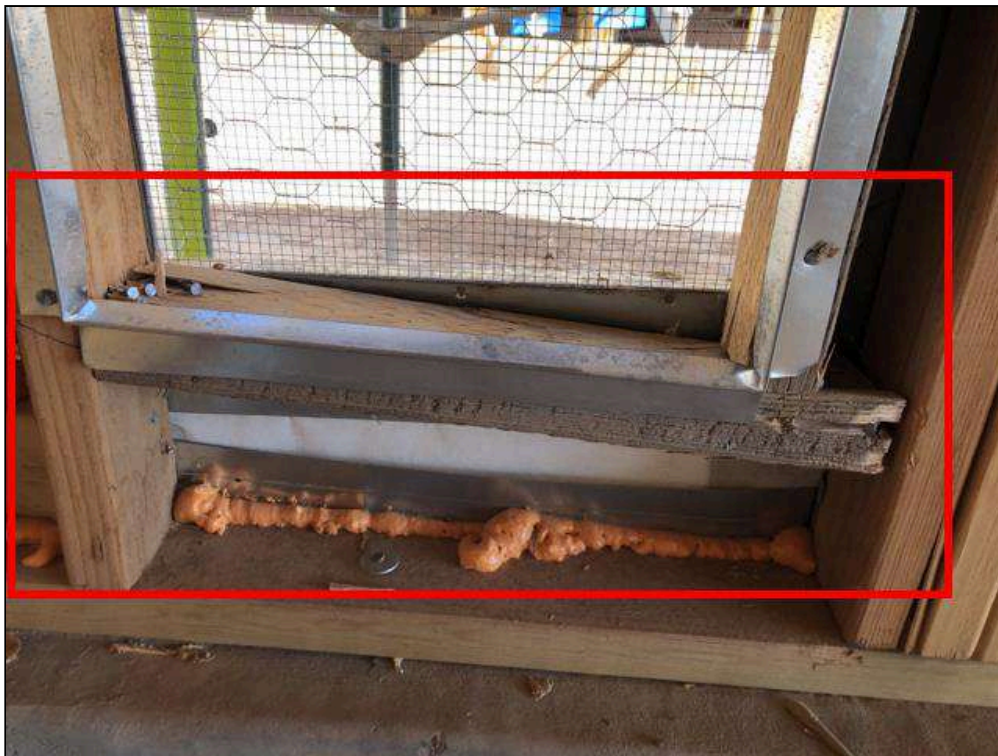
6.7 Item 1(Picture)

(2) On the date of inspection, I noticed that the vent insulations were not crippled and there is a note on the wall to cripple these boxes prior to drywall. Also on the lower vent they support lower support needs to be replaced prior to crippling. Recommend discussing with the builder to ensure this happens prior to drywall. **Attention**

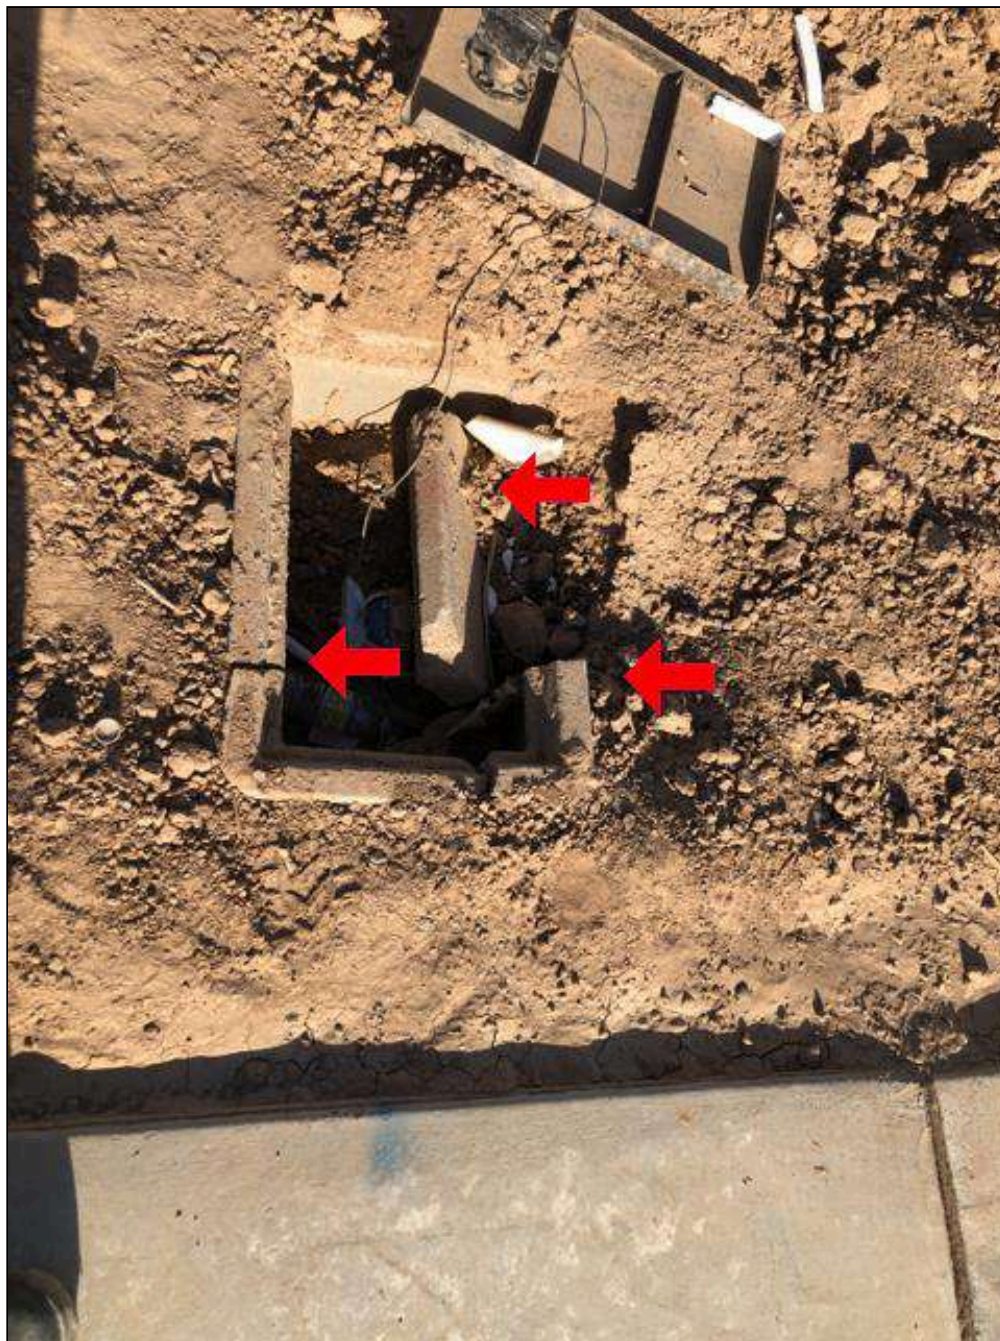
8.4 Item 6(Picture)

(3) On the date of inspection the concrete retaining walls around the meter and main shut off valve is broken in numerous places. This will not work as the final to set the meter or to set up for the long term. I recommend discussion with the builder on when this containment will be replaced by the builder. **Attention**

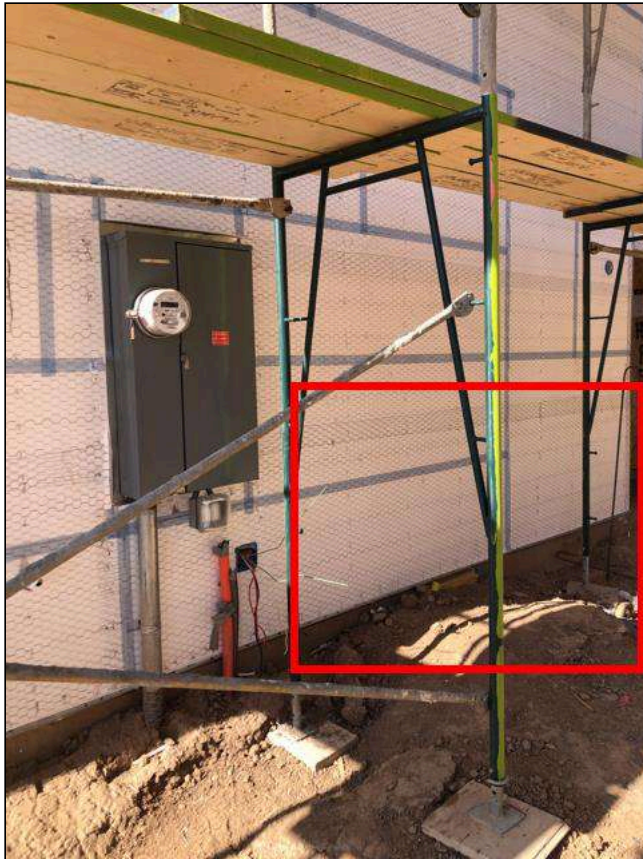
8.5 Item 1(Picture)

On the date of inspection, I am not observing the presence of a gas line to the property nor a gas installation within the home even though I am seeing others in the neighborhood. I do, however, observe some yellow PVC or plastic piping that would appear to be used for gas pipe. I am also seeing the beginnings of installation for a gas water heater as well as a gas furnace in the attic. This appears to be a rather large missing. I recommend discussion with the builder to determine how this is to be resolved. **Attention**

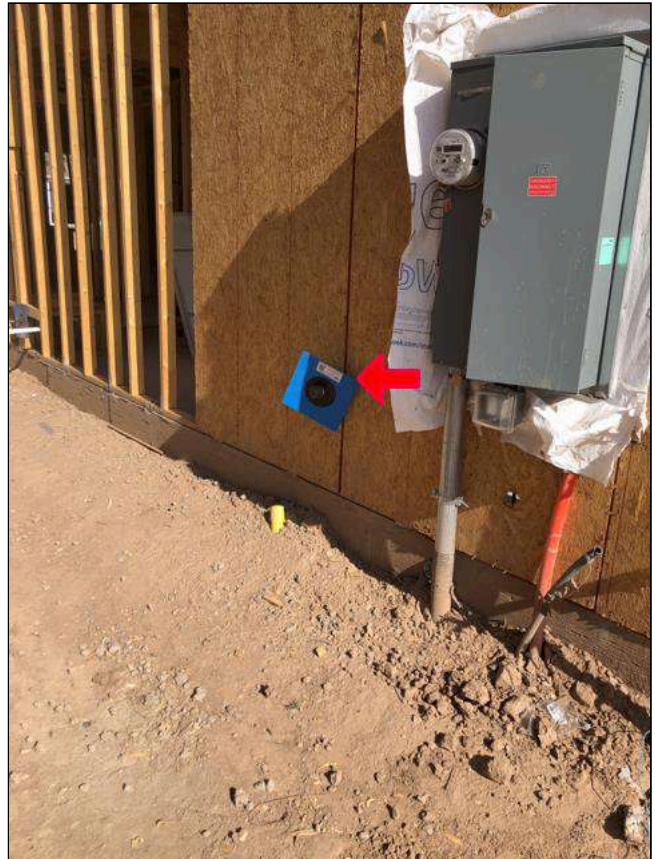
8.5 Item 2(Picture) Home next door

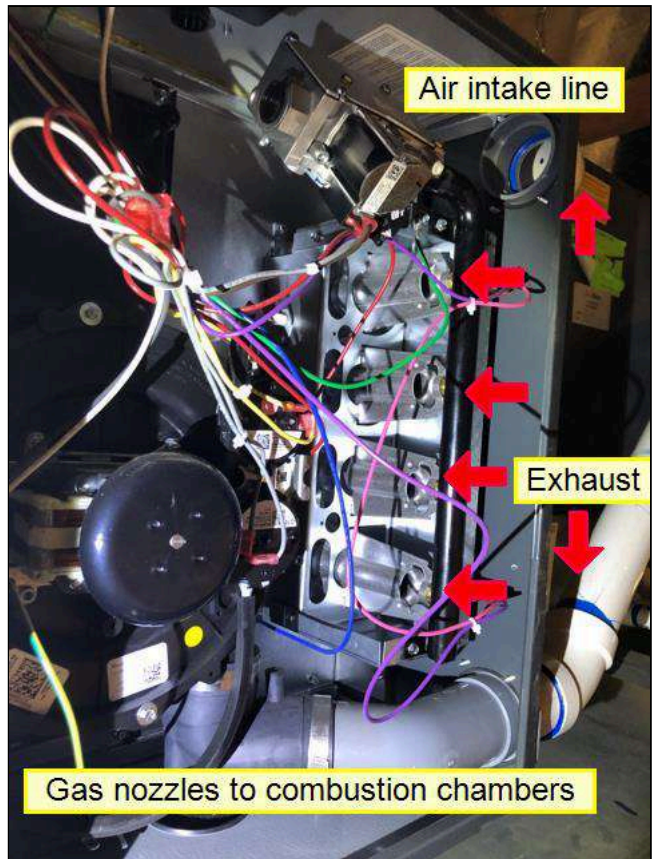
8.5 Item 4(Picture) Gas furnace but no gas line?

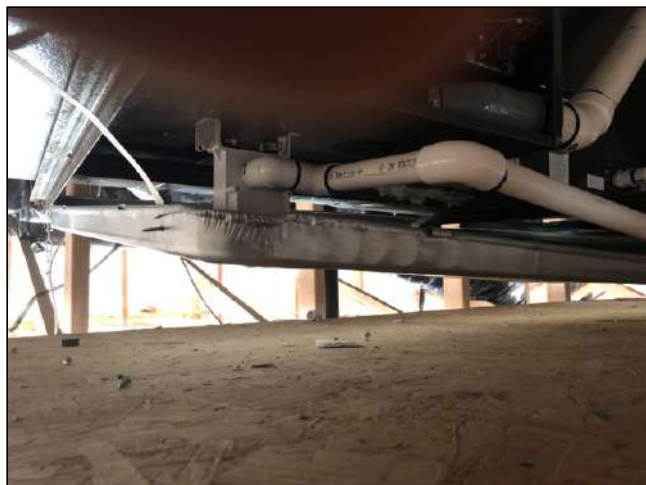
8.5 Item 5(Picture) No gas lines seen

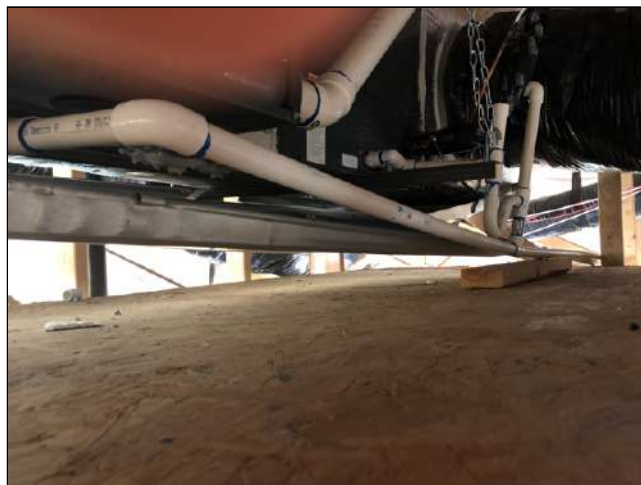
8.5 Item 6(Picture) Still none

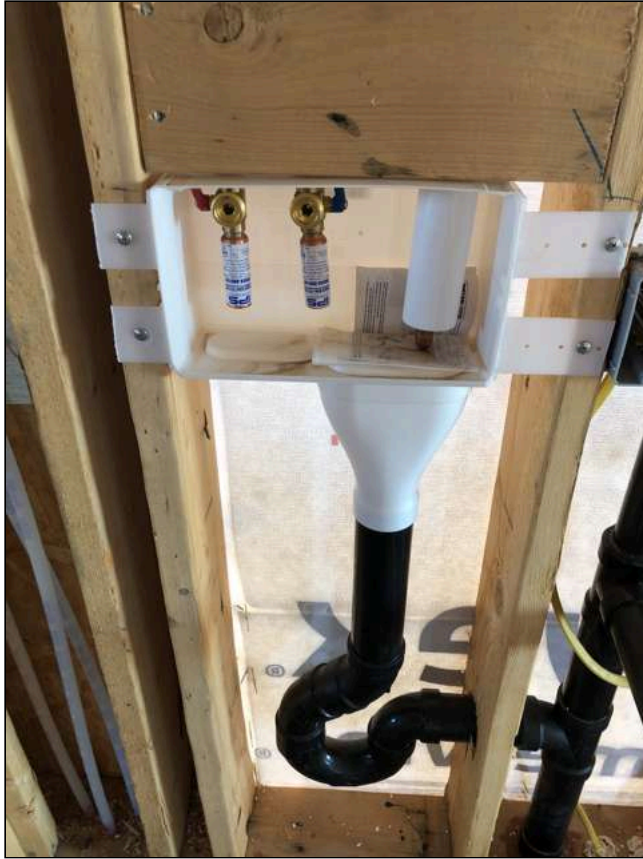
11.0 Item 1(Picture)

Note, as this is a second story laundry room it would be advisable to assure that the washing machine is installing into a secondary (spill) water containment pan plumbed to the exterior. I would recommend discussing this with the builder at this point as I am not seeing the plumbing connection readily. **Review**

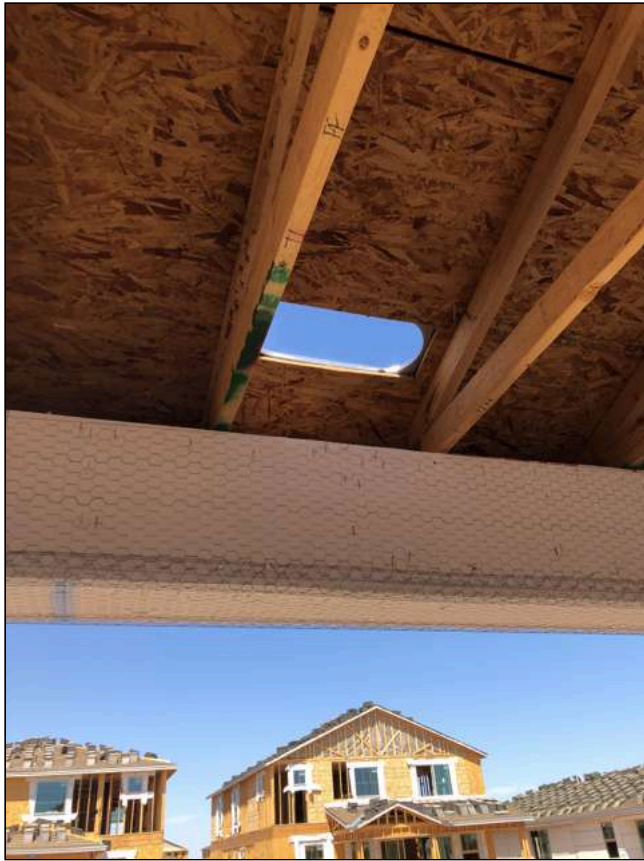
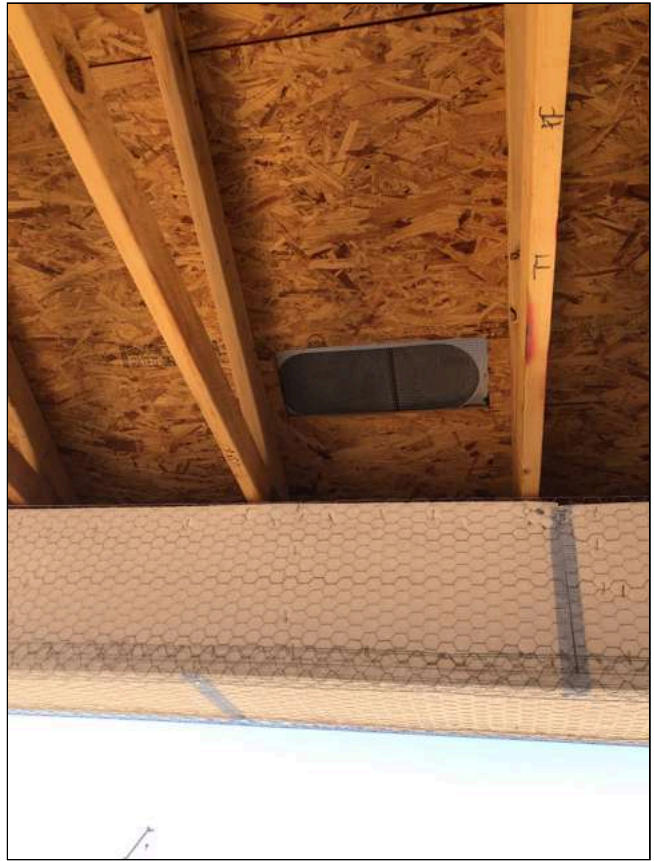
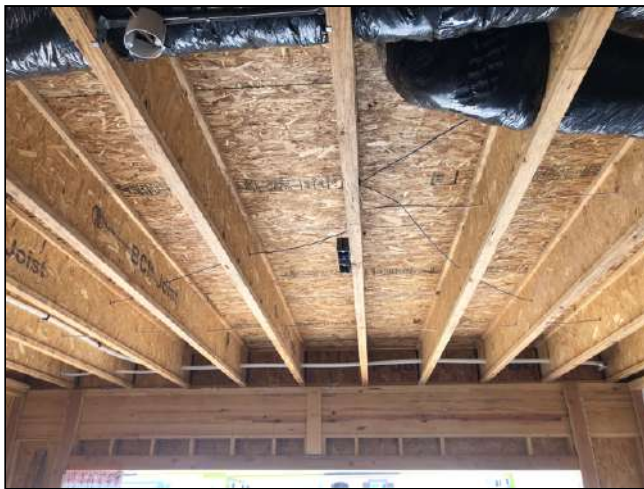
On the date of inspection the garage appears to be slated for insulation and no obvious ventilation. Observing on the back covered patio is supposed to be completed with O'Hagan vents installed with the tile. Over the main part of the house it appears to be sealed and ready for a permanent, sealed attic insulation types such as foam. I recommend discussion with the builder to understand which insulations will be used in which areas. **Monitor**
